# 2018 - 2019 Corvette: GM TechLink: Delayed Transmission Engagement

## Delayed Transmission Engagement

September 30, 2020

GM TechLink

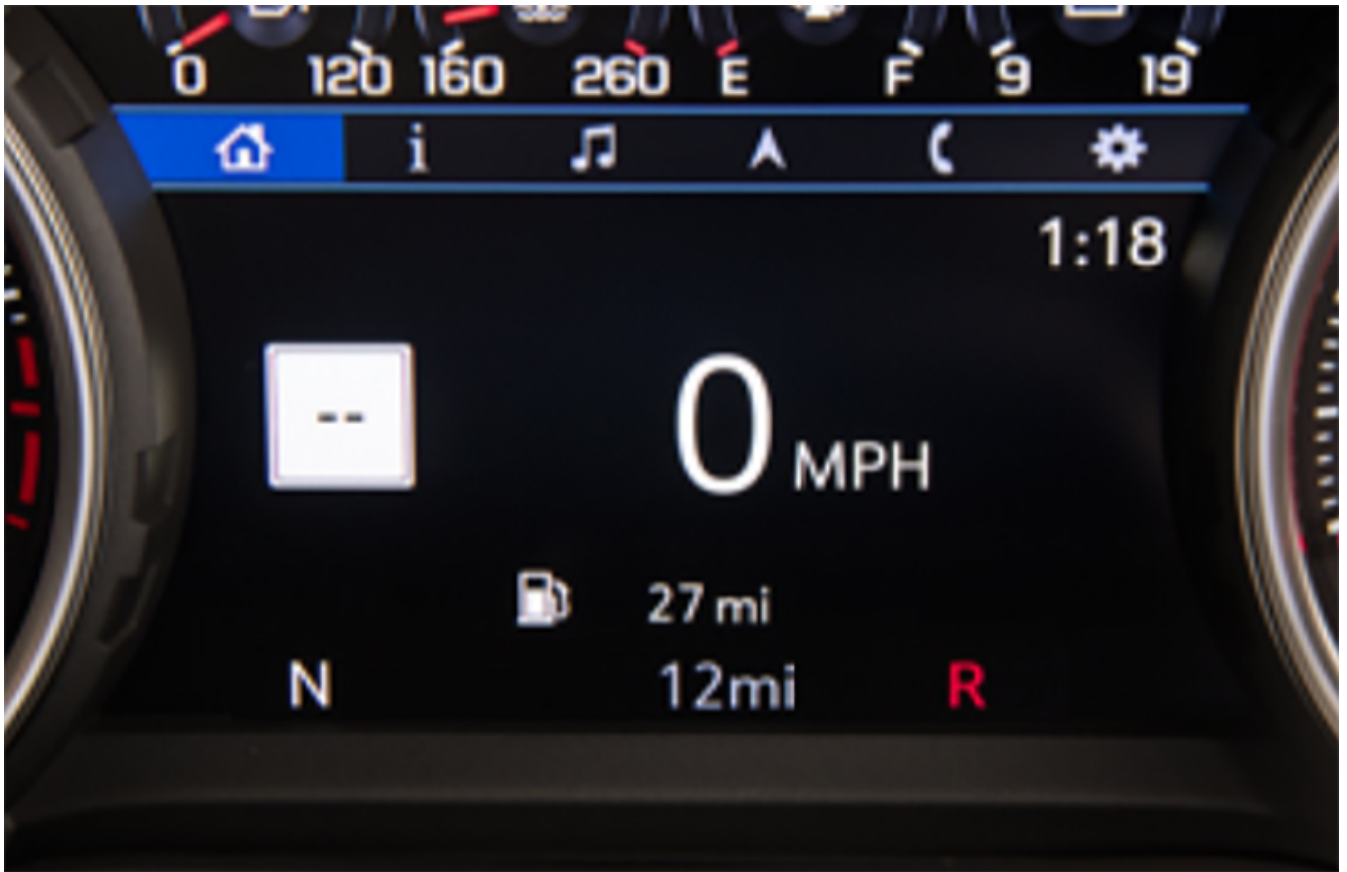
**Fig. 12**

Some **2018 - 2019 ATS, CTS, CT6, Corvette**; 2018 - 2020 Express; 2018 - 2021 Camaro, Colorado, Silverado, Canyon, Savana, Sierra; and 2021 CT4 models equipped with the 8L45 or 8L90 8-speed automatic transmission (RPO M5T, M5N, M5U, M5X, MQD, MQE) may have a delayed engagement condition when the transmission is shifted from Park to Reverse or Park to Drive after the vehicle has been sitting with the engine off. (Fig. 12) The delayed engagement typically occurs after several hours or, more commonly, overnight.

The condition may seem to be delayed gear engagement, a slipping transmission, or delayed engagement followed by a harsh engagement.

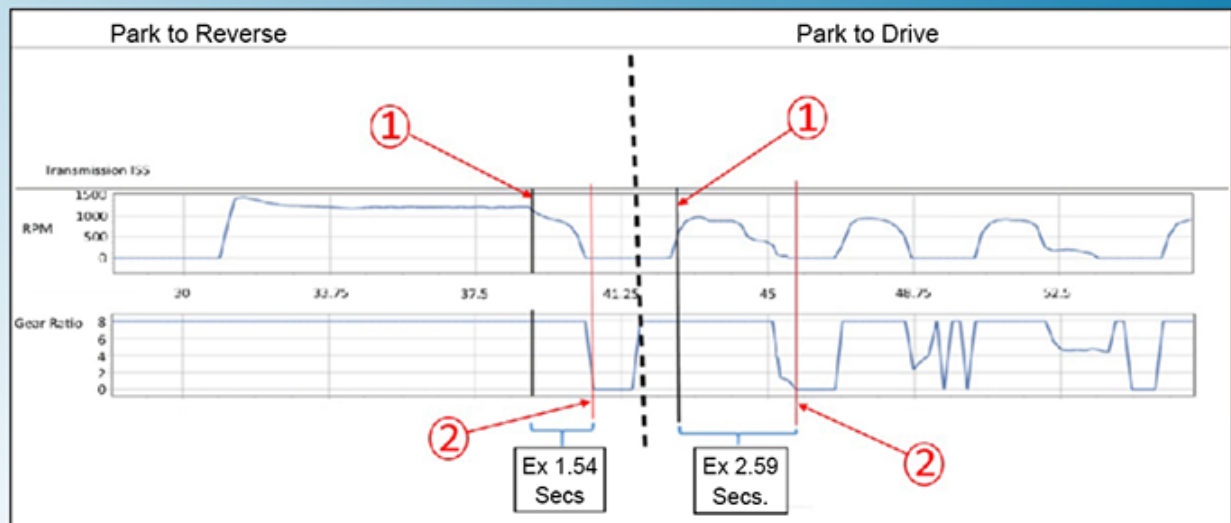
**Fig. 13**

Delayed engagement of Park to Reverse or Park to Drive is present if the time difference between the gear selected (Pt. 1) and the transmission input shaft speed reaching 0 RPMs (Pt. 2) exceeds three seconds. (Fig 13)

In most cases, the transmission will engage in three seconds or less, which is considered an acceptable engagement time and no repairs should be attempted.

If engagement time exceeds three seconds, attempt to learn the C3 – Drive and C5 Reverse – Clutch using the following steps:

1. Allow the transmission sump temperature to rise between 20° and 30°C (68° and 86°F). Do not apply the accelerator pedal.
2. Perform 20 Park to Reverse shifts or 20 Park to Drive shifts releasing the brake pedal with each shift, allowing the vehicle to roll 5-10 feet (1.5-3.0 m) per engagement into gear.

If the learn procedure does not correct the condition, disassemble the transmission and inspect the 1-3-5-6-7 Clutch (C3) for a delay into Drive condition and inspect the 4-5-6-7-8 Reverse Clutch (C5) for a delay into Reverse condition. The respective clutch plates and seals should be inspected for wear and or damage and repaired accordingly.
