# 2018 - 2019 Corvette: GM TechLink: Delayed Transmission Engagement

## Delayed Transmission Engagement

September 30, 2020

GM TechLink

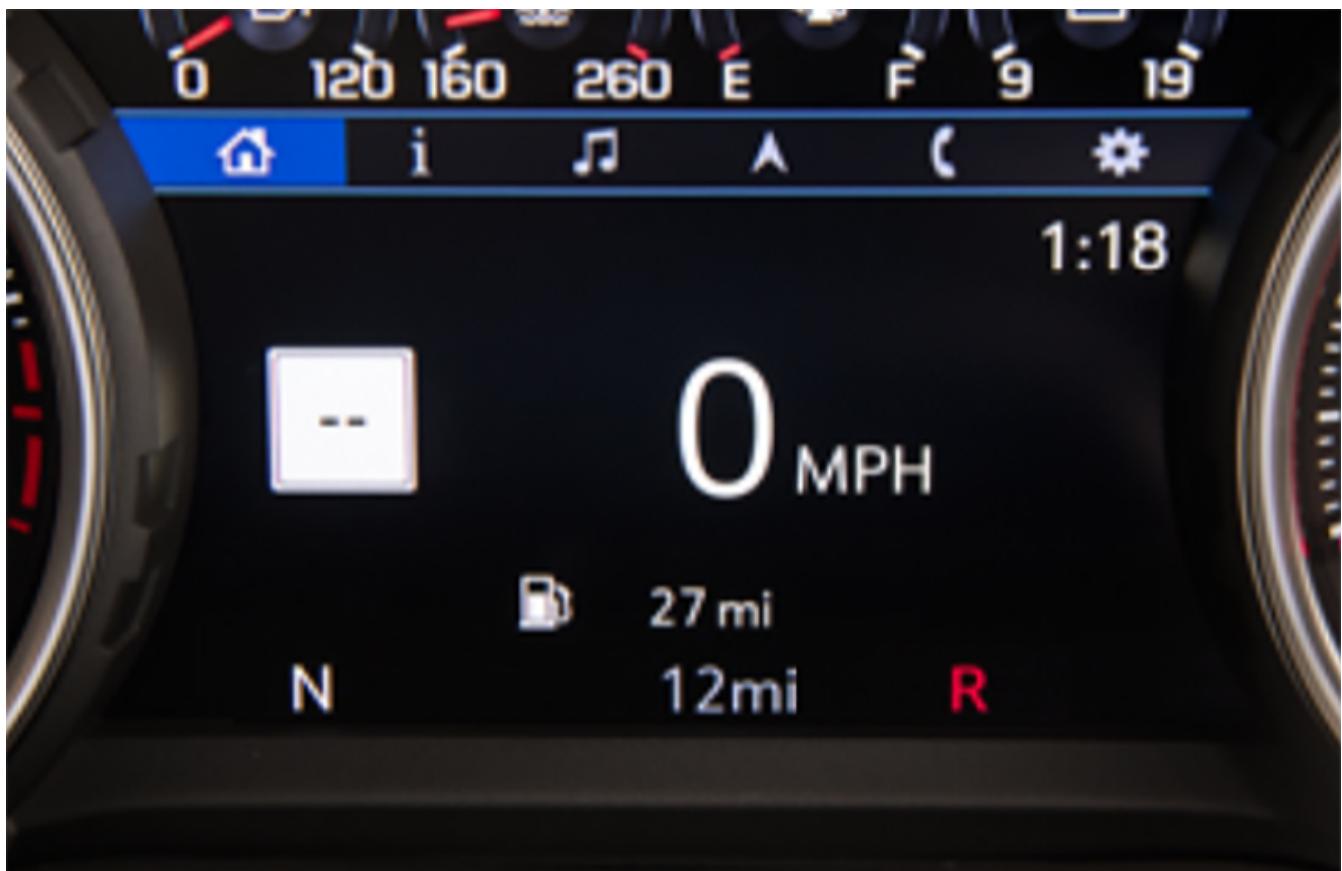
**Fig. 12**

Some **2018 - 2019 ATS, CTS, CT6, Corvette; 2018 - 2020 Express; 2018 - 2021 Camaro, Colorado, Silverado, Canyon, Savana, Sierra; and 2021 CT4** models equipped with the 8L45 or 8L90 8-speed automatic transmission (RPO M5T, M5N, M5U, M5X, MQD, MQE) may have a delayed engagement condition when the transmission is shifted from Park to Reverse or Park to Drive after the vehicle has been sitting with the engine off. (Fig. 12) The delayed engagement typically occurs after several hours or, more commonly, overnight.

The condition may seem to be delayed gear engagement, a slipping transmission, or delayed engagement followed by a harsh engagement.

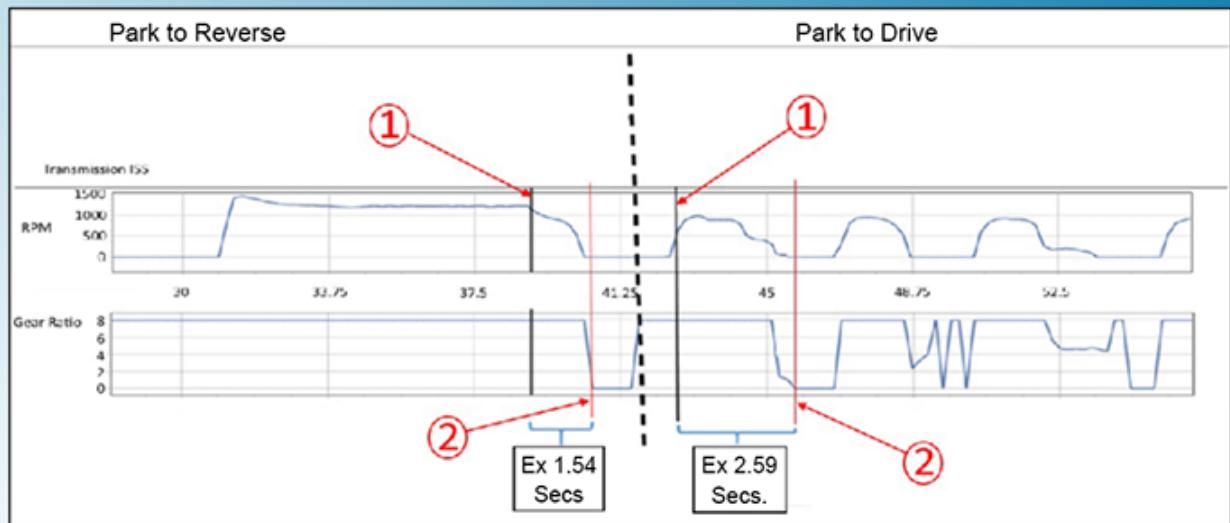
**Fig. 13**

Delayed engagement of Park to Reverse or Park to Drive is present if the time difference between the gear selected (Pt. 1) and the transmission input shaft speed reaching 0 RPMs (Pt. 2) exceeds three seconds. (Fig 13)

In most cases, the transmission will engage in three seconds or less, which is considered an acceptable engagement time and no repairs should be attempted.

If engagement time exceeds three seconds, attempt to learn the C3 – Drive and C5 Reverse – Clutch using the following steps:

1. Allow the transmission sump temperature to rise between 20° and 30°C (68° and 86°F). Do not apply the accelerator pedal.
2. Perform 20 Park to Reverse shifts or 20 Park to Drive shifts releasing the brake pedal with each shift, allowing the vehicle to roll 5-10 feet (1.5-3.0 m) per engagement into gear.

If the learn procedure does not correct the condition, disassemble the transmission and inspect the 1-3-5-6-7 Clutch (C3) for a delay into Drive condition and inspect the 4-5-6-7-8 Reverse Clutch (C5) for a delay into Reverse condition. The respective clutch plates and seals should be inspected for wear and or damage and repaired accordingly.
