# 2020 Corvette: Service Bulletin:: #20-NA-179: Malfunction Indicator Lamp (MIL) Illuminated - DTCs P0521 and/or P06DD Set - (Oct 23, 2020)

<b>Subject:</b>	Malfunction Indicator Lamp (MIL) Illuminated – DTCs P0521 and/or P06DD Set					
<b>Brand:</b>	<b>Model:</b>	<b>Model Year:</b>	<b>VIN Breakpoint:</b>	<b>Engine:</b>	<b>Transmi</b>	<b>ssion:</b>
		from      to	from      to			
Chevrolet	Corvette	2020	2020	SORP	September 10, 2020	6.2L (LT2)

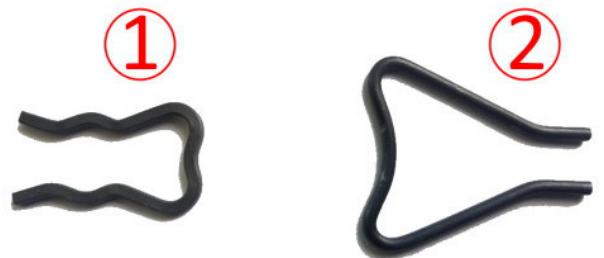
If P0521 and P06DD DTCs are present, then a redesigned oil pressure control valve retainer clip (1) may be necessary. Refer to the Service Procedure section below.

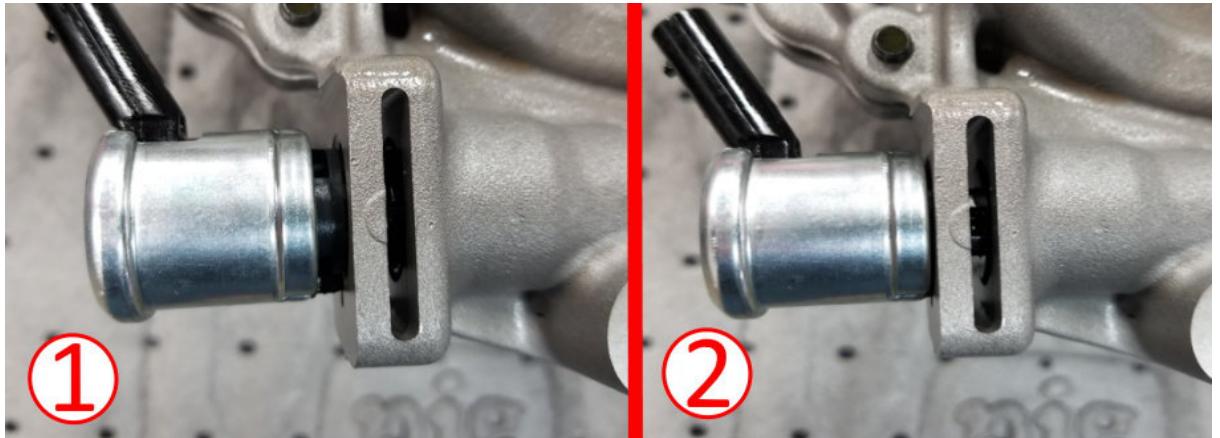
1. Inspect the OCV:

- If you find this oil pressure control valve dislodged (1), it will be necessary to install a redesigned oil control valve retainer.
- Disconnect the oil pressure control valve electrical connector and position aside.
