2020 Corvette: Service Bulletin:: #20-NA-179: Malfunction Indicator Lamp (MIL) Illuminated - DTCs P0521 and/or P06DD Set - (Oct 23, 2020)

Subject: Malfunction Indicator Lamp (MIL) Illuminated – DTCs P0521 and/or P06DD Set

Brand:	Model:	Model Year:		VIN Breakpoint:		Engine:	Transmission:
		from	to	from	to		
Chevrolet	Corvette	2020	2020	SORP	September 10, 2020	6.2L (LT2)	—

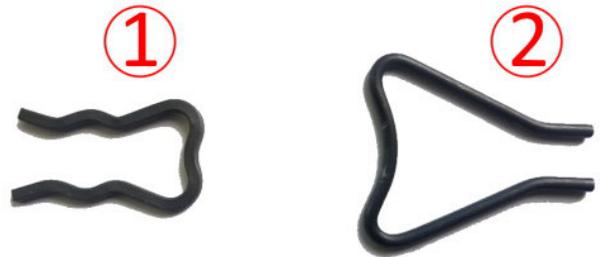
This condition may be caused by an unseated engine oil pressure control valve (OCV).

Note: If a vehicle comes in with one of these DTCs, follow SI for both DTCs to ensure there is not an electrical fault or other hardware concern. After diagnosis has been performed and no issues are found electrically, then it will be necessary to remove the engine oil pan and inspect for a unseated engine oil pressure control valve, which is mounted on the bottom of the engine oil pump.

If P0521 and P06DD DTCs are present, then a redesigned oil pressure control valve retainer clip (1) may be necessary. Refer to the Service Procedure section below.

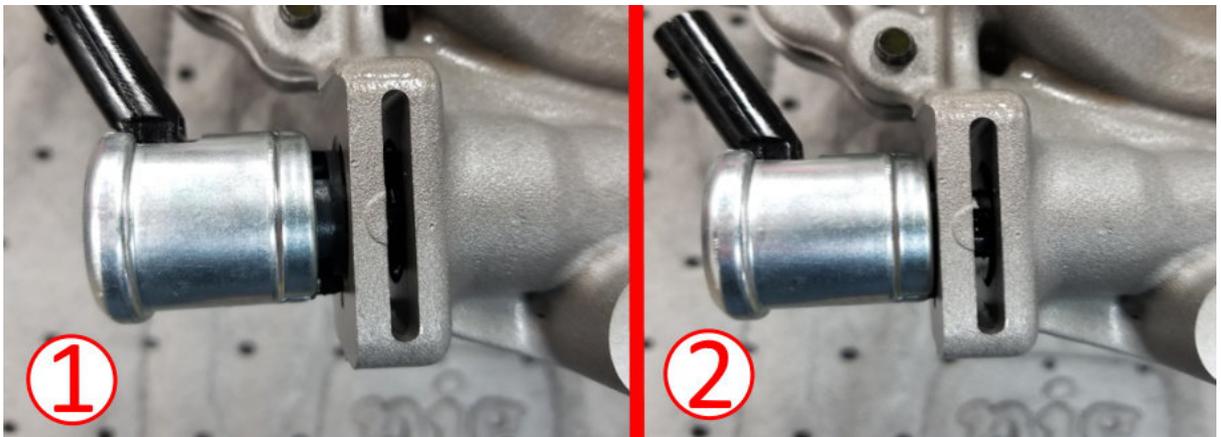
1. Inspect the OCV:
 - If you find this oil pressure control valve dislodged (1), it will be necessary to install a redesigned oil control valve retainer.
- Disconnect the oil pressure control valve electrical connector and position aside.
