2020 Corvette: Service Bulletin:: #20-NA-179: Malfunction Indicator Lamp (MIL) Illuminated - DTCs P0521 and/or P06DD Set - (Oct 23, 2020)

Subject: Malfunction Indicator Lamp (MIL) Illuminated – DTCs P0521 and/or P06DD Set

Brand:	Model:	Model Year:		VIN Breakpoint:		Engine:	Transmission:
		from	to	from	to		
Chevrolet	Corvette	2020	2020	SORP	September 10, 2020	6.2L (LT2)	—

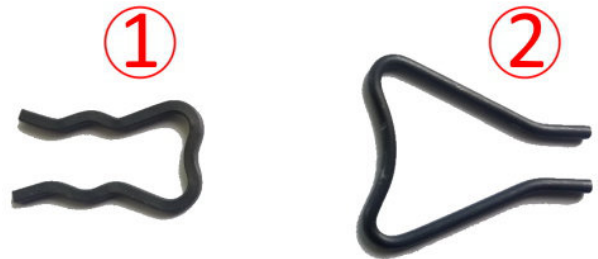
This condition may be caused by an unseated engine oil pressure control valve (OCV).

If P0521 and P06DD DTCs are present, then a redesigned oil pressure control valve retainer clip (1) may be necessary. Refer to the Service Procedure section below.

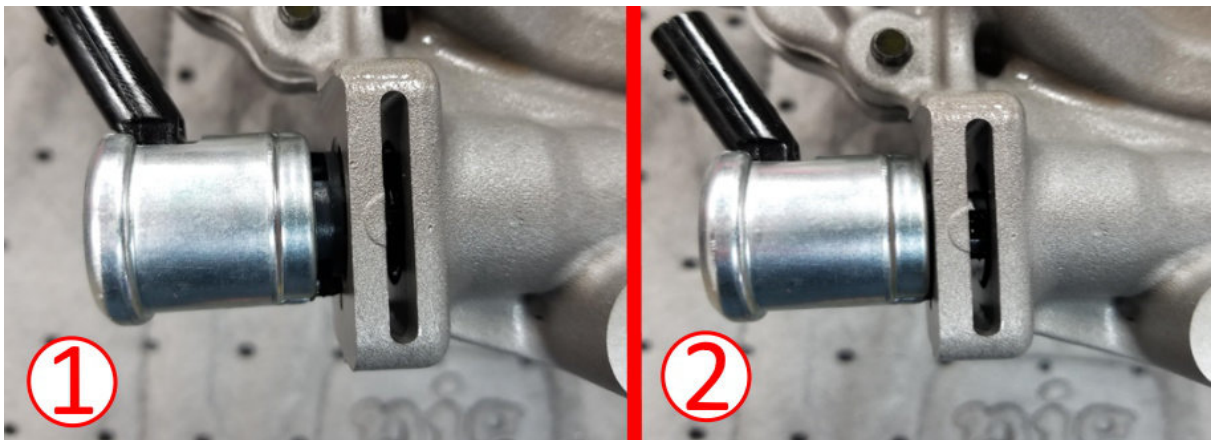
1. Inspect the OCV:
 - If you find this oil pressure control valve dislodged (1), it will be necessary to install a redesigned oil control valve retainer.
- Disconnect the oil pressure control valve electrical connector and position aside.
