# 2005 - 2020 Corvette: Service Bulletin: #PIC6378A: Diagnosing Various Concerns On A Power Folding Top - (Oct 29, 2020)

## #PIC6378A: Diagnosing Various Concerns On A Power Folding Top - (Oct 29, 2020)

Subject:		Diagnosing Various Concerns On A Power Folding Top					
Brand:	Model:	Model Year:		VIN:		Engine:	Transmi ssion:
		from	to	from	to		
Buick	Cascada	2016 - 2019		All	All	All	All
Cadillac	XLR	2004 - 2009		All	All	All	All
Chevrolet	Camaro	2011 - 2021		All	All	All	All
Chevrolet	Corvette	2005 - 2020		All	All	All	All
Pontiac	G6	2005 - 2010		All	All	All	All

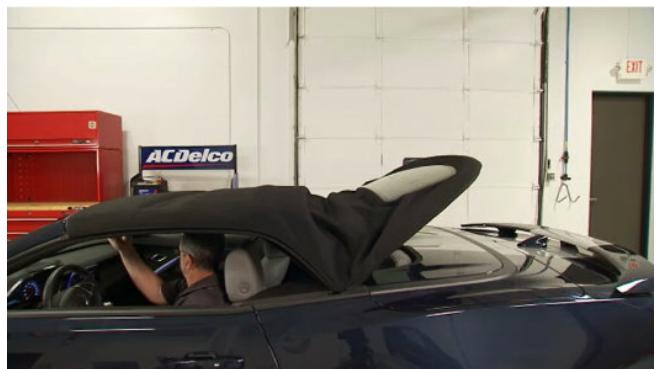
Example Case: Let's take a 2018 Chevrolet Camaro for instance, with a basic folding top concern. The customer states that the top will open fine, but it will not close all the way. A preliminary check will indicate that there is a "Top Not Secure" message in the DIC, but no DTCs are set. The tech is able to duplicate the concern each and every time. When closing, the top will lift up out of the stowage compartment, latch tightly to the windshield header, and the tension bow will lift up to a 45° angle. The Rear Stowage Compartment Lid will lower and lock into position, but the tension bow will not lower. It simply remains suspended in the air as seen in the photo below. The folding top pump quits working and the top stops moving at that point.

On a correctly working car, the stowage compartment lid must close completely before the tension bow is commanded down. Because the steps or phases must be completed in order, the technician must go to the point where the failure occurs, and then go back one step to look at the scan tool data.

Looking at the scan tool sensor data below, we can see that only one of the two Stowage Compartment Lid Closed Position Sensors read "On". Because the Folding Top Control Module will not command the tension bow to lower if both Stowage Compartment Lid Closed Position Sensors are not showing that they are closed, the module thinks that the stowage lid is still raised. As a matter of operation, it will not continue the top cycle. In this instance, the technician must further inspect the Right Folding Top Stowage Compartment Lid Closed Position Sensor to determine what the fault is.
