# 2005 - 2020 Corvette: Service Bulletin: #PIC6378A: Diagnosing Various Concerns On A Power Folding Top - (Oct 29, 2020)

**Subject:** Diagnosing Various Concerns On A Power Folding Top

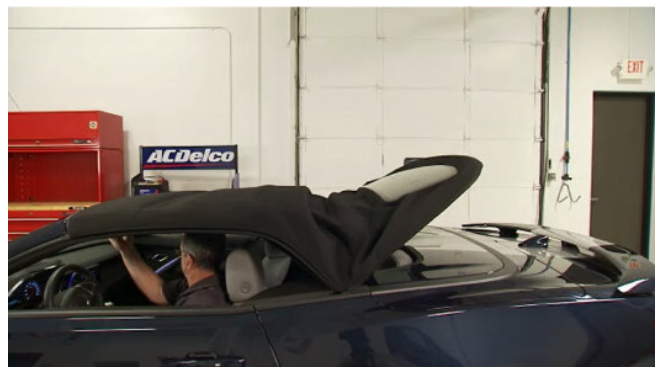
Example Case: Let's take a 2018 Chevrolet Camaro for instance, with a basic folding top concern. The customer states that the top will open fine, but it will not close all the way. A preliminary check will indicate that there is a "Top Not Secure" message in the DIC, but no DTCs are set. The tech is able to duplicate the concern each and every time. When closing, the top will lift up out of the stowage compartment, latch tightly to the windshield header, and the tension bow will lift up to a 45° angle. The Rear Stowage Compartment Lid will lower and lock into position, but the tension bow will not lower. It simply remains suspended in the air as seen in the photo below. The folding top pump quits working and the top stops moving at that point.

On a correctly working car, the stowage compartment lid must close completely before the tension bow is commanded down. Because the steps or phases must be completed in order, the technician must go to the point where the failure occurs, and then go back one step to look at the scan tool data.

Looking at the scan tool sensor data below, we can see that only one of the two Stowage Compartment Lid Closed Position Sensors read "On". Because the Folding Top Control Module will not command the tension bow to lower if both Stowage Compartment Lid Closed Position Sensors are not showing that they are closed, the module thinks that the stowage lid is still raised. As a matter of operation, it will not continue the top cycle. In this instance, the technician must further inspect the Right Folding Top Stowage Compartment Lid Closed Position Sensor to determine what the fault is.
