2014 - 2019 Corvette: Service Bulletin: #15-06-01-002K: Engine Misfire/Tick Noise, Malfunction Indicator Lamp (MIL) Illuminated - DTC P0300 Set - (Dec 17, 2020)

#15-06-01-002K: Engine Misfire/Tick Noise, Malfunction Indicator Lamp (MIL) Illuminated - DTC P0300 Set - (Dec 17, 2020)

Equipped with 5.3L Engine (RPOs L83, L8B) or 6.2L Engine (RPOs L86, LT1, LT4)

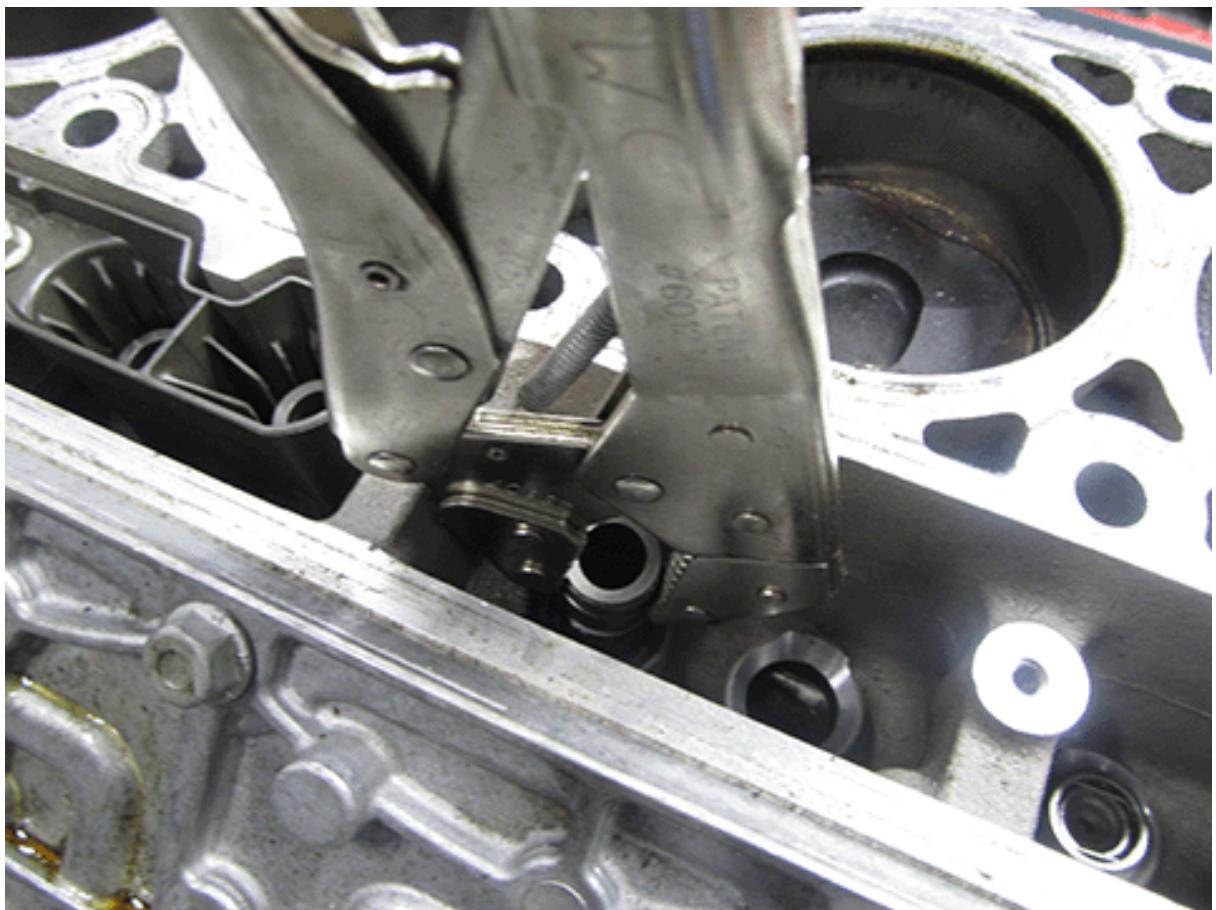
- Active fuel management (AFM) lifter that is mechanically collapsed and/or stuck all of the time.
- Internal locking pin damage in the lifter, due to oil aeration.
- Lifter that has collapsed and is stuck in the lifter bore.

1. Use vice grips with a slide hammer.

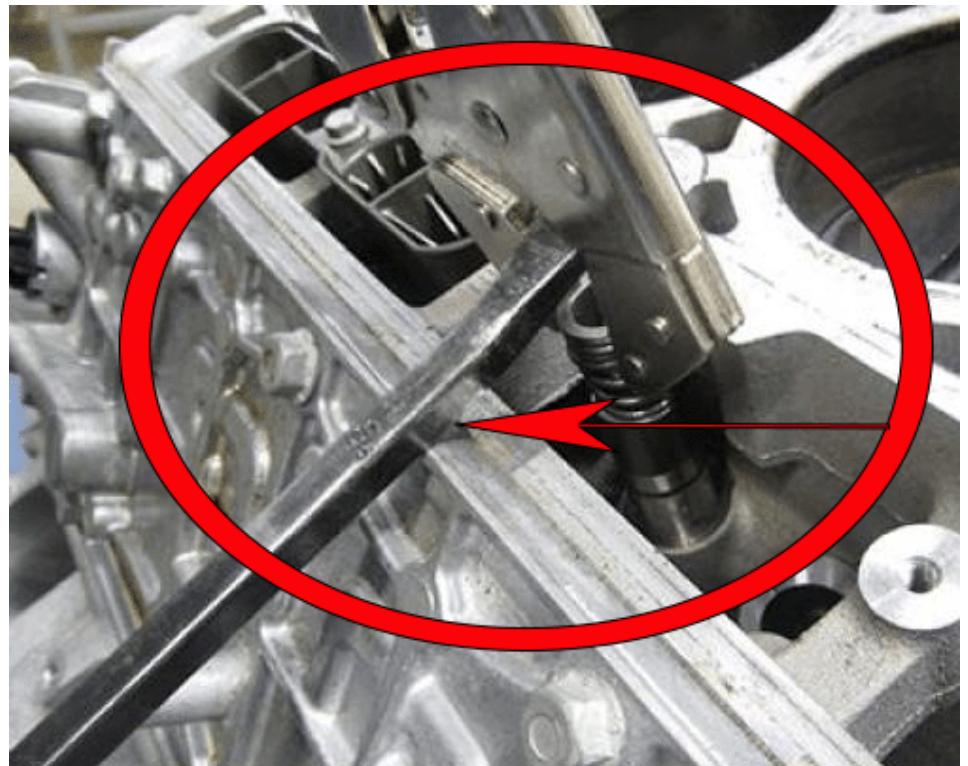
Note: Be sure *NOT* to pry on the sealing surface of the block, as shown in the illustration above.

1. Use vice grips with a small pry bar.
