2014 - 2019 Corvette: Service Bulletin: #15-06-01-002K: Engine Misfire/Tick Noise, Malfunction Indicator Lamp (MIL) Illuminated - DTC P0300 Set - (Dec 17, 2020)

Subject:	Engine Misfire/Tick Noise, Malfunction Indicator Lamp (MIL) Illuminated - DTC P0300 Set
Models:	2015-2019 Cadillac Escalade 2016 - 2019 Cadillac CTS-V 2014 Chevrolet Silverado 1500 2014 - 2019 Chevrolet Corvette 2015-2018 Chevrolet Silverado 2015-2019 Chevrolet Suburban, Tahoe 2016-2019 Chevrolet Camaro 2019 Chevrolet Silverado LD 2014 GMC Sierra 1500 2015-2018 GMC Sierra 2015-2019 GMC Yukon, Yukon XL 2019 GMC Sierra Limited Equipped with 5.3L Engine (RPOs L83, L8B) or 6.2L Engine (RPOs L86, LT1, LT4)
Attention:	This bulletin also applies to any of the above models from North America, Europe, Uzbekistan, Russia, Middle East, Iraq, Israel, Palestine, Argentina, Brazil, Bolivia, Chile, Colombia, Ecuador, Paraguay, Peru, Uruguay, Venezuela, Japan, Cadillac Korea (South Korea), GM Korea Company, China, Taiwan,

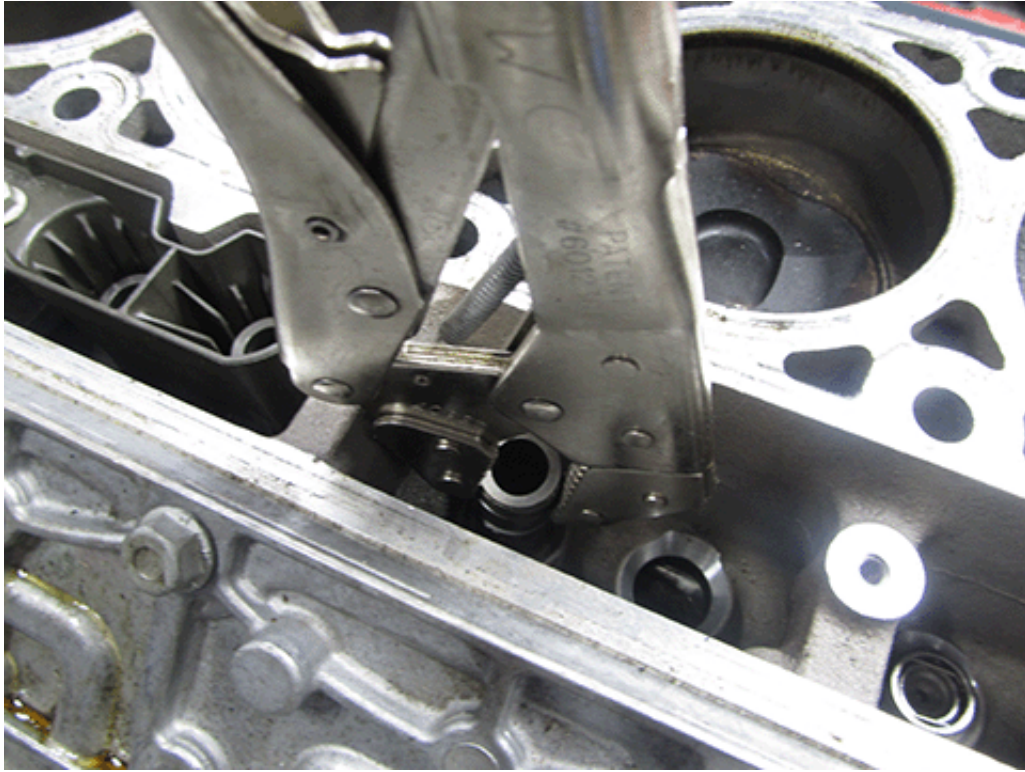
There are two approved processes for removing the lifter when stuck in the bore.

1. Use vice grips with a slide hammer.

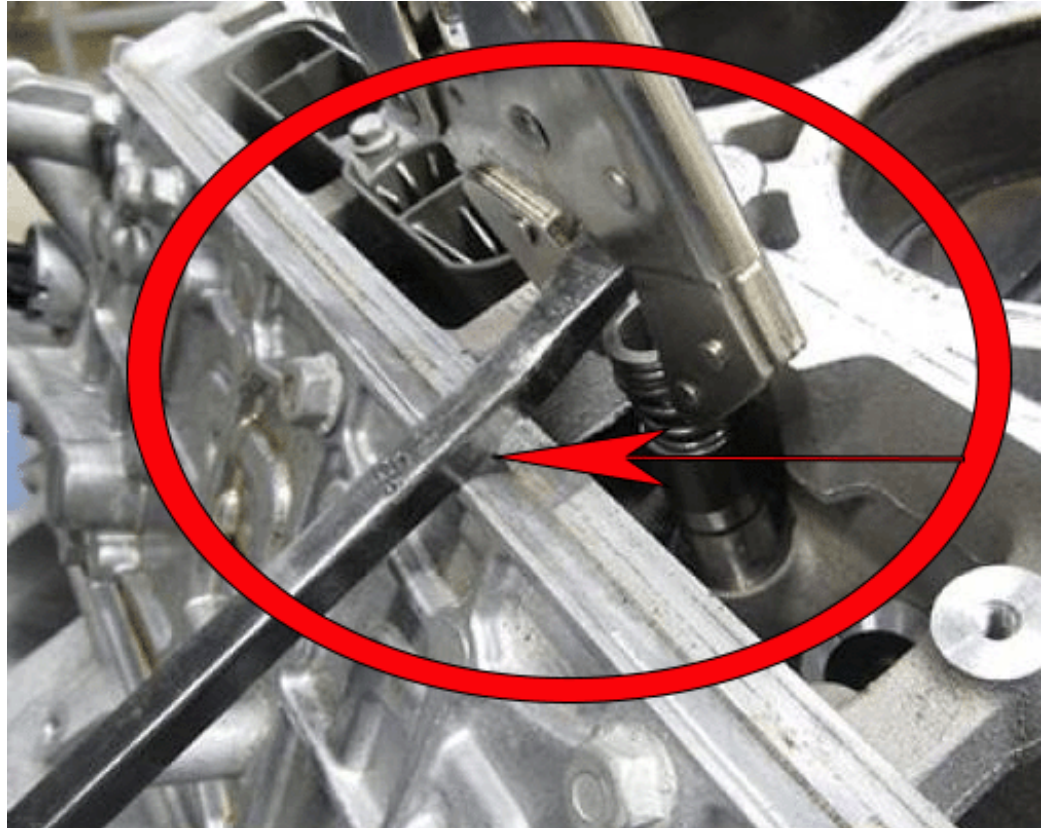
Note: Be sure *NOT* to pry on the sealing surface of the block, as shown in the illustration above.

1. Use vice grips with a small pry bar.
