**2014 - 2019 Corvette: Service Bulletin:  
#15-06-01-002K: Engine Misfire/Tick Noise,  
Malfunction Indicator Lamp (MIL) Illuminated -  
DTC P0300 Set - (Dec 17, 2020)**

**Subject:** Engine Misfire/Tick Noise,  
Malfunction Indicator Lamp (MIL)  
Illuminated - DTC P0300 Set

**Models:** 2015-2019 Cadillac Escalade  
2016 - 2019 Cadillac CTS-V  
2014 Chevrolet Silverado 1500  
2014 - 2019 Chevrolet Corvette  
2015-2018 Chevrolet Silverado  
2015-2019 Chevrolet Suburban,  
Tahoe  
2016-2019 Chevrolet Camaro  
2019 Chevrolet Silverado LD  
2014 GMC Sierra 1500  
2015-2018 GMC Sierra  
2015-2019 GMC Yukon, Yukon XL  
2019 GMC Sierra Limited

Equipped with 5.3L Engine (RPOs L83, L8B) or 6.2L Engine (RPOs L86, LT1, LT4)

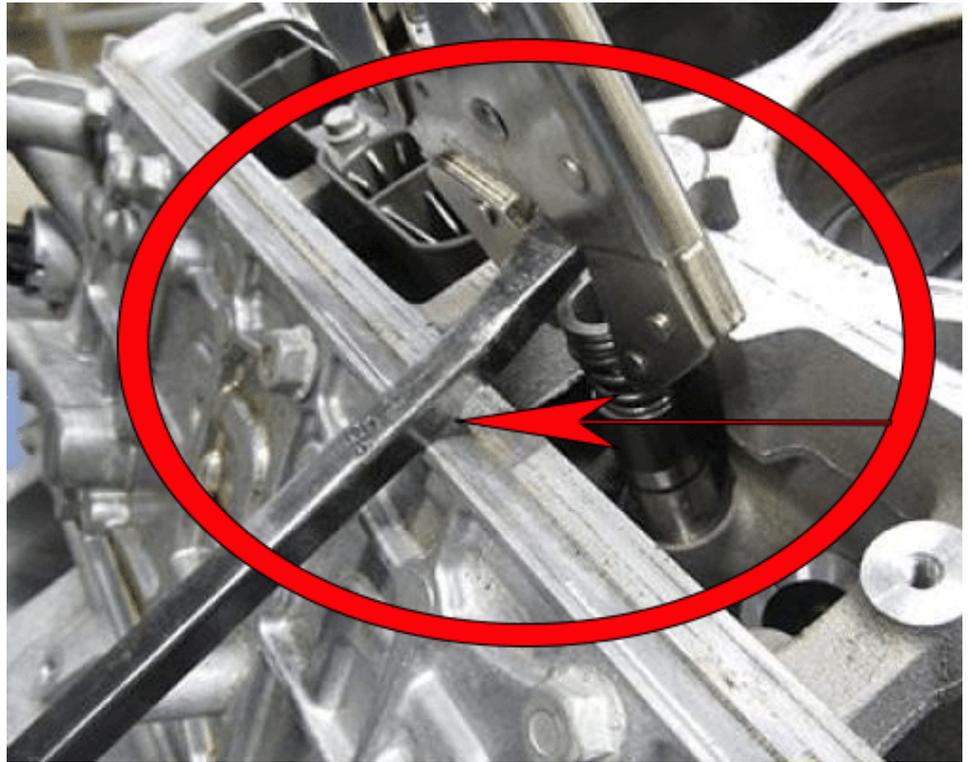
**Note:** Be sure *NOT* to pry on the sealing surface of the block, as shown in the illustration above.

1. Use vice grips with a small pry bar.
