**2014 - 2019 Corvette: Service Bulletin:
#15-06-01-002K: Engine Misfire/Tick Noise,
Malfunction Indicator Lamp (MIL) Illuminated -
DTC P0300 Set - (Dec 17, 2020)**

Subject: Engine Misfire/Tick Noise,
Malfunction Indicator Lamp (MIL)
Illuminated - DTC P0300 Set

Models: 2015-2019 Cadillac Escalade
2016 - 2019 Cadillac CTS-V
2014 Chevrolet Silverado 1500
2014 - 2019 Chevrolet Corvette
2015-2018 Chevrolet Silverado
2015-2019 Chevrolet Suburban,
Tahoe
2016-2019 Chevrolet Camaro
2019 Chevrolet Silverado LD
2014 GMC Sierra 1500
2015-2018 GMC Sierra
2015-2019 GMC Yukon, Yukon XL
2019 GMC Sierra Limited

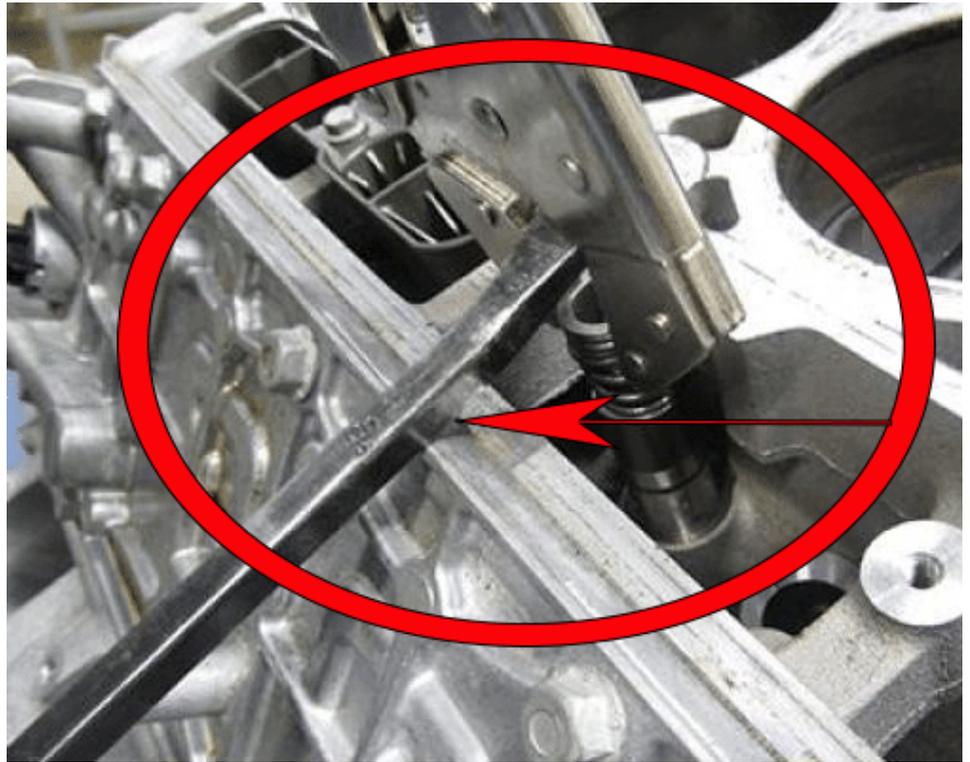
Note: Be sure *NOT* to pry on the sealing surface of the block, as shown in the illustration above.

1. Use vice grips with a small pry bar.
