# 2014 - 2019 Corvette: Service Bulletin: #19-NA-217: Manual Transmission Stalling, Clutch Chatter and/or Hard Shifting into 1st Gear or Reverse; Automatic Transmission Vibration on Launch and/or Engine Noise - (Dec 21, 2020)

**Subject:** Manual Transmission Stalling, Clutch Chatter and/or Hard Shifting into 1st Gear or Reverse; Automatic Transmission Vibration on Launch and/or Engine Noise

Brand:	Model:	Model Year:		VIN Breakpoint		Engine:	Transmission:
		from	to	from	to		
Chevrolet	Corvette	2014	2019	—	—	6.2L (LT1, LT4)	6L80 Automatic (MYC), 8L90 Automatic (M5U) or Manual

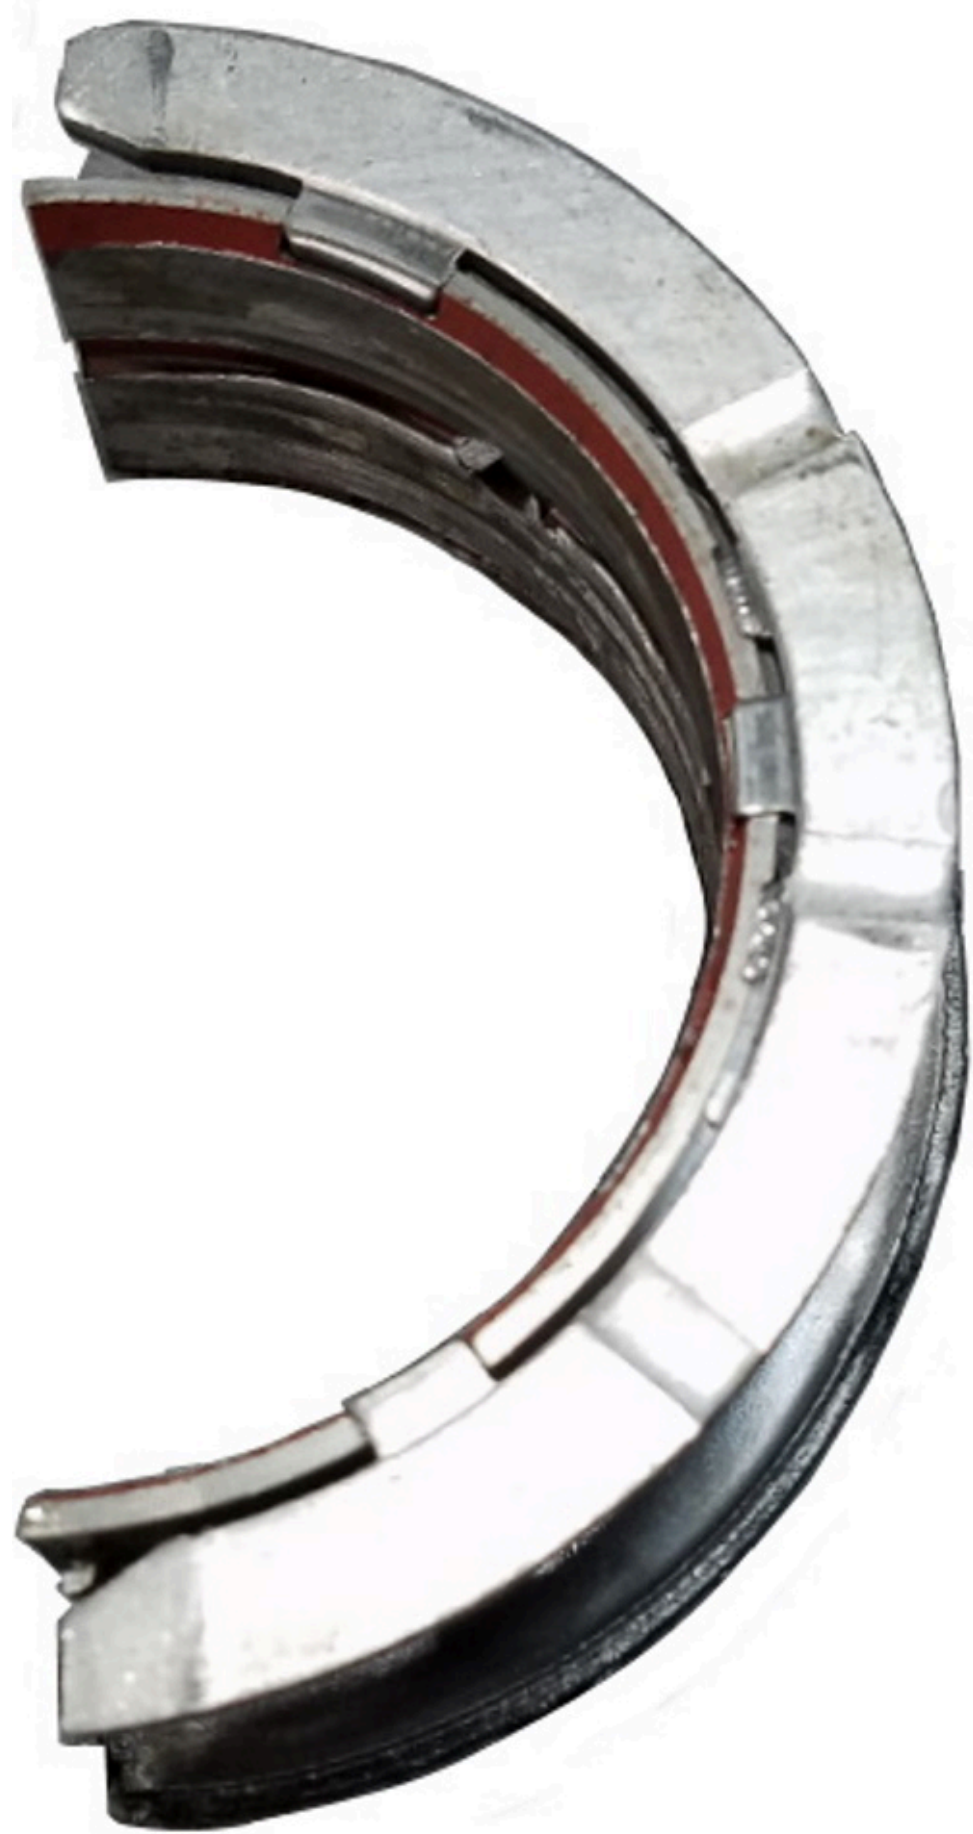
*Example of a good thrust bearing face.*
