2014 - 2019 Corvette: Service Bulletin: #19-NA-217: Manual Transmission Stalling, Clutch Chatter and/or Hard Shifting into 1st Gear or Reverse; Automatic Transmission Vibration on Launch and/or Engine Noise - (Dec 21, 2020)

Subject: Manual Transmission Stalling, Clutch
Chatter and/or Hard Shifting into 1st
Gear or Reverse; Automatic
Transmission Vibration on Launch
and/or Engine Noise

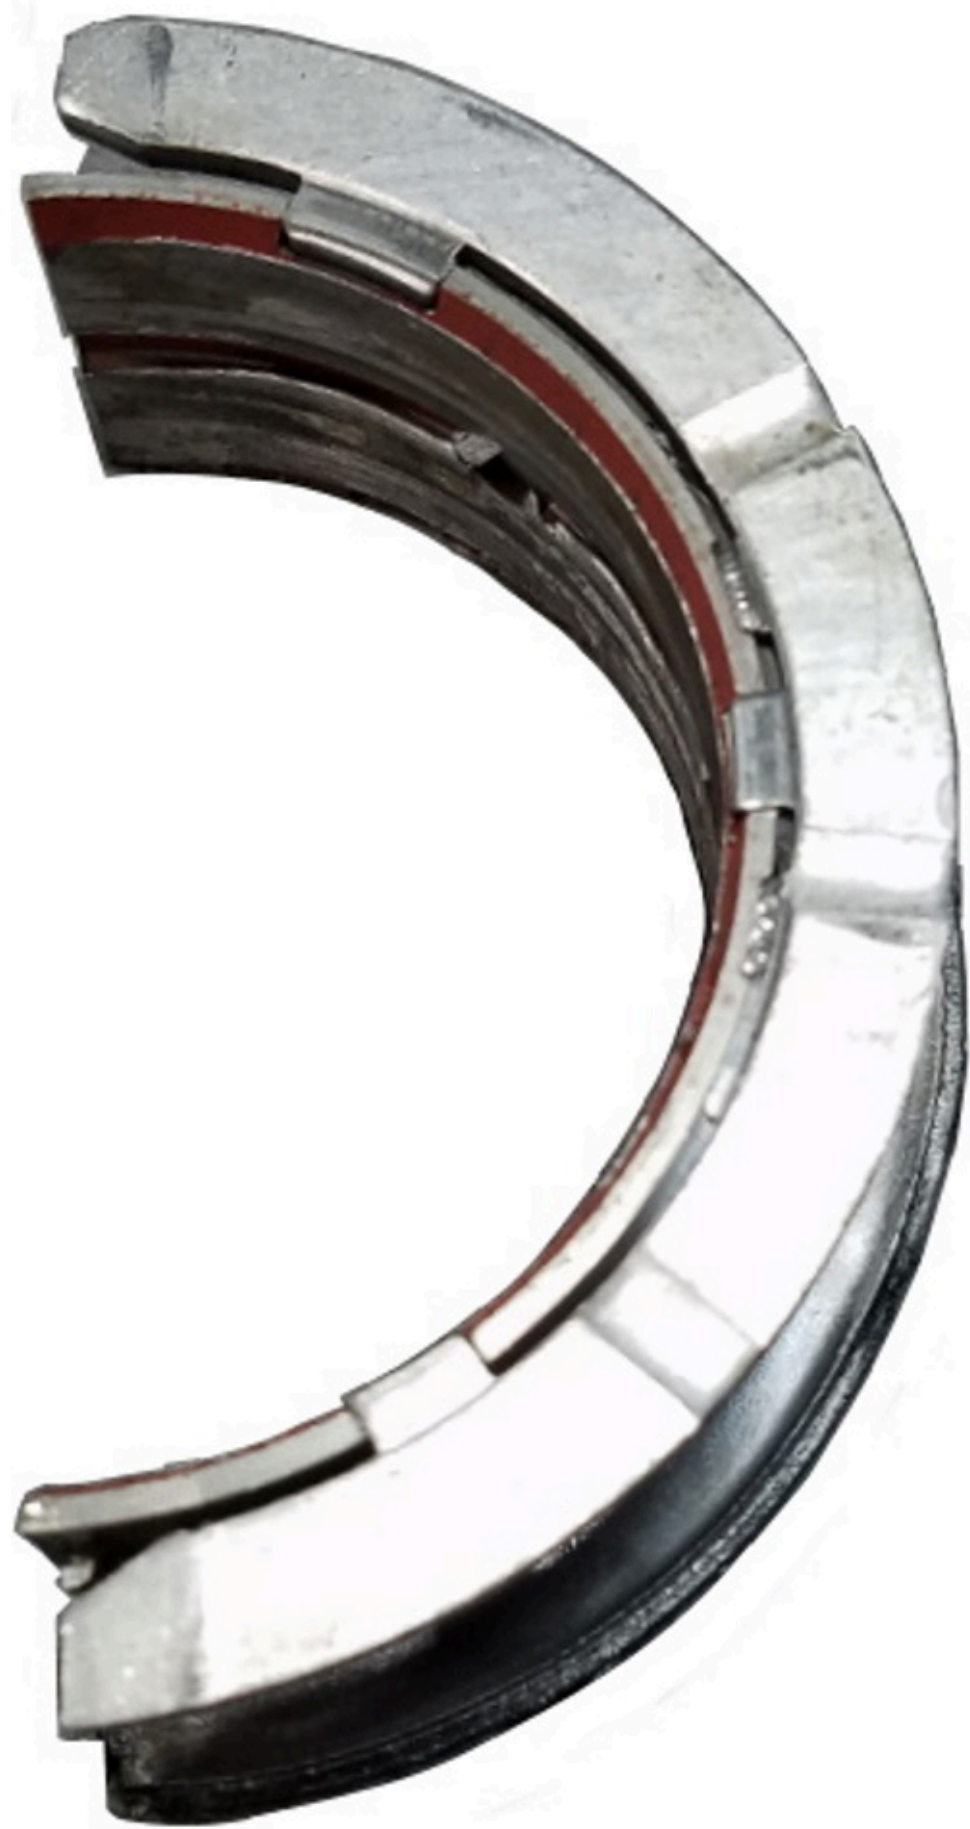
Example of a good thrust bearing face.

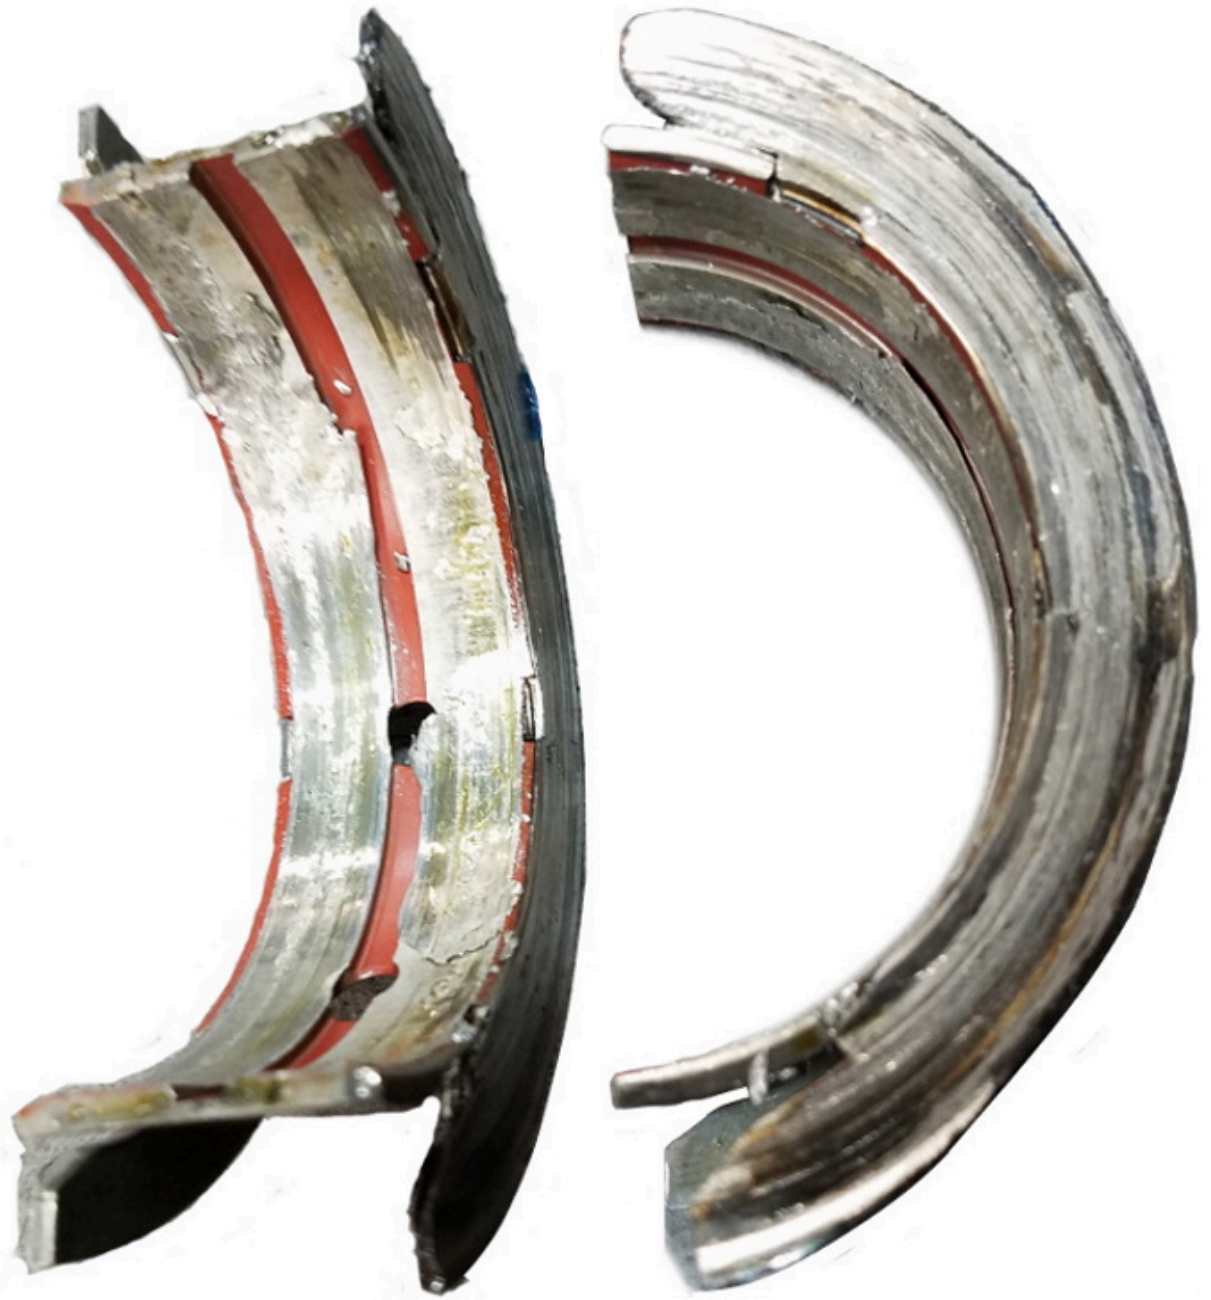
This condition may be caused by excessive crankshaft endplay associated with a damaged thrust bearing.

1. Inspect the thrust bearing for wear on one side and crankshaft on the corresponding mating surface. The

graphic above shows an example of a damaged thrust bearing.

- If wear is evident (3 vertical channels worn off), it will be necessary to replace the crankshaft, connecting rods and main bearings.
- Refer to *Crankshaft and Bearing Removal* in SI.

If bearing damage is found and if the vehicle is equipped with a dry sump system, it will be necessary to replace the oil tank with lines and oil cooler.
