## 2014 - 2021 Corvette: Service Buletin: #PIP5212C: Concern Of An Engine Thermostat Tick Noise And/Or Running Hot - (Mar 30, 2021)

### #PIP5212C: Concern Of An Engine Thermostat Tick Noise And/Or Running Hot - (Mar 30, 2021)

**Subject:** Concern Of An Engine Thermostat  
Tick Noise And/Or Running Hot

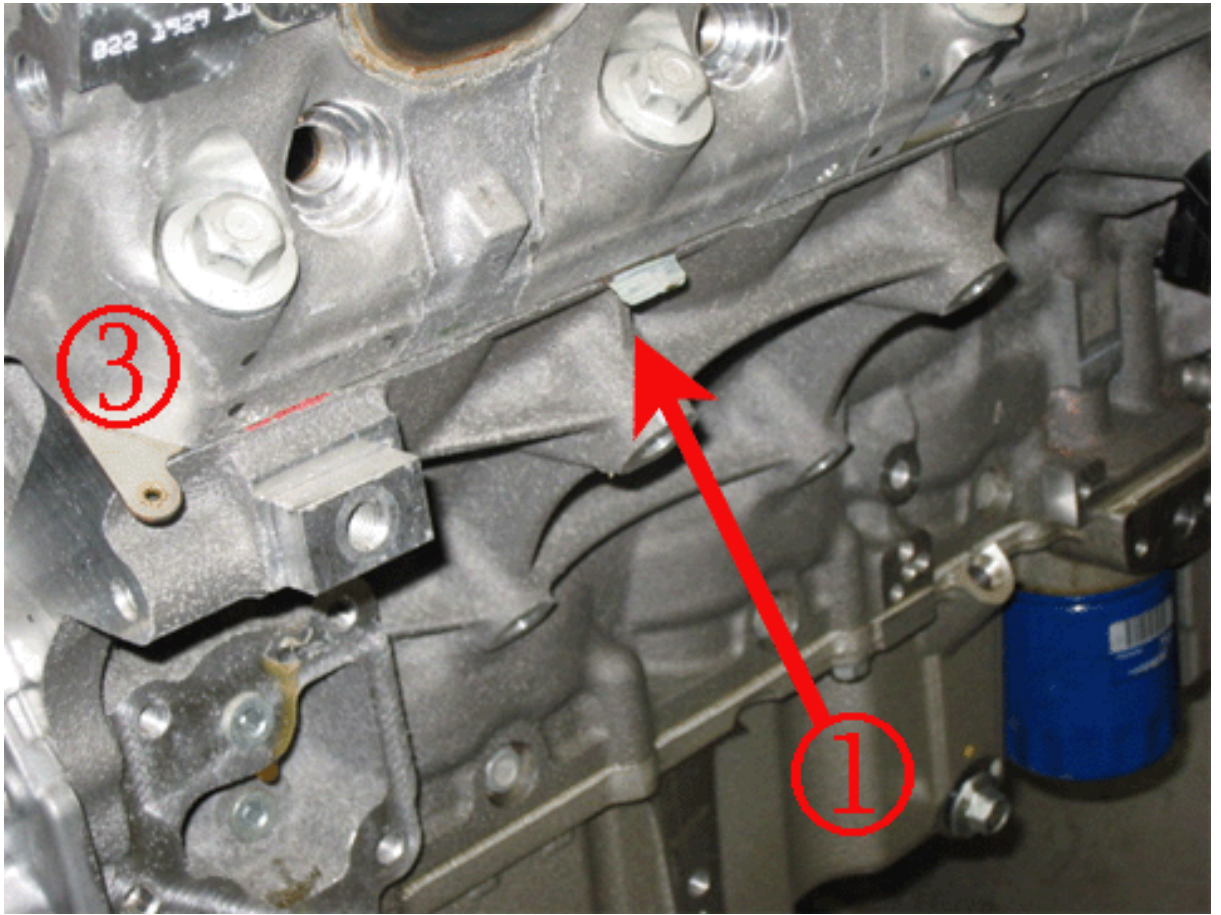
Per the attached pictures, the head gasket locating tabs for both of the engine cylinder banks should be toward the front of the engine.

1. Bank 1 tab near cylinder 3
2. Bank 2 tab near cylinder 4
3. Is the front of the engine

If the head gasket locating tabs are found to be closer to cylinders 5 or 6, this indicates the head gaskets were installed incorrectly restricting the engine coolant flow.

Replace the head gasket to repair for this concern.
