2014 - 2021 Corvette: Service Buletin: #PIP5212C: Concern Of An Engine Thermostat Tick Noise And/Or Running Hot - (Mar 30, 2021)

#PIP5212C: Concern Of An Engine Thermostat Tick Noise And/Or Running Hot - (Mar 30, 2021)

Subject: Concern Of An Engine Thermostat
Tick Noise And/Or Running Hot

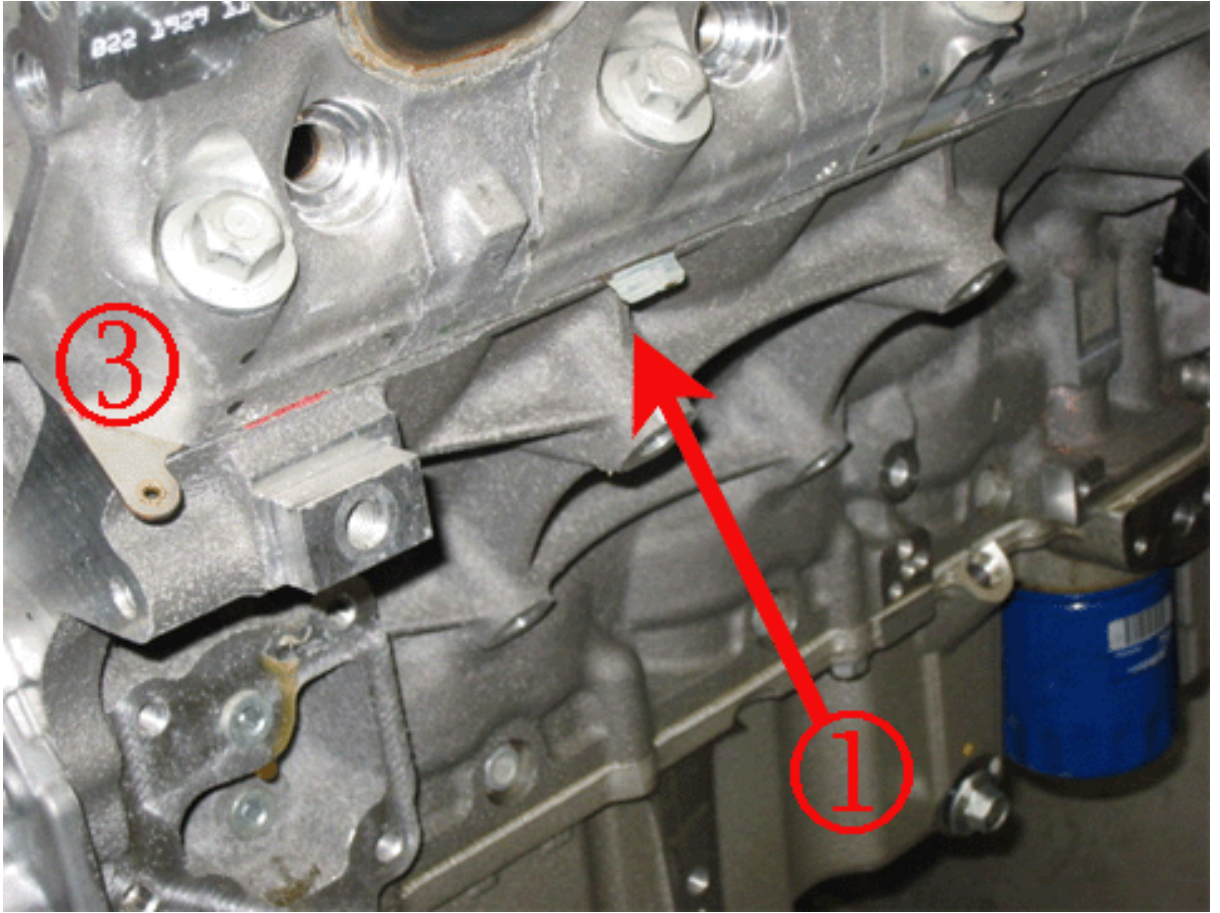
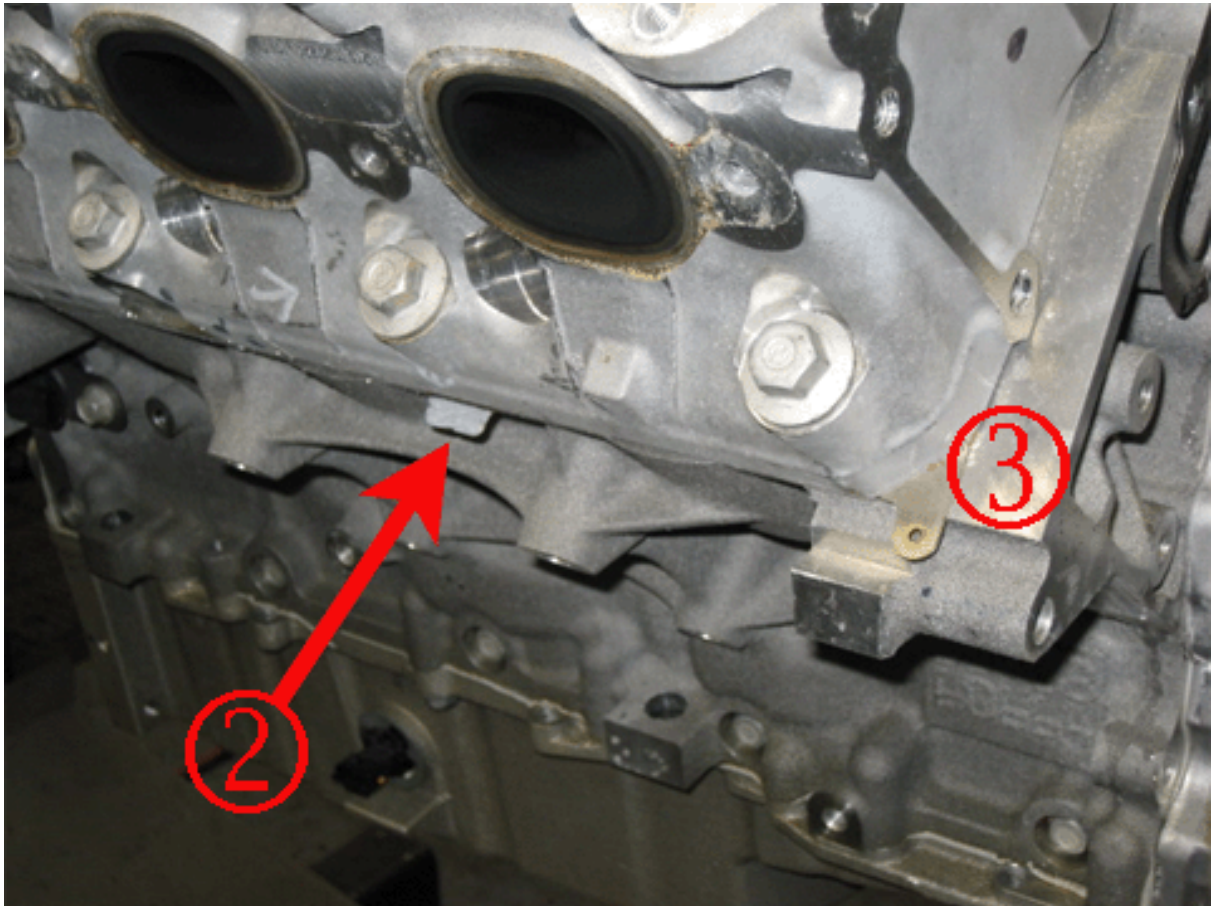
Per the attached pictures, the head gasket locating tabs for both of the engine cylinder banks should be toward the front of the engine.

1. Bank 1 tab near cylinder 3
2. Bank 2 tab near cylinder 4
3. Is the front of the engine

If the head gasket locating tabs are found to be closer to cylinders 5 or 6, this indicates the head gaskets were installed incorrectly restricting the engine coolant flow.

Replace the head gasket to repair for this concern.
