# 2014 - 2021 Corvette: Service Buletin: #PIP5212C: Concern Of An Engine Thermostat Tick Noise And/Or Running Hot - (Mar 30, 2021)

## #PIP5212C: Concern Of An Engine Thermostat Tick Noise And/Or Running Hot - (Mar 30, 2021)

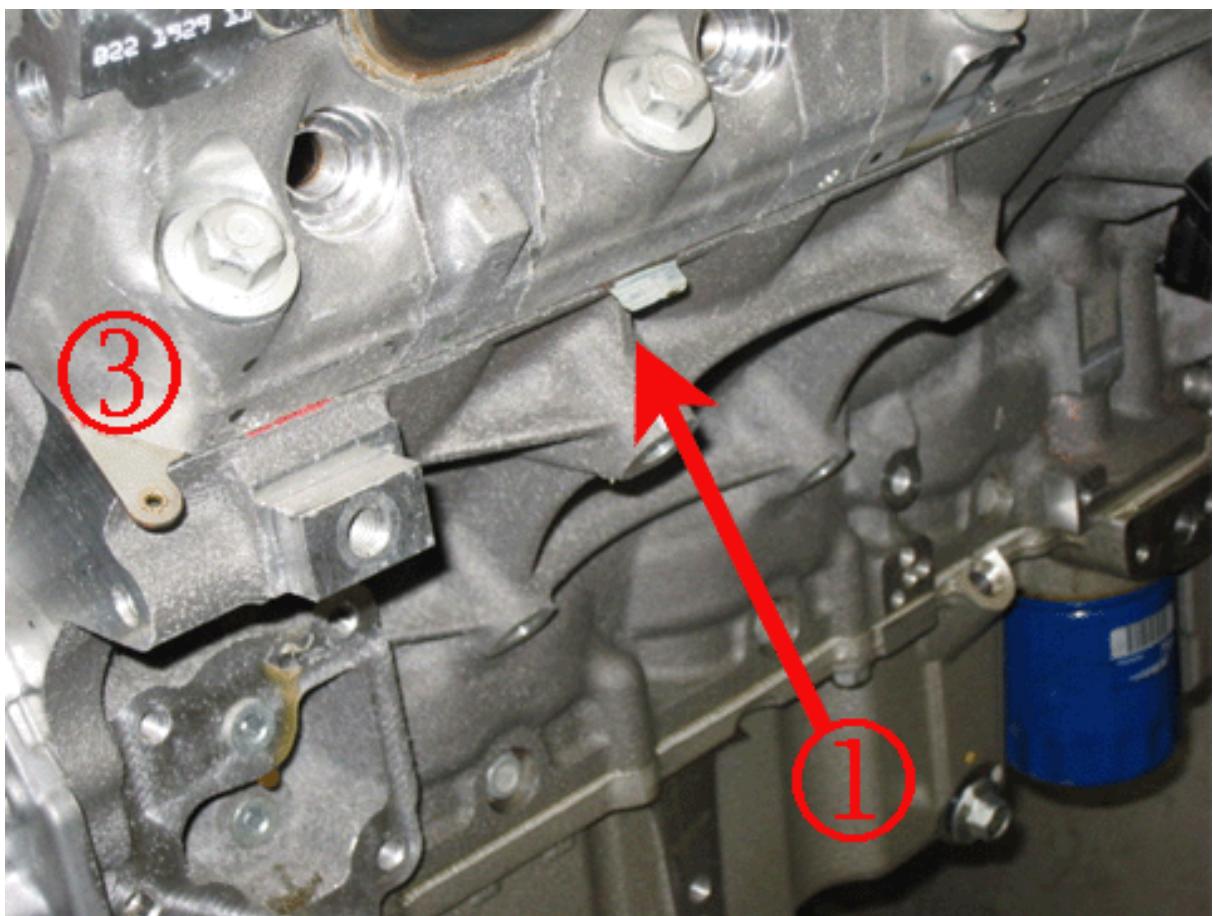
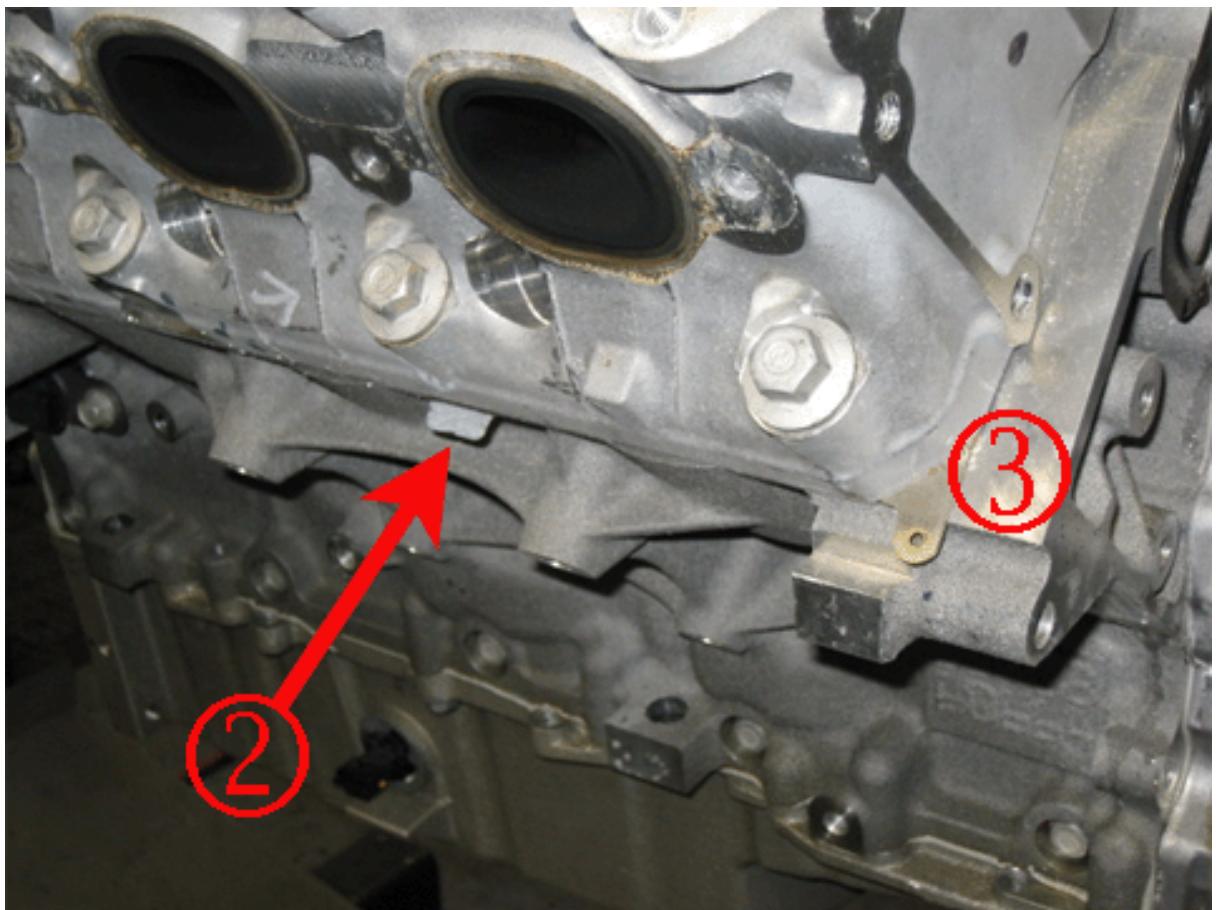
Per the attached pictures, the head gasket locating tabs for both of the engine cylinder banks should be toward the front of the engine.

1. Bank 1 tab near cylinder 3
2. Bank 2 tab near cylinder 4
3. Is the front of the engine

If the head gasket locating tabs are found to be closer to cylinders 5 or 6, this indicates the head gaskets were installed incorrectly restricting the engine coolant flow.

Replace the head gasket to repair for this concern.
