## 2014 - 2021 Corvette: Service Buletin: #PIP5212C: Concern Of An Engine Thermostat Tick Noise And/Or Running Hot - (Mar 30, 2021)

### #PIP5212C: Concern Of An Engine Thermostat Tick Noise And/Or Running Hot - (Mar 30, 2021)

**Subject:** Concern Of An Engine Thermostat  
Tick Noise And/Or Running Hot

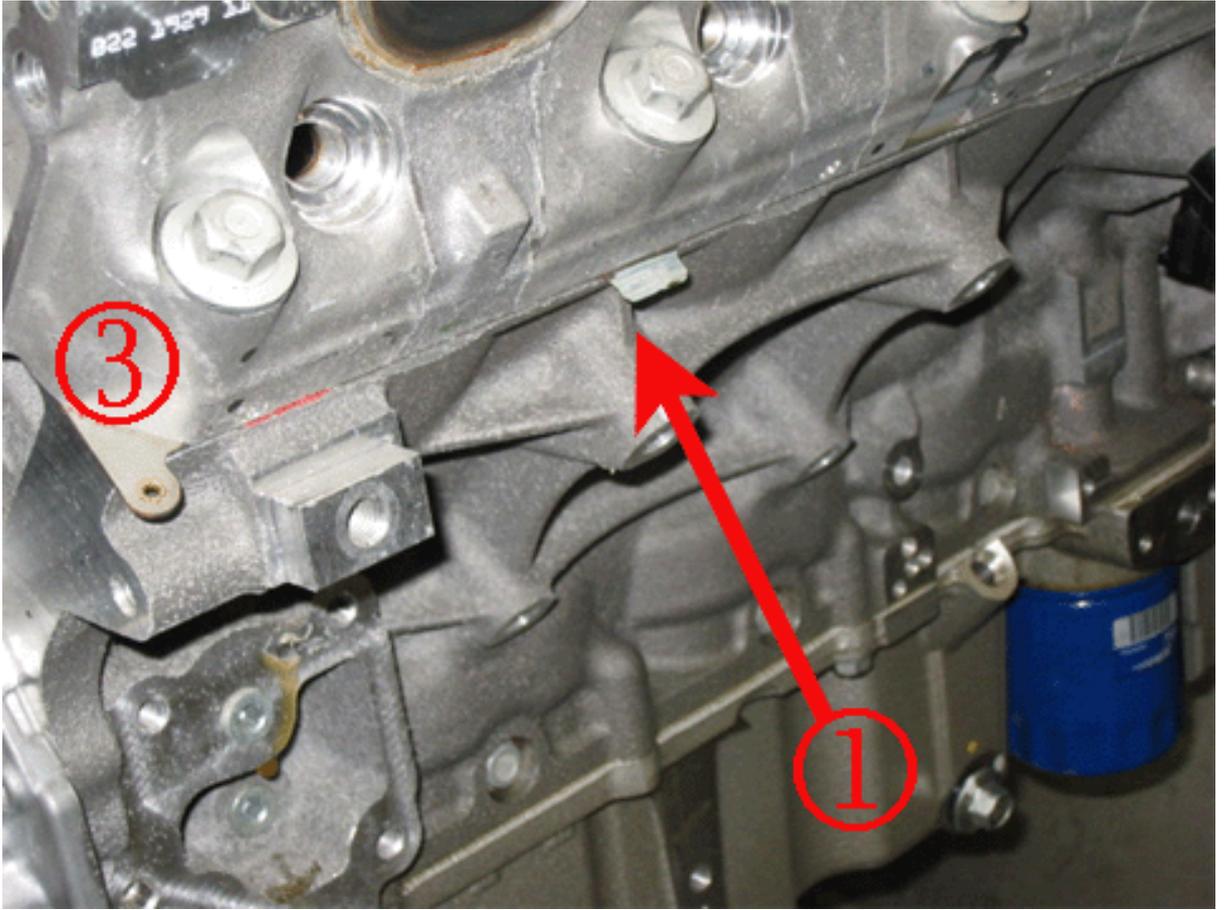
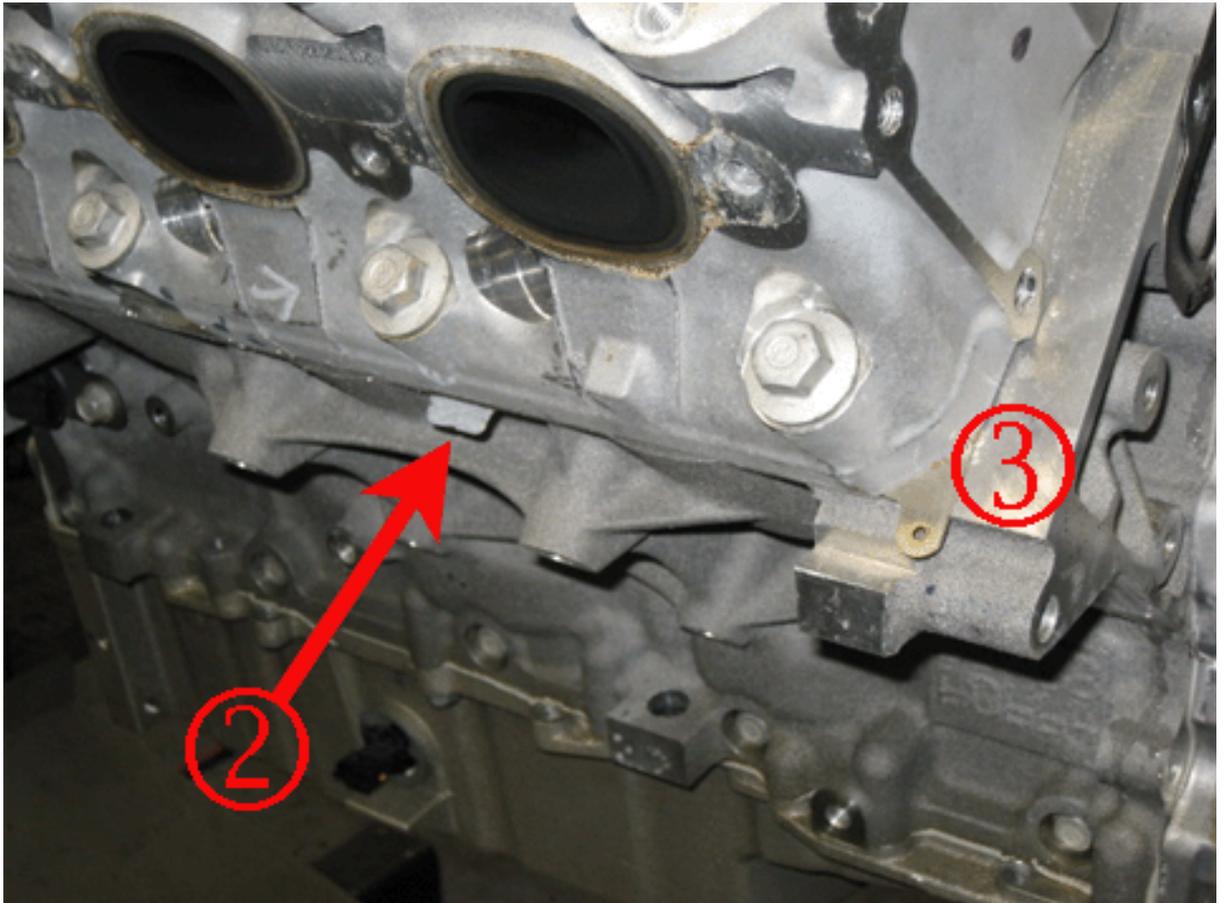
Per the attached pictures, the head gasket locating tabs for both of the engine cylinder banks should be toward the front of the engine.

1. Bank 1 tab near cylinder 3
2. Bank 2 tab near cylinder 4
3. Is the front of the engine

If the head gasket locating tabs are found to be closer to cylinders 5 or 6, this indicates the head gaskets were installed incorrectly restricting the engine coolant flow.

Replace the head gasket to repair for this concern.
