2020 - 2021 Corvette: Service Bulletin: #21-NA-091: Information on Normal Rearview Camera Display Operation - Flashing Diamond - Spot - or UFO like image on Rear View Camera Display - (Apr 13, 2021)

Subject: Information on Normal Rear View
Camera Display Operation - Flashing
Diamond - Spot - or UFO like image
on Rear View Camera Display

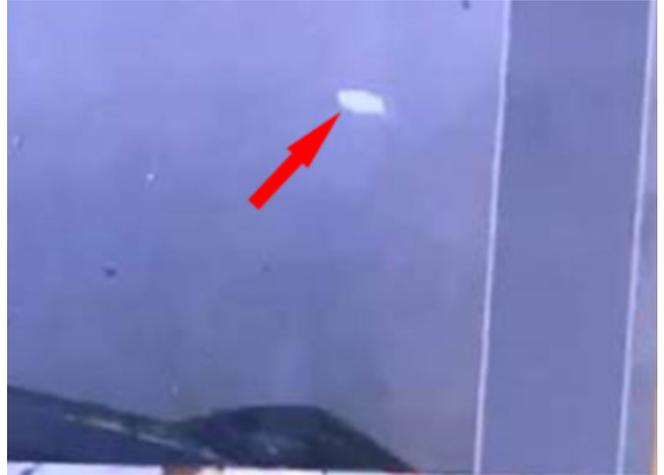
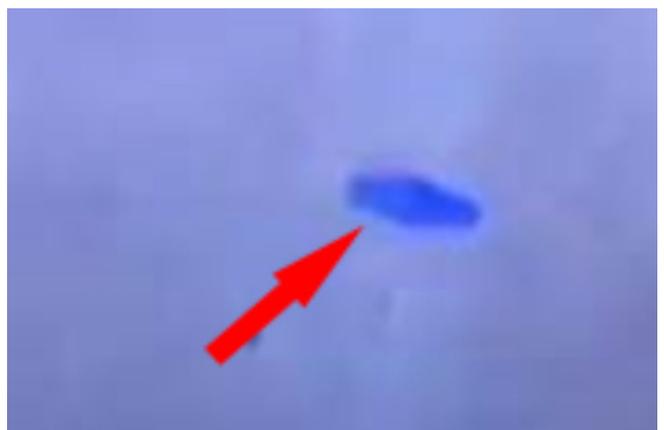
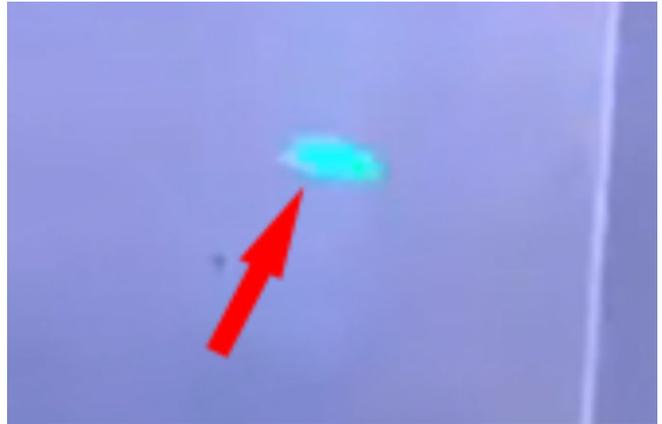
Some customers may comment on a flashing light present on the radio display when in Reverse and with the rear view camera on, usually is

corrected by an ignition cycle.

Please communicate to the customer that the rear view camera system and radio display are functioning as designed and this is a normal condition of their vehicle. Please share this information with the customer, including a copy of this bulletin.

Technicians should verify that no other conditions are present and return the vehicle to the customer.
