# **2020 - 2021 Corvette: GM TechLink: Internal Transmission Faults Not Serviceable at the Dealership**

April 13, 2021

### **GM TechLink**

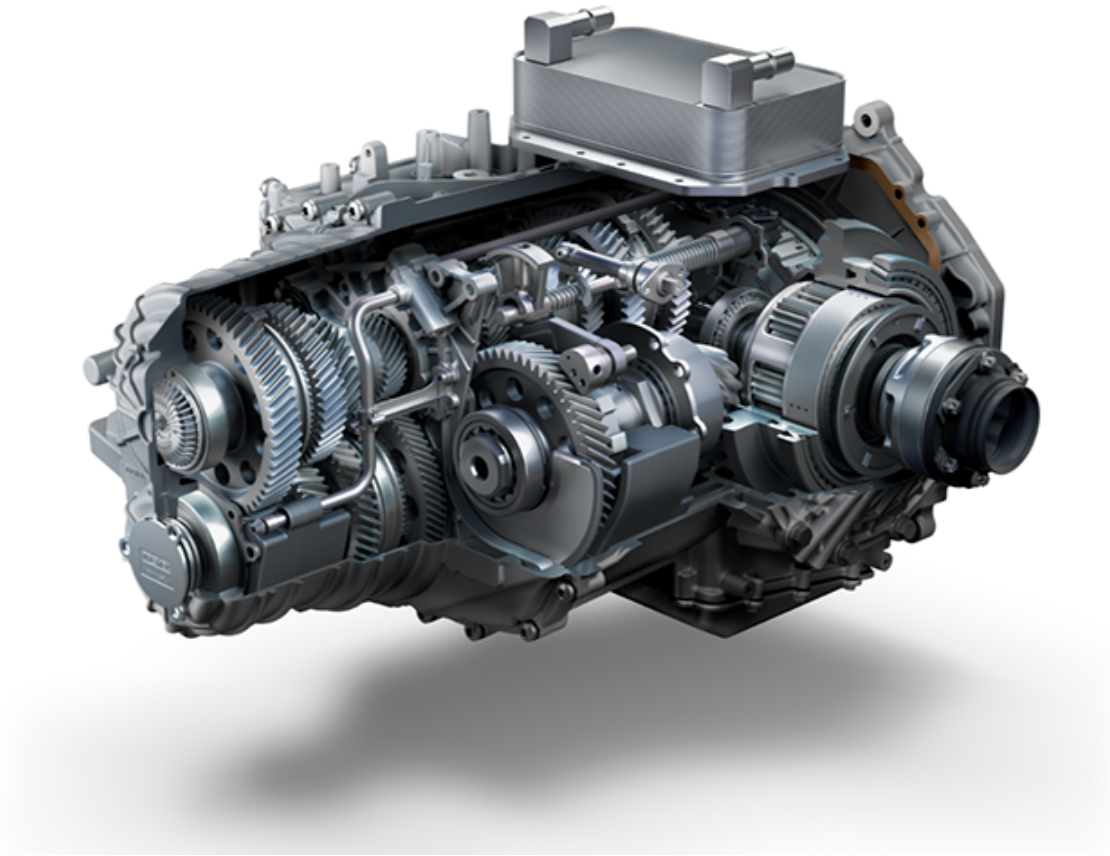
**Fig. 18**

A Service Transmission message or a Service Engine Soon message may be displayed on the Driver Information Center of some 2020-2021 Corvettes equipped with the DCT TR9080 transmission (RPO M1L) (Fig. 18) along with DTCs P2838 (Shift Fork 2 Position Sensor Circuit Low), P2839 (Shift Fork 2 Position Sensor Circuit High) or P283A (Shift Fork 2 Position Sensor Circuit Intermittent).
