2020 - 2021 Corvette: GM TechLink: Internal Transmission Faults Not Serviceable at the Dealership

Internal Transmission Faults Not Serviceable at the Dealership

April 13, 2021

GM TechLink

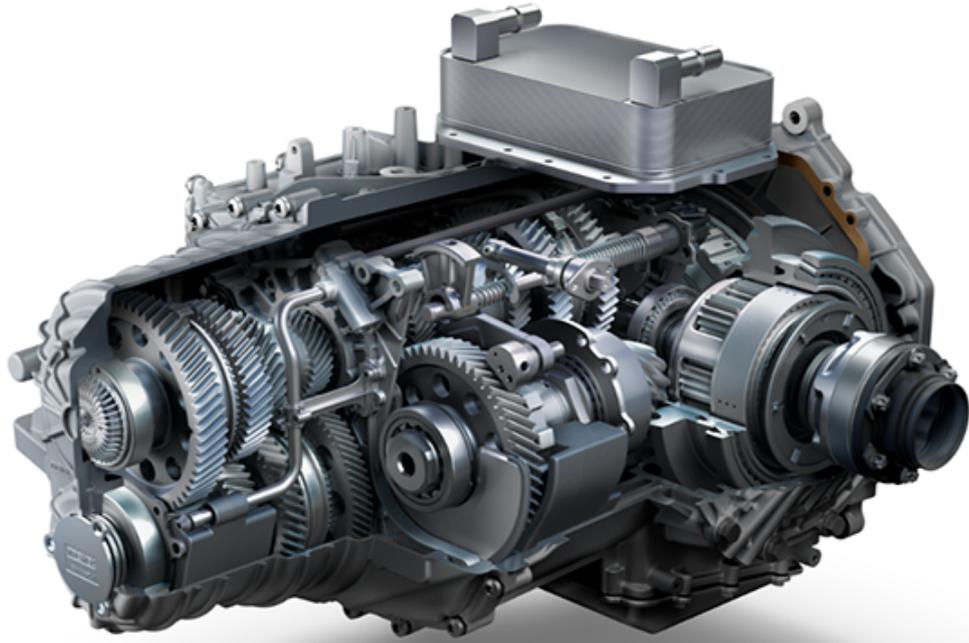
Fig. 18

A Service Transmission message or a Service Engine Soon message may be displayed on the Driver Information Center of some 2020-2021 Corvettes equipped with the DCT TR9080 transmission (RPO M1L) (Fig. 18) along with DTCs P2838 (Shift Fork 2 Position Sensor Circuit Low), P2839 (Shift Fork 2 Position Sensor Circuit High) or P283A (Shift Fork 2 Position Sensor Circuit Intermittent).

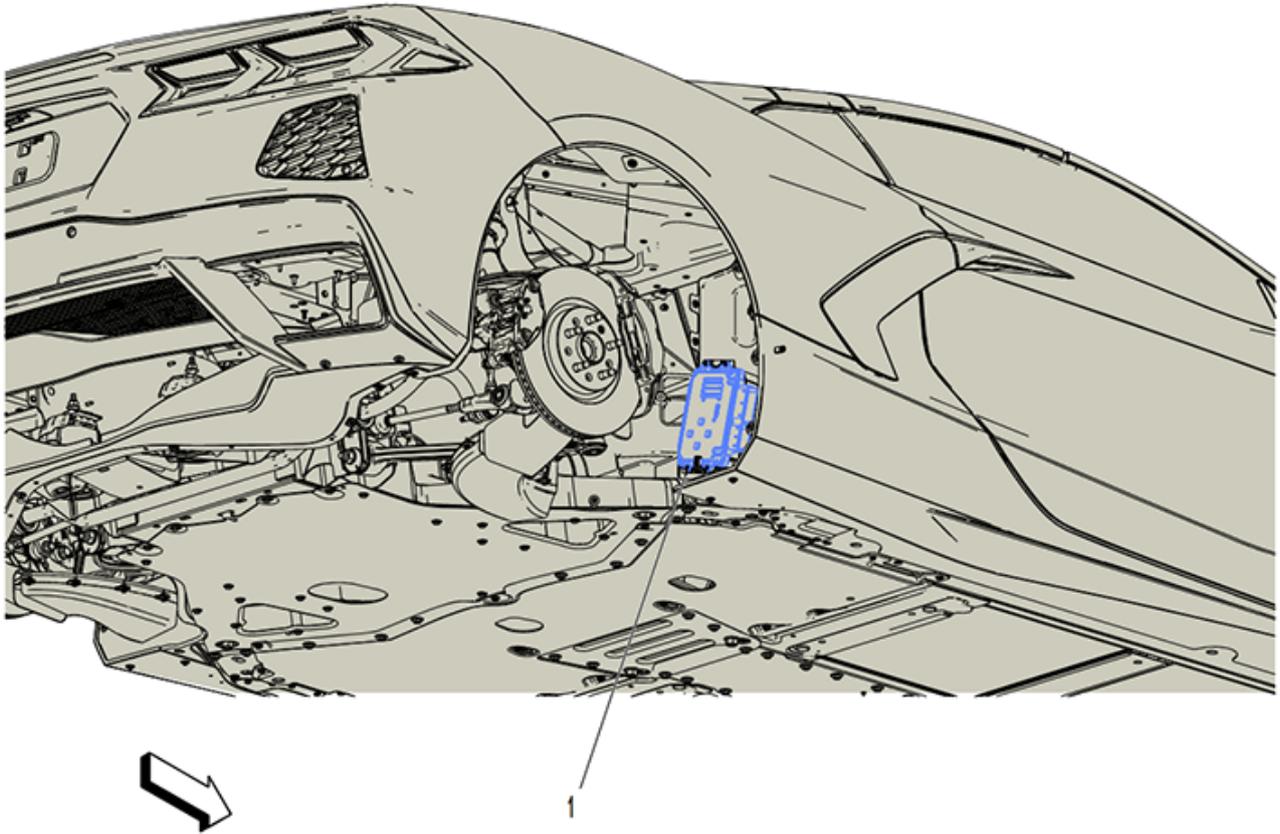
Fig. 19

If any combination of these DTCs have set (current or in history), check circuit integrity on circuit 7812 between the Transmission Control Module (TCM) (Fig. 19, #1) and the transmission. Check the terminal tension as well as for a possible short to ground.

If any issues are found, repair as needed and verify proper vehicle operation. If no issues are noted, the transmission would need to be replaced as anything related to the Odd Sensor Module (OSM) is not serviced.

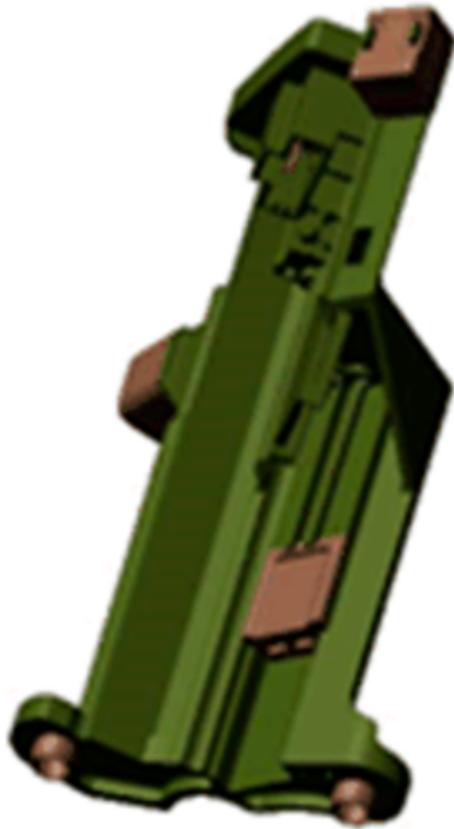
Fig. 20

The Odd Sensor Module (Fig. 20) is located in the shift fork assembly and contains the transmission input shaft speed sensor – odd gears and the shift fork 1 position sensor and shift fork 2 position sensor. The TCM uses the output speed sensor signal along with the even and odd input shaft speed sensor signals to determine transmission line pressure, shift patterns, and the correct gear ratio.
