# **2020 - 2021 Corvette: GM TechLink: Internal Transmission Faults Not Serviceable at the Dealership**

April 13, 2021

### **GM TechLink**

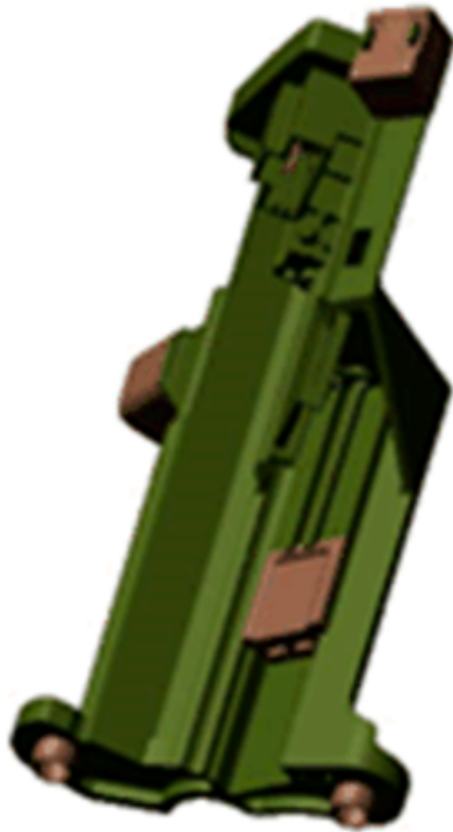
**Fig. 20**

The Odd Sensor Module (Fig. 20) is located in the shift fork assembly and contains the transmission input shaft speed sensor – odd gears and the shift fork 1 position sensor and shift fork 2 position sensor. The TCM uses the output speed sensor signal along with the even and odd input shaft speed sensor signals to determine transmission line pressure, shift patterns, and the correct gear ratio.

If any issues are found, repair as needed and verify proper vehicle operation. If no issues are noted, the transmission would need to be replaced as anything related to the Odd Sensor Module (OSM) is not serviced.
