# **2020 - 2021 Corvette: GM TechLink: Internal Transmission Faults Not Serviceable at the Dealership**

**April 13, 2021**

**GM TechLink**

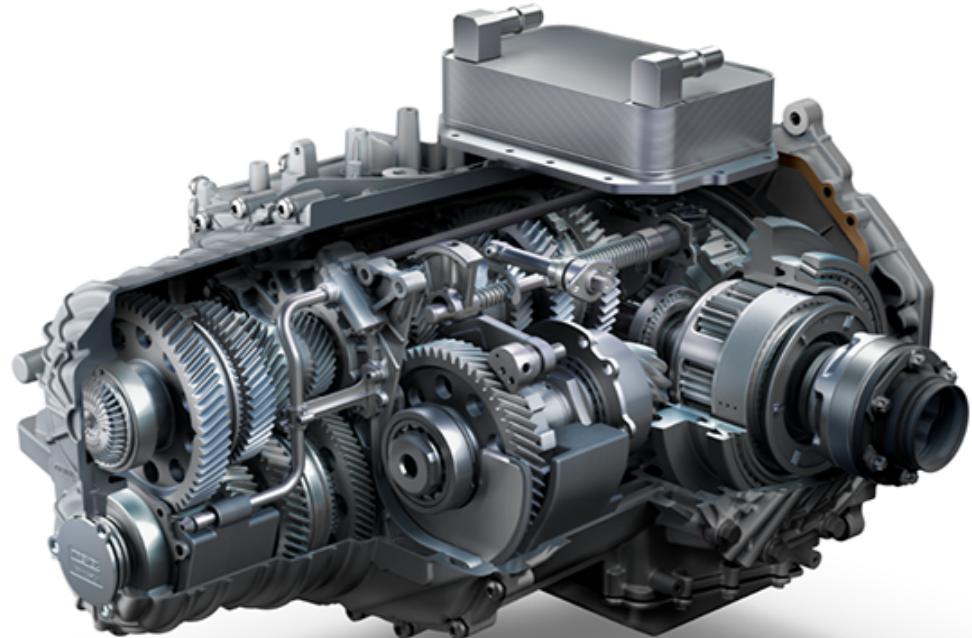
**Fig. 18**

A Service Transmission message or a Service Engine Soon message may be displayed on the Driver Information Center of some 2020-2021 Corvettes equipped with the DCT TR9080 transmission (RPO M1L) (Fig. 18) along with DTCs P2838 (Shift Fork 2 Position Sensor Circuit Low), P2839 (Shift Fork 2 Position Sensor Circuit High) or P283A (Shift Fork 2 Position Sensor Circuit Intermittent).

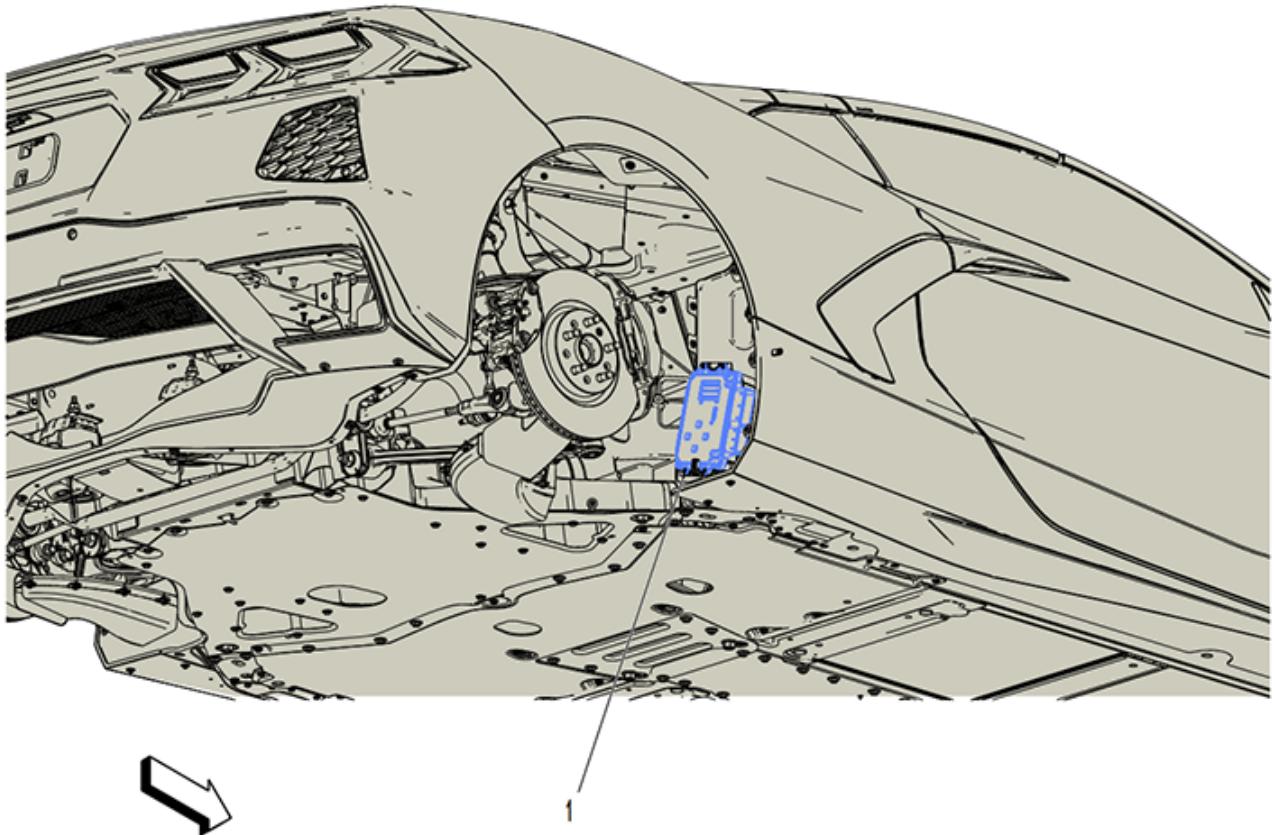
**Fig. 19**

If any combination of these DTCs have set (current or in history), check circuit integrity on circuit 7812 between the Transmission Control Module (TCM) (Fig. 19, #1) and the transmission. Check the terminal tension as well as for a possible short to ground.

If any issues are found, repair as needed and verify proper vehicle operation. If no issues are noted, the transmission would need to be replaced as anything related to the Odd Sensor Module (OSM) is not serviced.

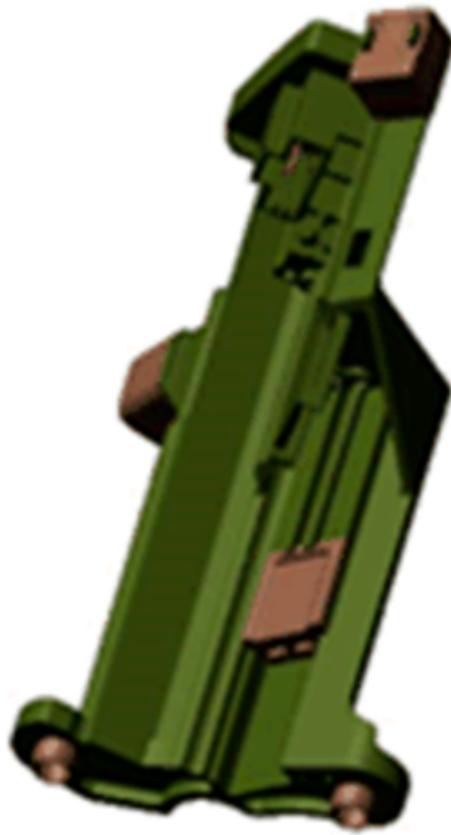
**Fig. 20**

The Odd Sensor Module (Fig. 20) is located in the shift fork assembly and contains the transmission input shaft speed sensor – odd gears and the shift fork 1 position sensor and shift fork 2 position sensor. The TCM uses the output speed sensor signal along with the even and odd input shaft speed sensor signals to determine transmission line pressure, shift patterns, and the correct gear ratio.
