## 2020 - 2021 Corvette: GM TechLink: Inoperative Hood Release Buttons

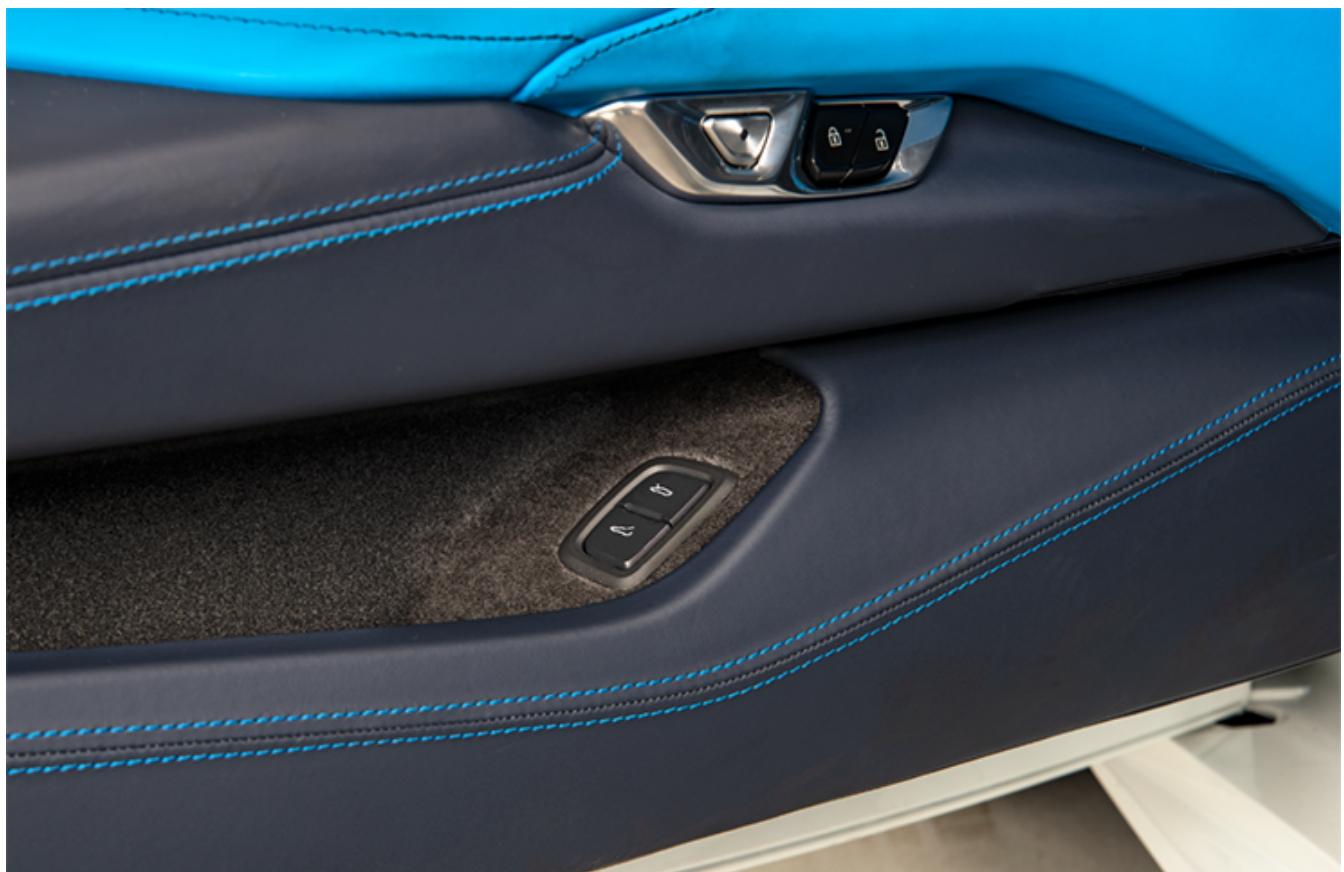
**Fig. 11**

The electrical hood release buttons (Fig. 11) may be inoperative and a Hood Ajar message may be displayed on the Driver Information Center on some 2020-2021 Corvette models. The hood can be opened using the manual release cable.

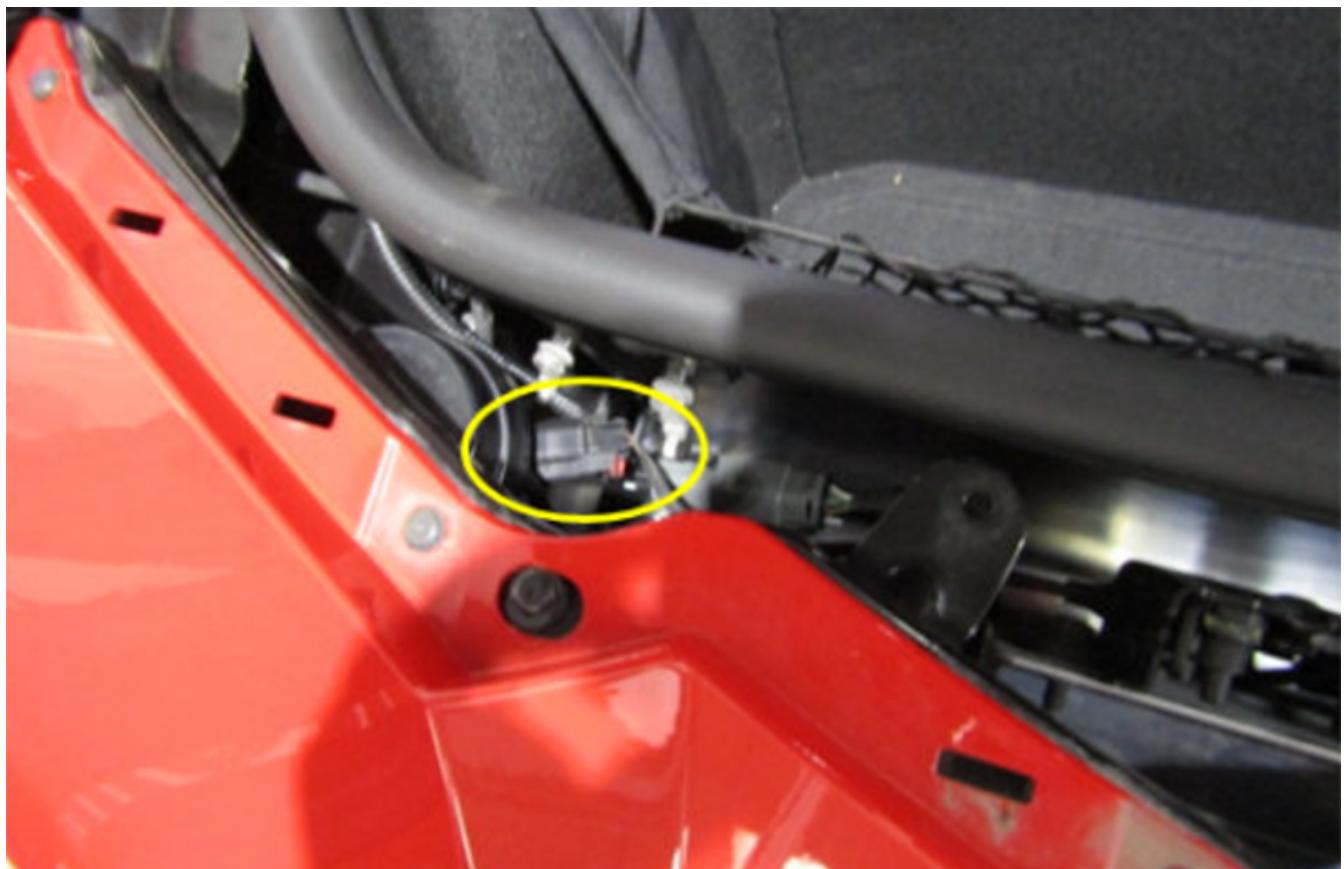
**Fig. 12**

These conditions may be caused by possible water intrusion and terminal corrosion in connector X103 (Fig. 12), water intrusion in the hood latch actuator or failure of the auxiliary hood latch release switch. Check each of these components to determine the repair needed.

When reinstalling the front compartment front panel, be sure that the X103 connector is positioned below the right horn connector.
