2020 - 2021 Corvette: GM TechLink: Inoperative Hood Release Buttons

Refer to Bulletin #21-NA-094 for additional information and part numbers.

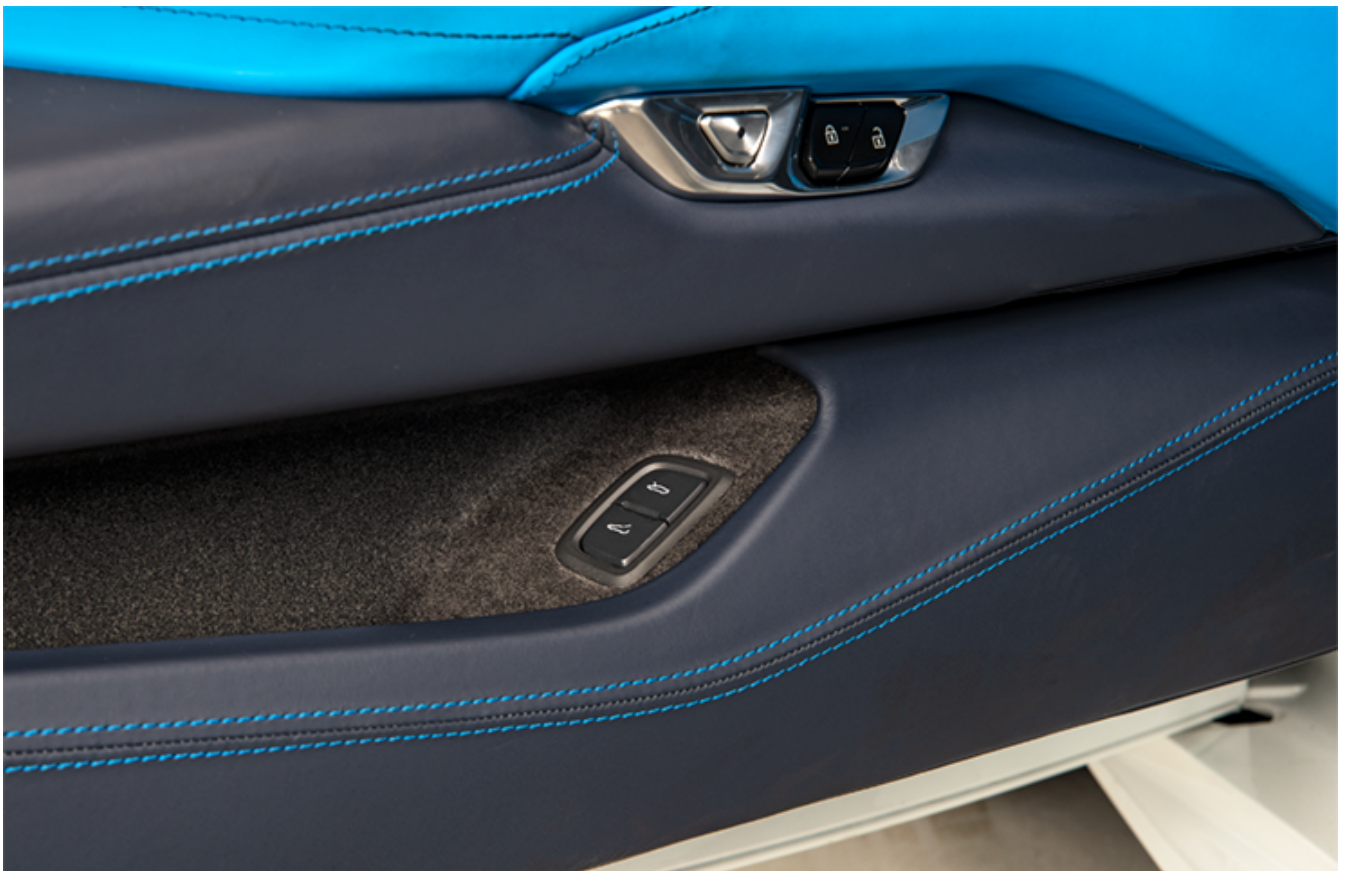
Fig. 11

The electrical hood release buttons (Fig. 11) may be inoperative and a Hood Ajar message may be displayed on the Driver Information Center on some 2020-2021 Corvette models. The hood can be opened using the manual release cable.

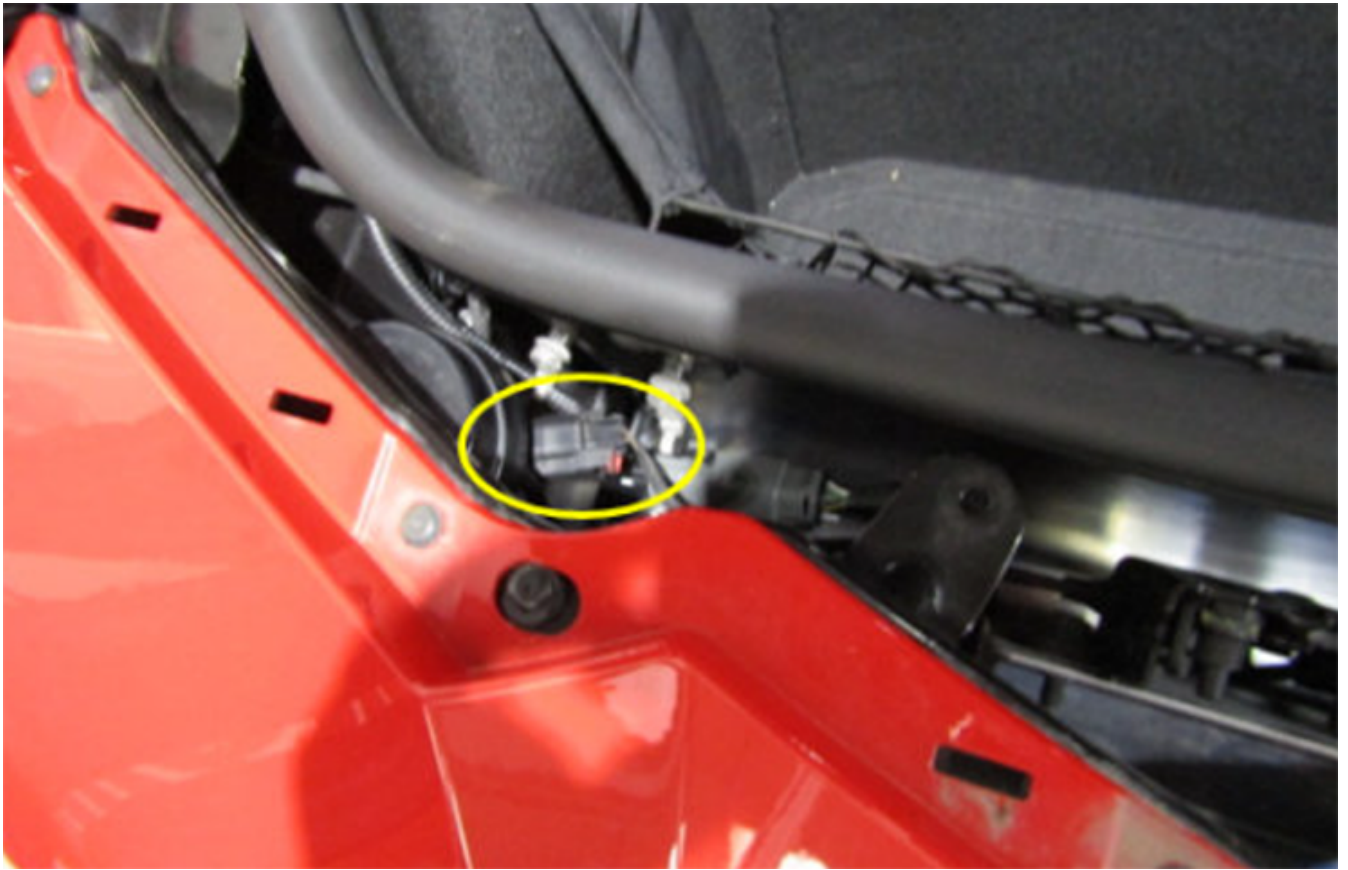
Fig. 12

These conditions may be caused by possible water intrusion and terminal corrosion in connector X103 (Fig. 12), water intrusion in the hood latch actuator or failure of the auxiliary hood latch release switch. Check each of these components to determine the repair needed.

When reinstalling the front compartment front panel, be sure that the X103 connector is positioned below the right horn connector.

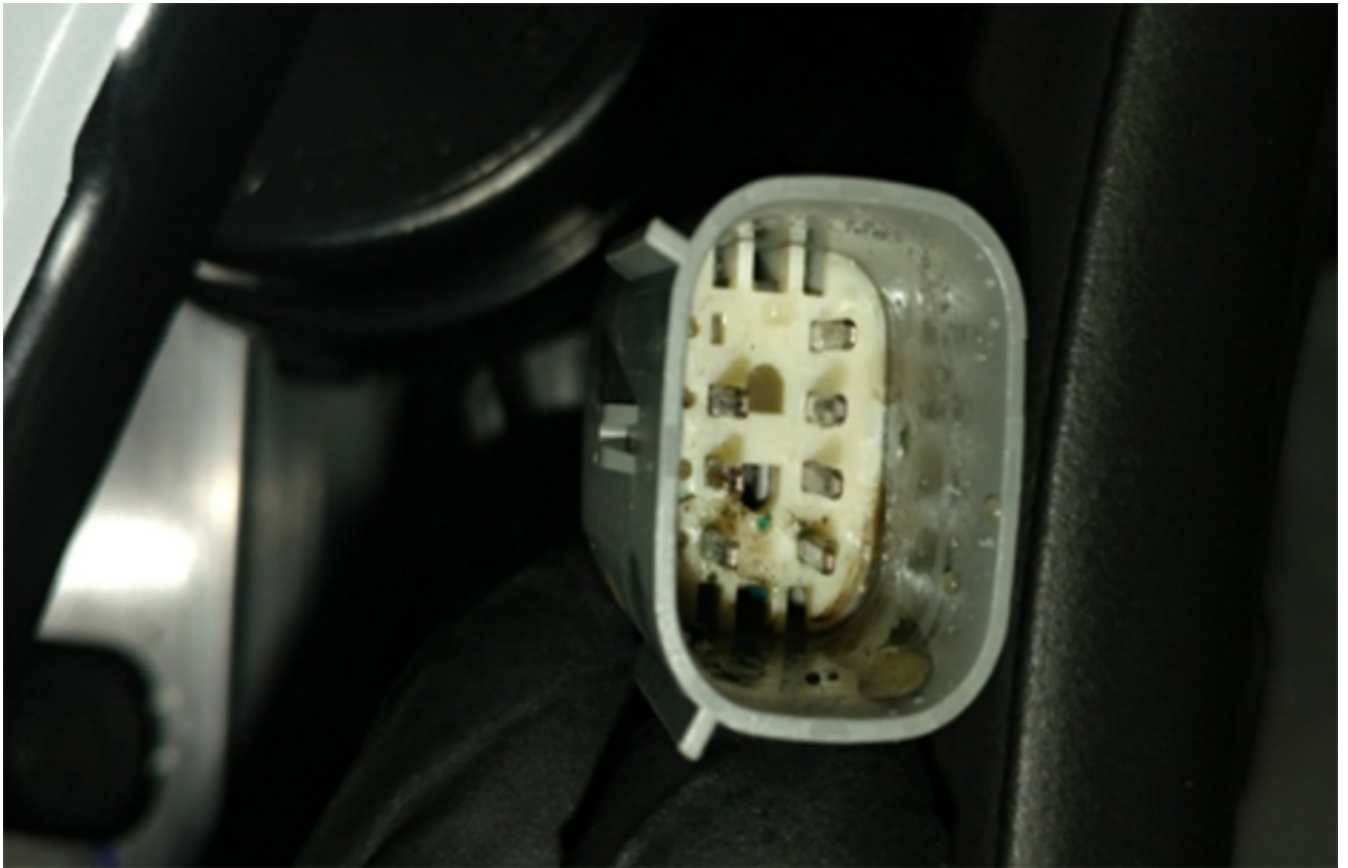
Fig. 13

Remove the front compartment front panel to inspect connector X103. If corrosion is found in the connector (Fig. 13), replace the connector as necessary.

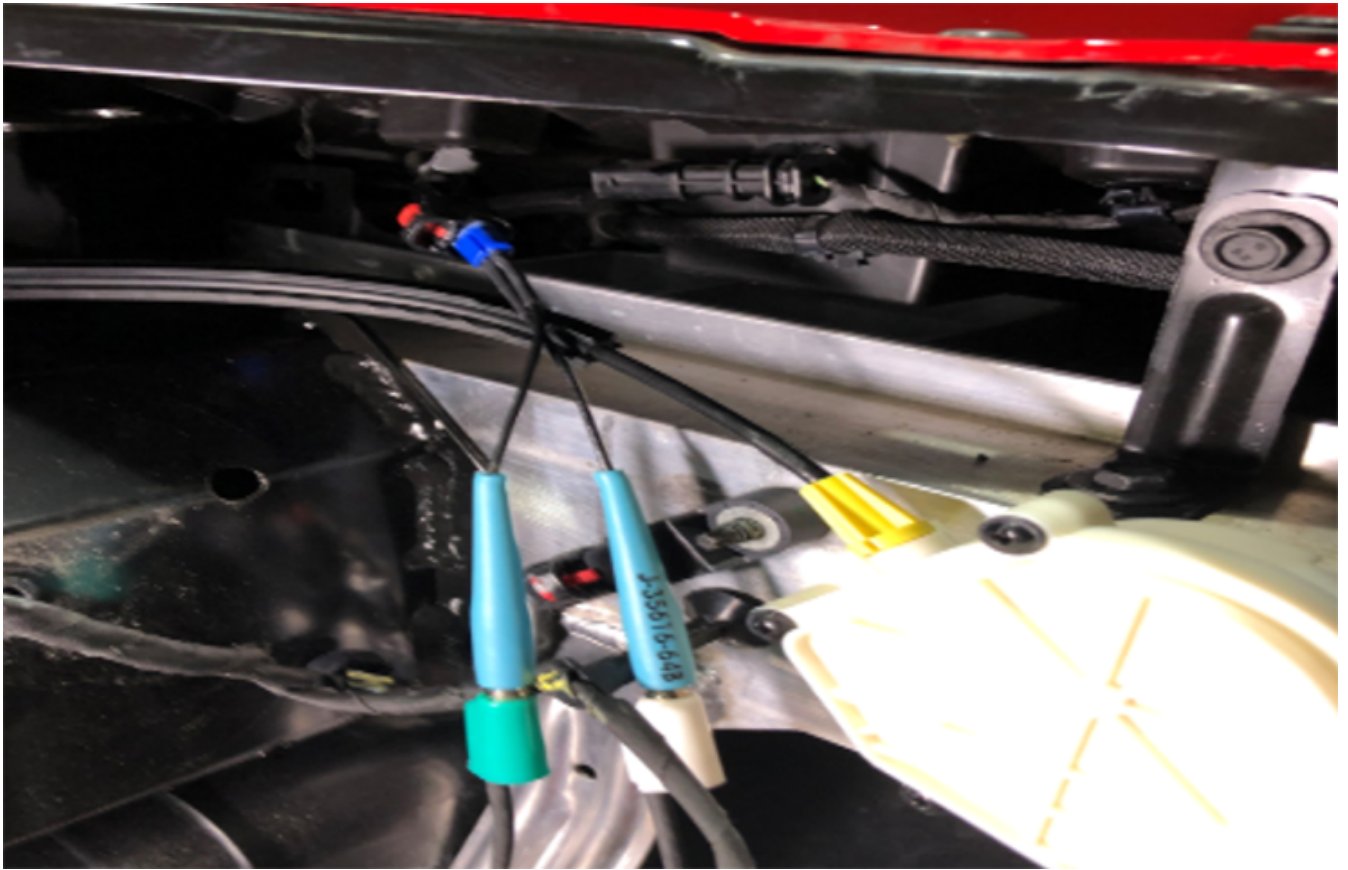
Fig. 14

If there is not any corrosion in connector X103, access the hood switch connector X102, remove the left horn and test the auxiliary hood latch release switch with an ohmmeter. (Fig. 14) The switch should be open when it's not pressed, and resistance should be no more than 0.2 ohm when the switch is pressed. If the switch is not operating correct, replace the switch.
