2020 - 2021 Corvette: GM TechLink: Inoperative Hood Release Buttons

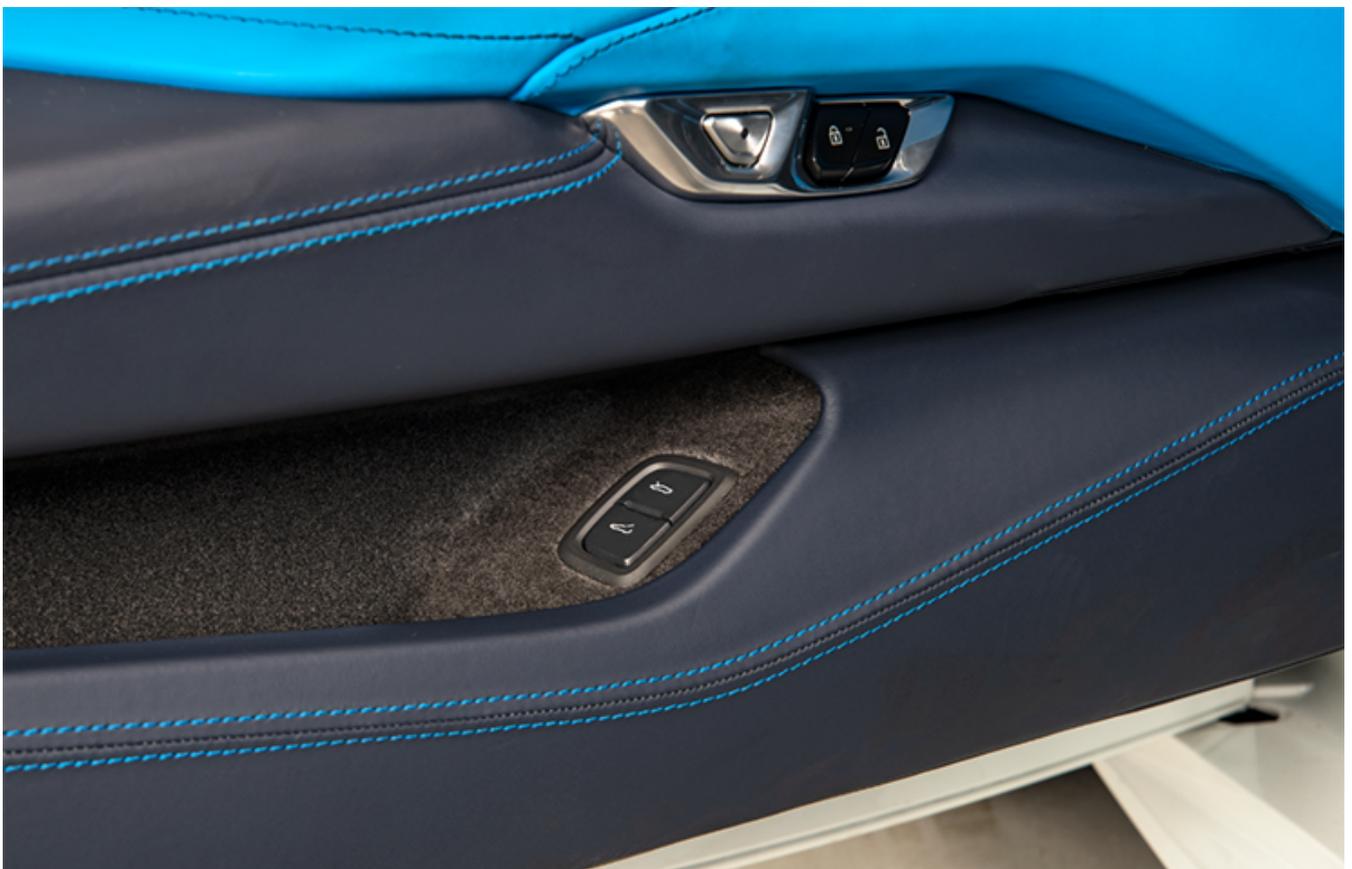
Fig. 11

The electrical hood release buttons (Fig. 11) may be inoperative and a Hood Ajar message may be displayed on the Driver Information Center on some 2020-2021 Corvette models. The hood can be opened using the manual release cable.

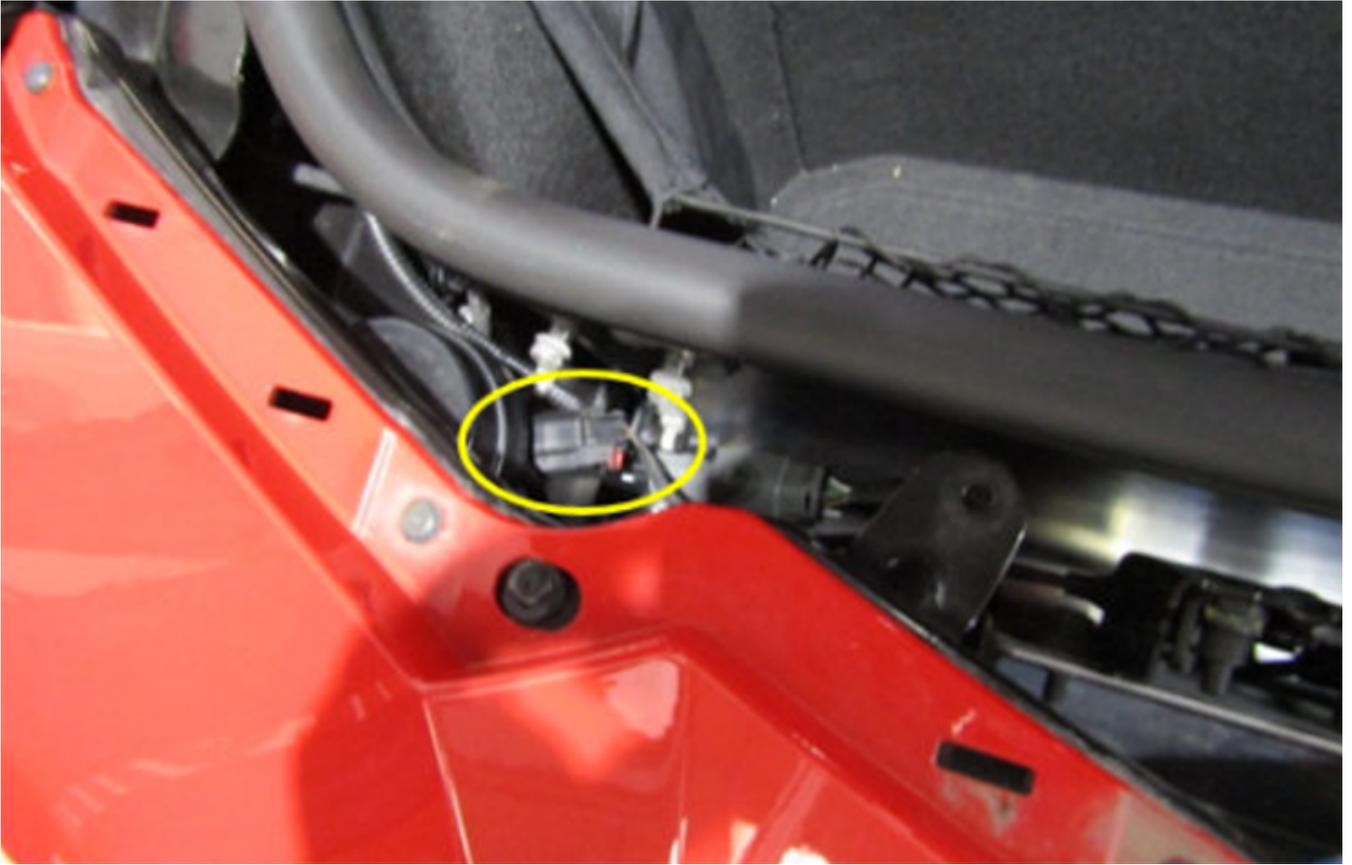
Fig. 12

These conditions may be caused by possible water intrusion and terminal corrosion in connector X103 (Fig. 12), water intrusion in the hood latch actuator or failure of the auxiliary hood latch release switch. Check each of these components to determine the repair needed.

When reinstalling the front compartment front panel, be sure that the X103 connector is positioned below the right horn connector.
