2020 - 2024 Corvette: Noise From the Transmission Area

July 23, 2024

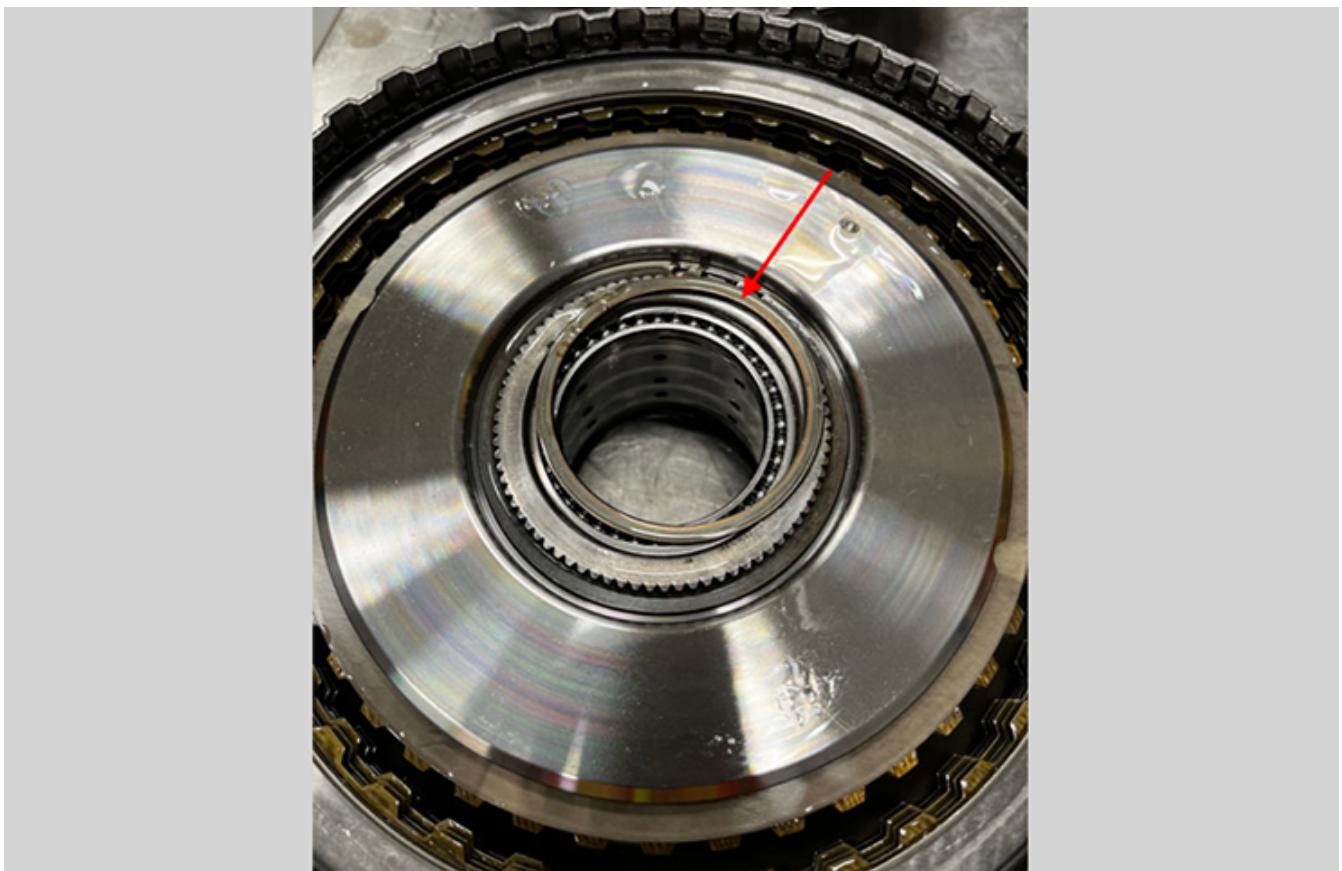
Fig. 15

There may be a noise from the bell housing area of the DCT TR9080 transmission (RPO M1L, M1M) on some 2020-2024 Corvettes along with a number of DTCs set in the Transmission Control Module (TCM). The noise may be due to a dislodged snap ring in the direct clutch assembly. (Fig. 15) As a result, one or more pressure DTCs may set if there is debris caused by the valves sticking in the Main Control Valve (MCV) Body or the direct clutch may contact the fluid tubes, stator shaft or transmission housing.

- If there is direct clutch snap ring failure without any DTCs set as current, replace the direct clutch and stator. In addition, remove the transmission pan to clean any debris from the magnets and replace the sump and canister filter elements.
- If there is direct clutch gear noise, replace the direct clutch, stator and pump gear. Also remove the transmission pan to clean debris from the magnets and replace the sump and canister filter elements.
- If there is direct clutch snap ring failure with an illuminated MIL and pressure DTCs set, replace the direct clutch and stator. Also remove the transmission pan to clean debris from the magnets, replace the sump and canister filter elements, and replace the Main Control Valve (MCV).

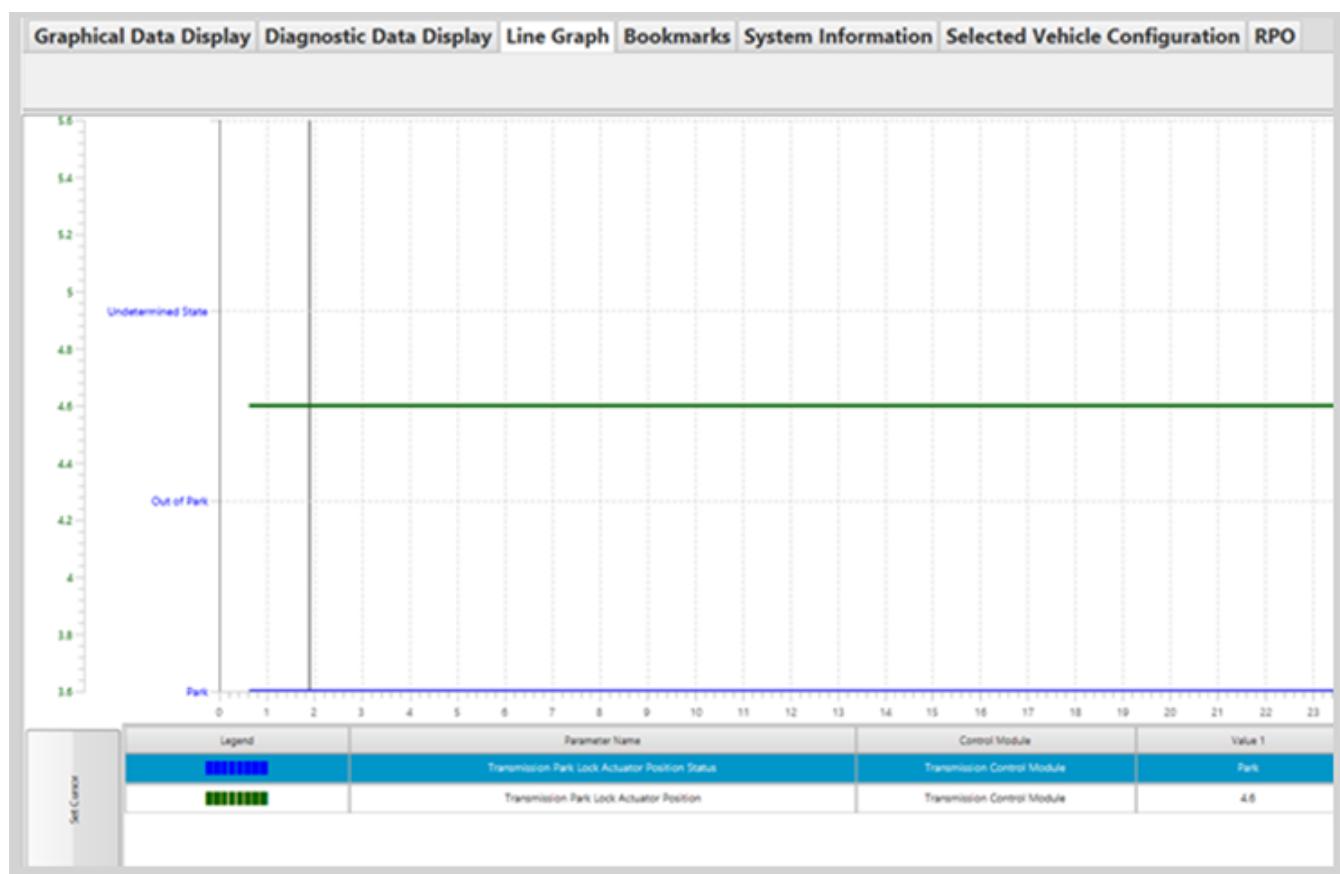
Fig. 16

If the noise from the bell housing area follows engine RPM and can be duplicated without moving the vehicle, verify that the vehicle has the latest TCM calibrations, set up a TAC case and attach the PicoScope sound files (refer to Bulletin #21-NA-049), and verify the park sensor measurement in the GDS transmission data for Park Lock Valve (PLV) drift (refer to Bulletin #23-NA-176). (Fig. 16)

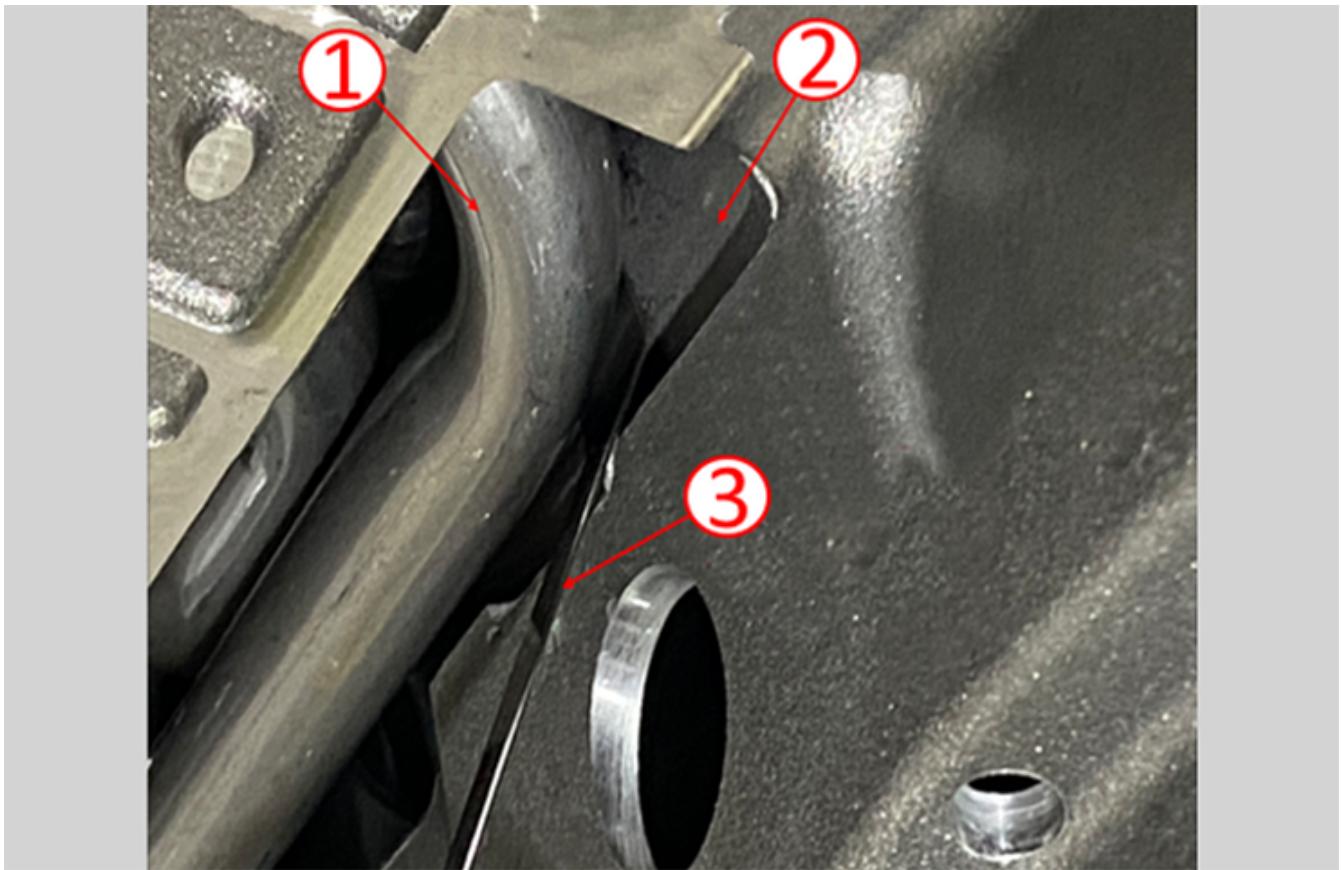
Fig. 17

Inspect the direct clutch for failure by removing the MCV and check the clearance between the fluid tube (Fig. 17, #1) and direct clutch (Fig. 17, #2) using a feeler gauge. (Fig. 17, #3) If the clearance is 0 mm with obvious contact, follow the repairs for Direct Clutch Replacement in the appropriate Service Information. If the clearance is 0.5 mm, follow the repairs for direct clutch pump gear noise.

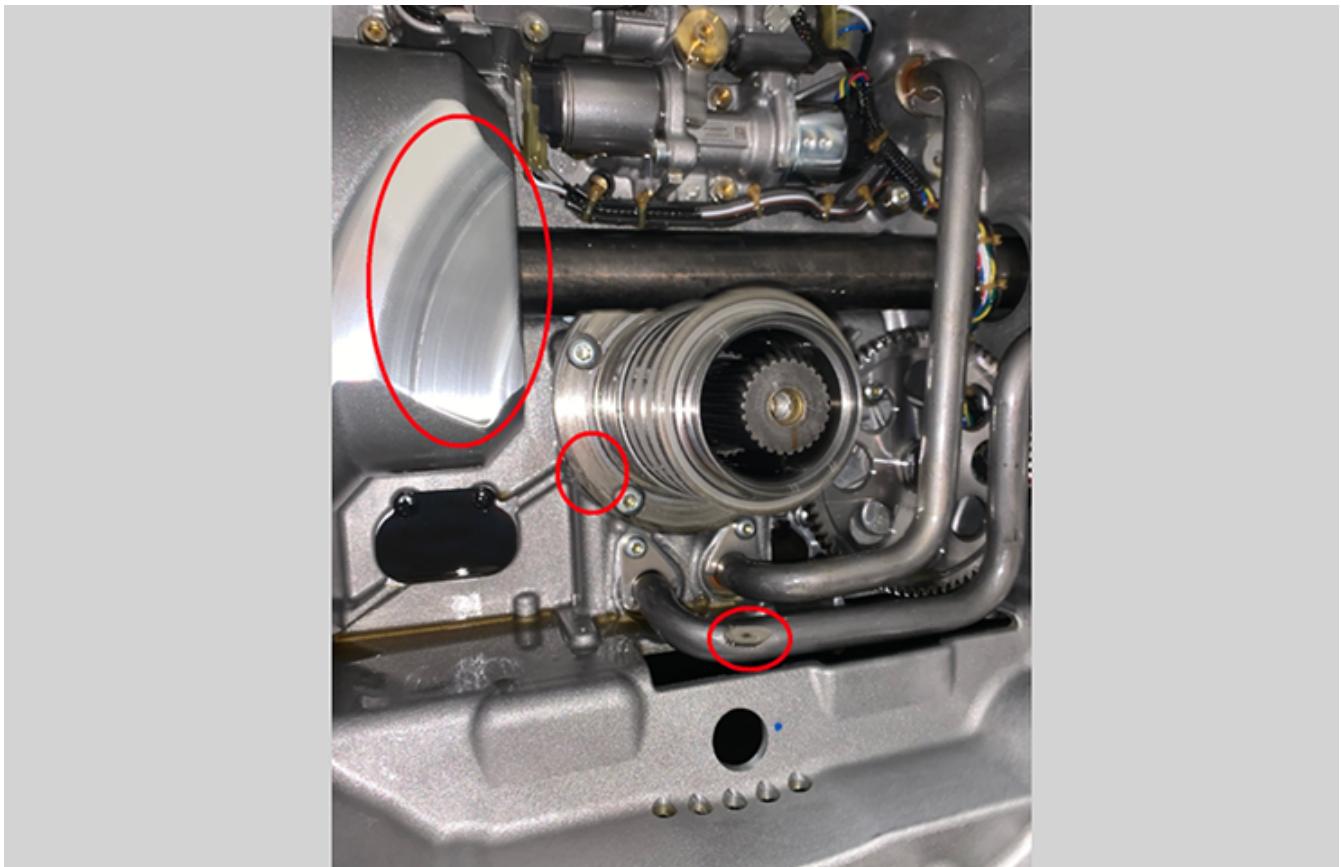
Fig. 18

While inspecting the pump gear for damage, if the direct clutch can be removed easily but there is contact with the pipe and stator, replace parts as needed. Light damage to the housing caused by direct clutch contact will not require replacement. (Fig. 18)
