2020 - 2024 Corvette: Noise From the Transmission Area

July 23, 2024

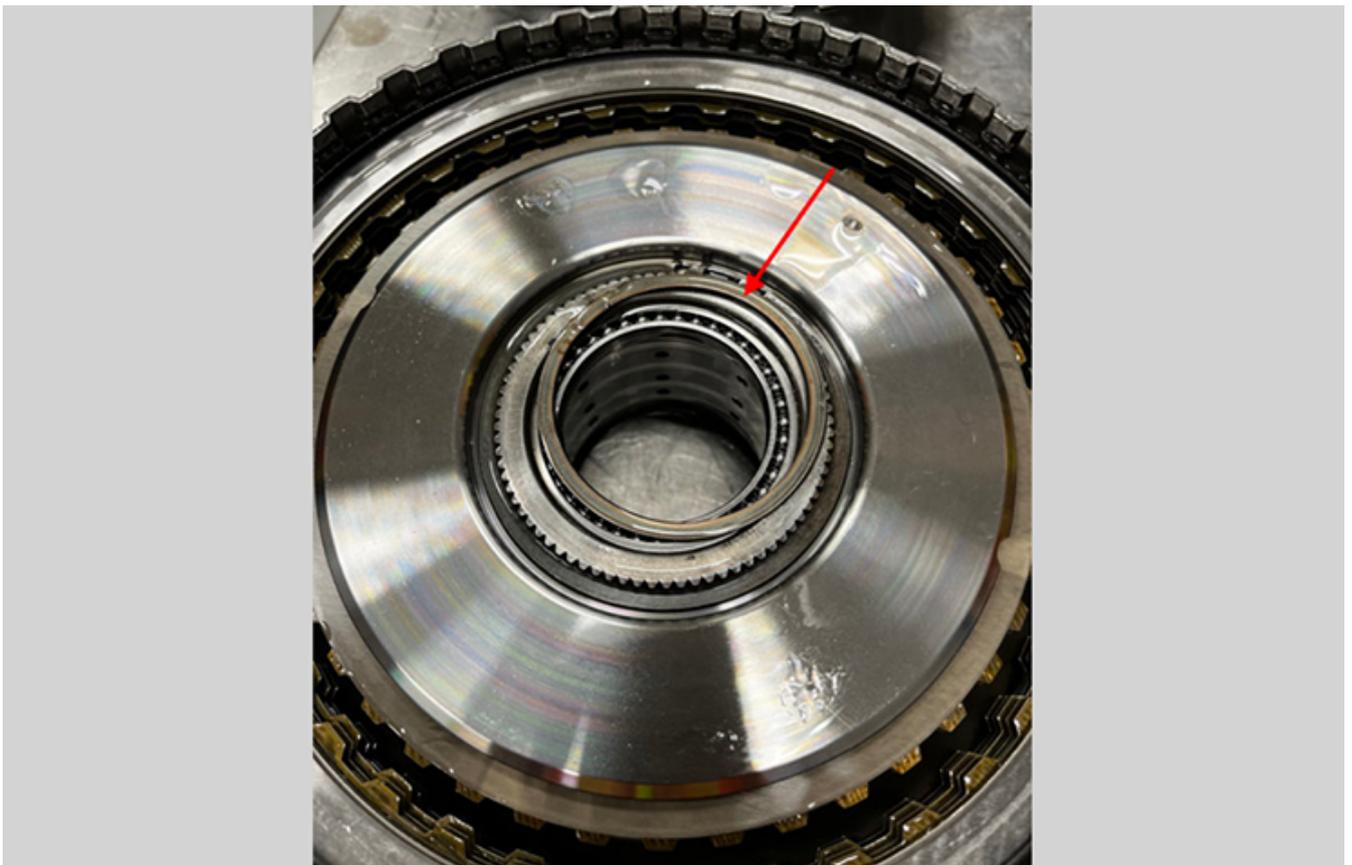
Fig. 15

There may be a noise from the bell housing area of the DCT TR9080 transmission (RPO M1L, M1M) on some 2020-2024 Corvettes along with a number of DTCs set in the Transmission Control Module (TCM). The noise may be due to a dislodged snap ring in the direct clutch assembly. (Fig. 15) As a result, one or more pressure DTCs may set if there is debris caused by the valves sticking in the Main Control Valve (MCV) Body or the direct clutch may contact the fluid tubes, stator shaft or transmission housing.

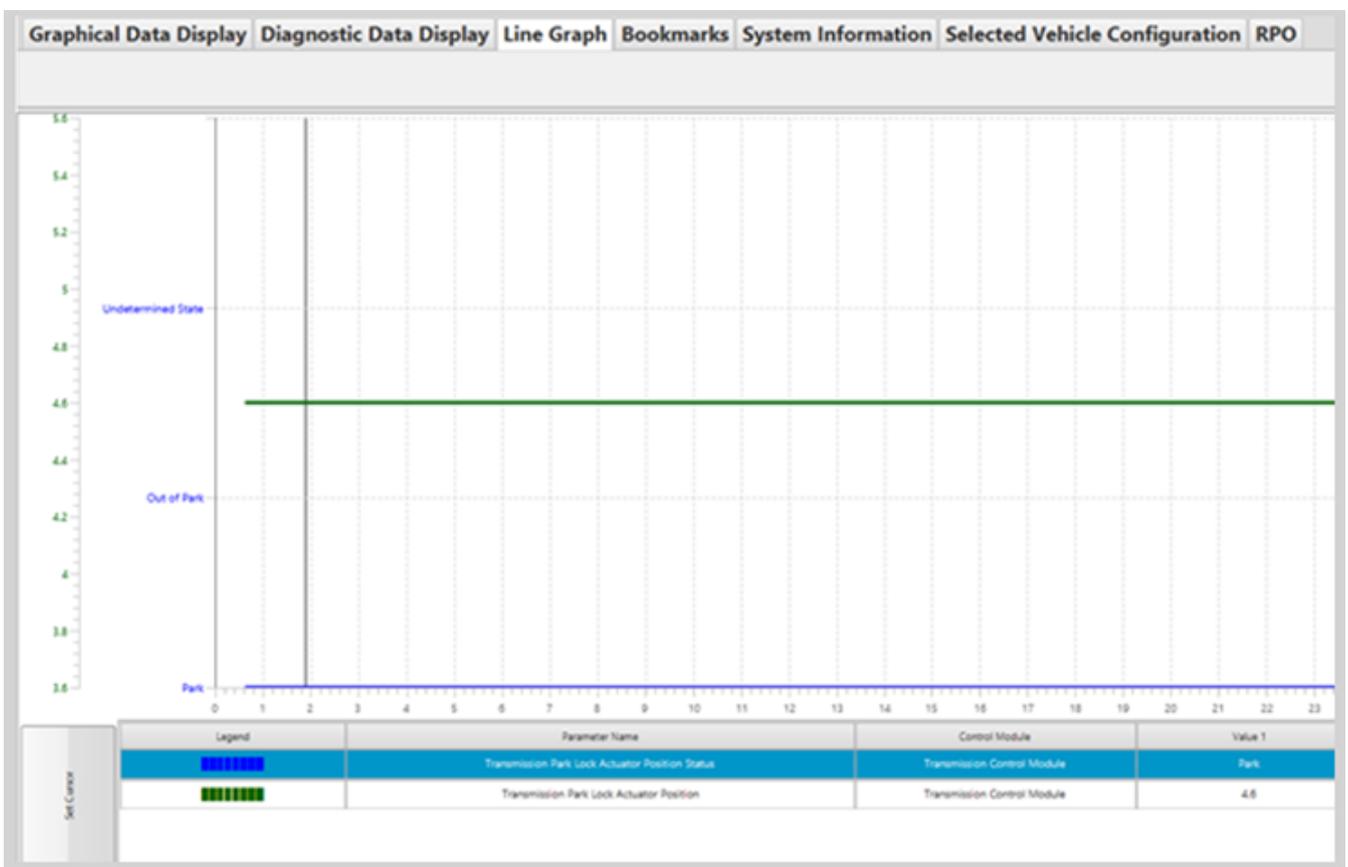
Fig. 16

If the noise from the bell housing area follows engine RPM and can be duplicated without moving the vehicle, verify that the vehicle has the latest TCM calibrations, set up a TAC case and attach the PicoScope sound files (refer to Bulletin #21-NA-049), and verify the park sensor measurement in the GDS transmission data for Park Lock Valve (PLV) drift (refer to Bulletin #23-NA-176). (Fig. 16)

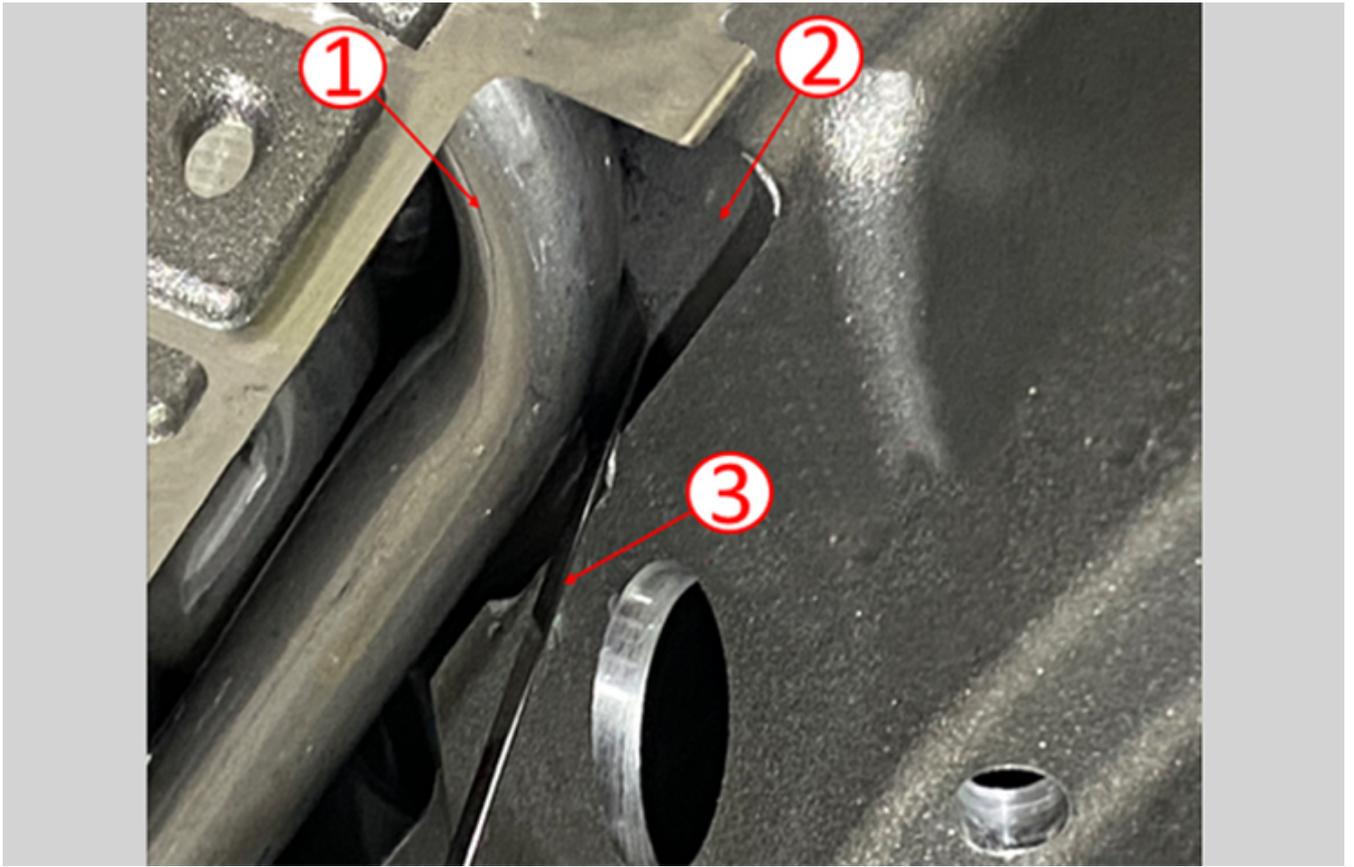
Fig. 17

Inspect the direct clutch for failure by removing the MCV and check the clearance between the fluid tube (Fig. 17, #1) and direct clutch (Fig. 17, #2) using a feeler gauge. (Fig. 17, #3) If the clearance is 0 mm with obvious contact, follow the repairs for Direct Clutch Replacement in the appropriate Service Information. If the clearance is 0.5 mm, follow the repairs for direct clutch pump gear noise.

- If there is direct clutch snap ring failure without any DTCs set as current, replace the direct clutch and stator. In addition, remove the transmission pan to clean any debris from the magnets and replace the sump and canister filter elements.
- If there is direct clutch gear noise, replace the direct clutch, stator and pump gear. Also remove the transmission pan to clean debris from the magnets and replace the sump and canister filter elements.
- If there is direct clutch snap ring failure with an illuminated MIL and pressure DTCs set, replace the direct clutch and stator. Also remove the transmission pan to clean debris from the magnets, replace the sump and canister filter elements, and replace the Main Control Valve (MCV).

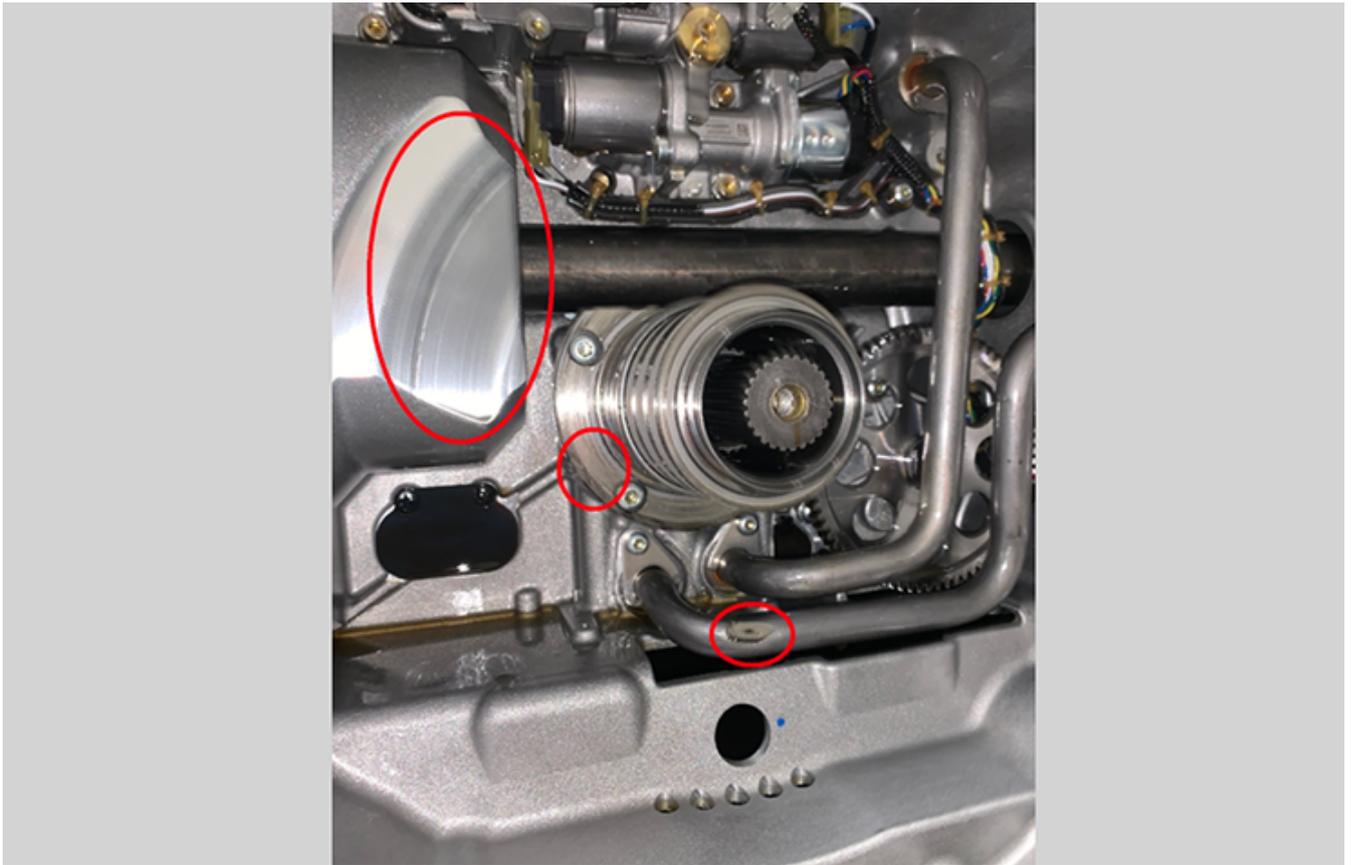
Fig. 18

While inspecting the pump gear for damage, if the direct clutch can be removed easily but there is contact with the pipe and stator, replace parts as needed. Light damage to the housing caused by direct clutch contact will not require replacement. (Fig. 18)
