2020 - 2024 Corvette: Noise From the Transmission Area

July 23, 2024

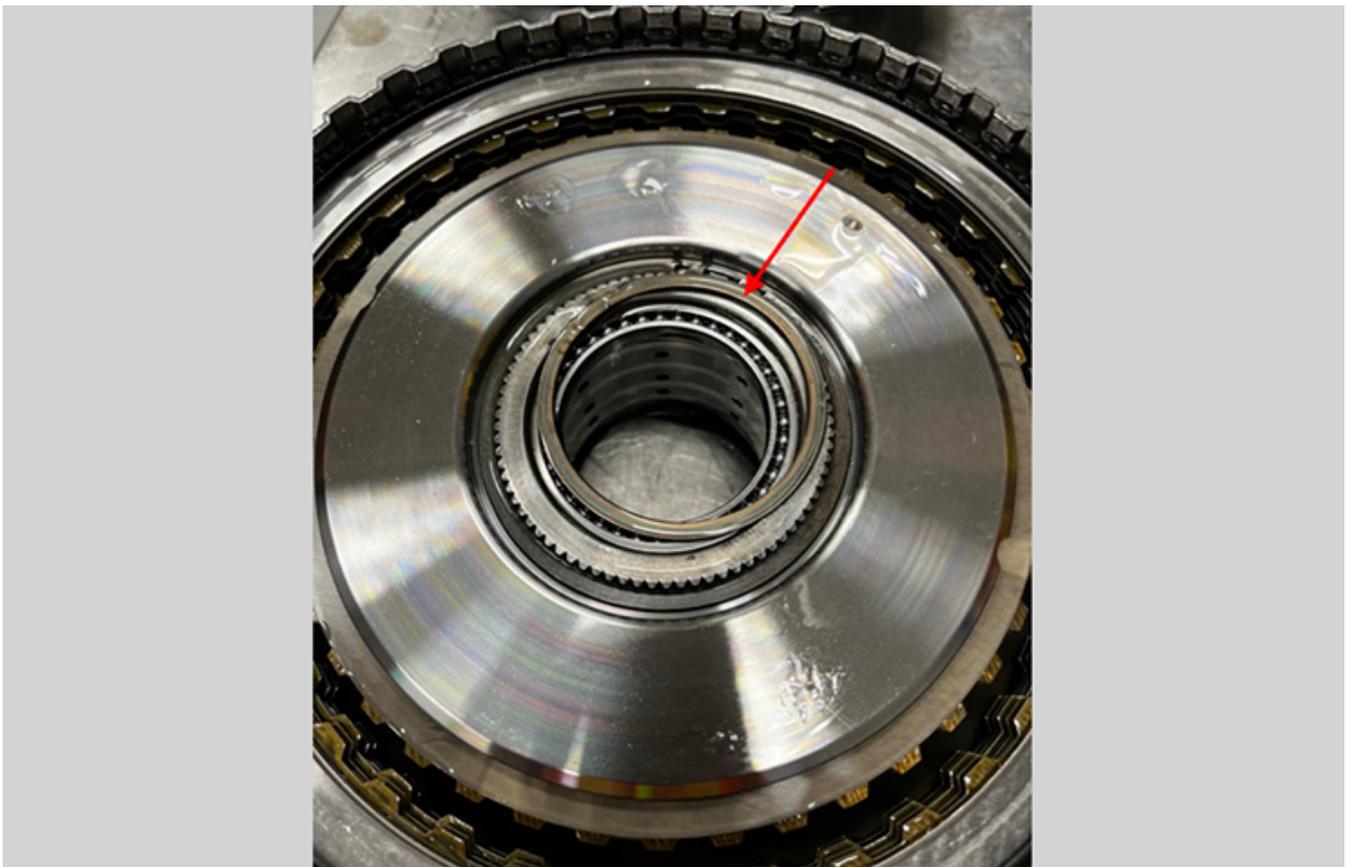
Fig. 15

There may be a noise from the bell housing area of the DCT TR9080 transmission (RPO M1L, M1M) on some 2020-2024 Corvettes along with a number of DTCs set in the Transmission Control Module (TCM). The noise may be due to a dislodged snap ring in the direct clutch assembly. (Fig. 15) As a result, one or more pressure DTCs may set if there is debris caused by the valves sticking in the Main Control Valve (MCV) Body or the direct clutch may contact the fluid tubes, stator shaft or transmission housing.

- If there is direct clutch snap ring failure without any DTCs set as current, replace the direct clutch and stator. In addition, remove the transmission pan to clean any debris from the magnets and replace the sump and canister filter elements.
- If there is direct clutch gear noise, replace the direct clutch, stator and pump gear. Also remove the transmission pan to clean debris from the magnets and replace the sump and canister filter elements.
- If there is direct clutch snap ring failure with an illuminated MIL and pressure DTCs set, replace the direct clutch and stator. Also remove the transmission pan to clean debris from the magnets, replace the sump and canister filter elements, and replace the Main Control Valve (MCV).
