# 2020 - 2024 Corvette: Noise From the Transmission Area

July 23, 2024

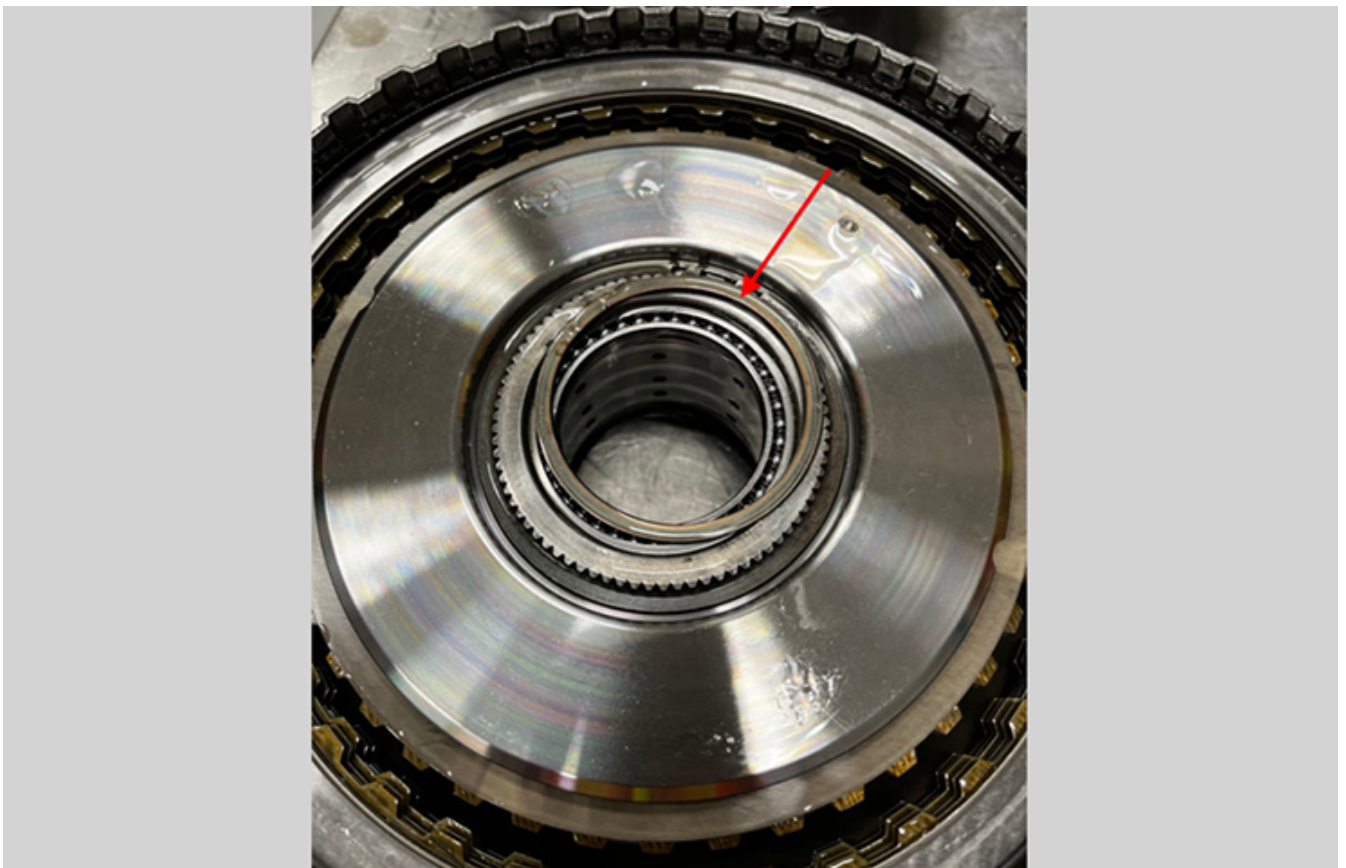
Fig. 15

There may be a noise from the bell housing area of the DCT TR9080 transmission (RPO M1L, M1M) on some 2020-2024 Corvettes along with a number of DTCs set in the Transmission Control Module (TCM). The noise may be due to a dislodged snap ring in the direct clutch assembly. (Fig. 15) As a result, one or more pressure DTCs may set if there is debris caused by the valves sticking in the Main Control Valve (MCV) Body or the direct clutch may contact the fluid tubes, stator shaft or transmission housing.

- If there is direct clutch snap ring failure without any DTCs set as current, replace the direct clutch and stator. In addition, remove the transmission pan to clean any debris from the magnets and replace the sump and canister filter elements.
- If there is direct clutch gear noise, replace the direct clutch, stator and pump gear. Also remove the transmission pan to clean debris from the magnets and replace the sump and canister filter elements.
- If there is direct clutch snap ring failure with an illuminated MIL and pressure DTCs set, replace the direct clutch and stator. Also remove the transmission pan to clean debris from the magnets, replace the sump and canister filter elements, and replace the Main Control Valve (MCV).

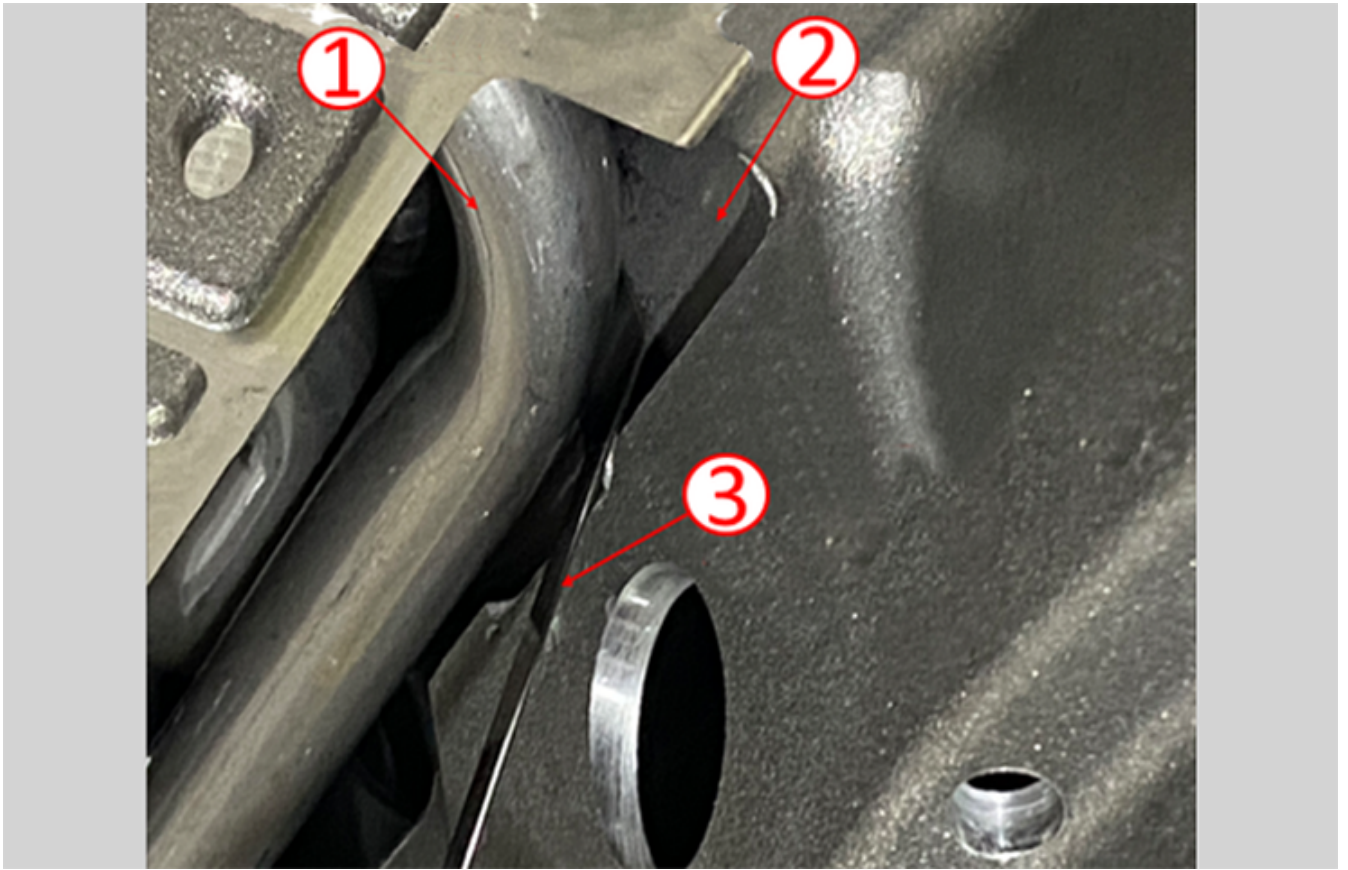
**Fig. 17**

Inspect the direct clutch for failure by removing the MCV and check the clearance between the fluid tube (Fig. 17, #1) and direct clutch (Fig. 17, #2) using a feeler gauge. (Fig. 17, #3) If the clearance is 0 mm with obvious contact, follow the repairs for Direct Clutch Replacement in the appropriate Service Information. If the clearance is 0.5 mm, follow the repairs for direct clutch pump gear noise.

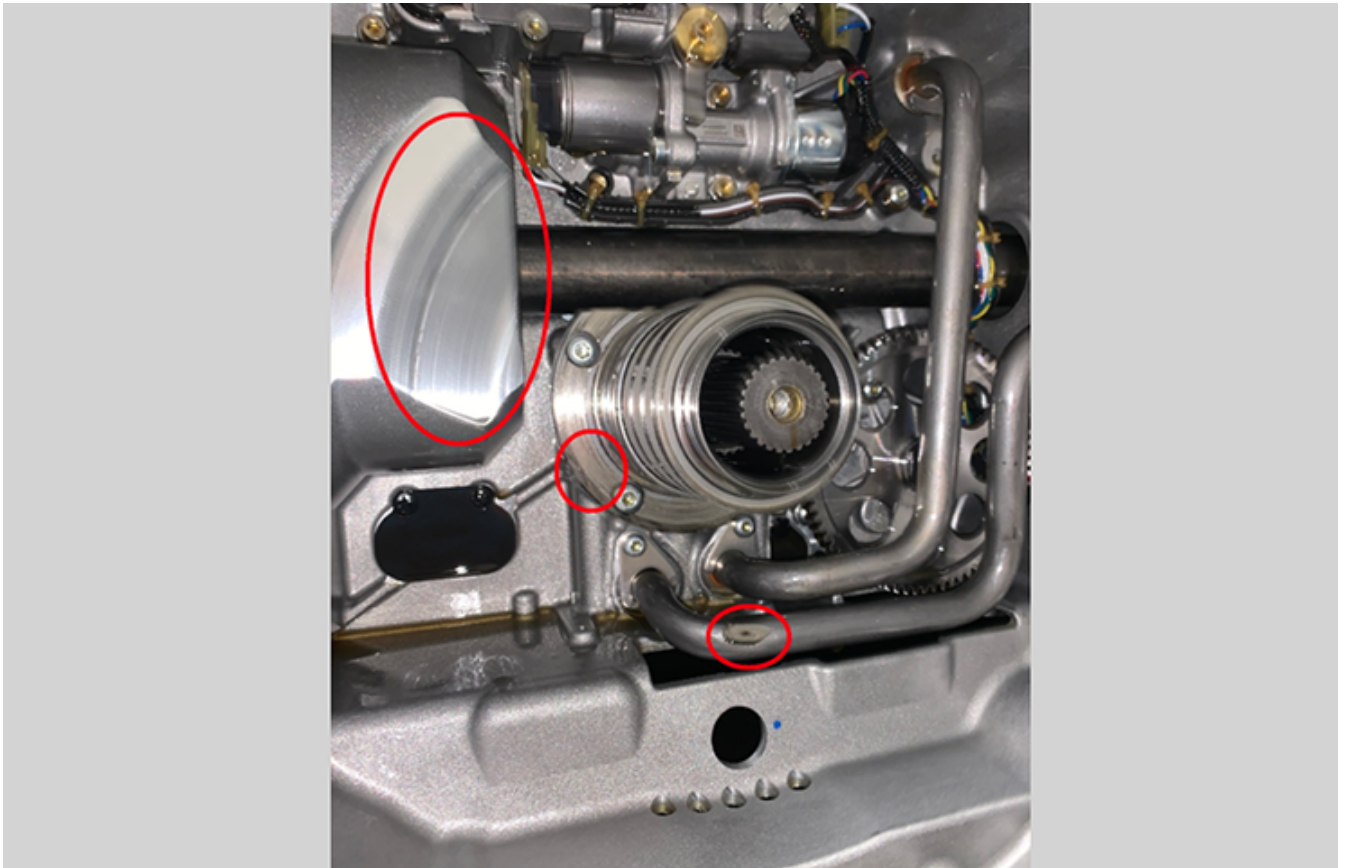
**Fig. 18**

While inspecting the pump gear for damage, if the direct clutch can be removed easily but there is contact with the pipe and stator, replace parts as needed. Light damage to the housing caused by direct clutch contact will not require replacement. (Fig. 18)
