# 2019 - 2024 Corvette: Crankshaft Bearing Diagnosis

March 21, 2024

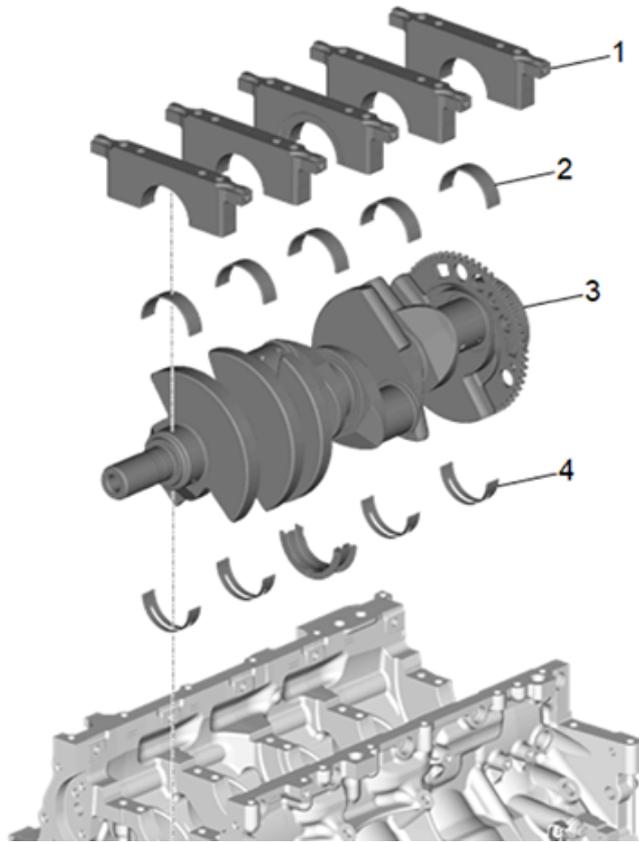
**Fig. 8**

If these engine conditions are present, check for crankshaft bearing failure or a damaged thrust bearing. (Fig. 8) There are several items to inspect to determine if bearing failure has occurred.

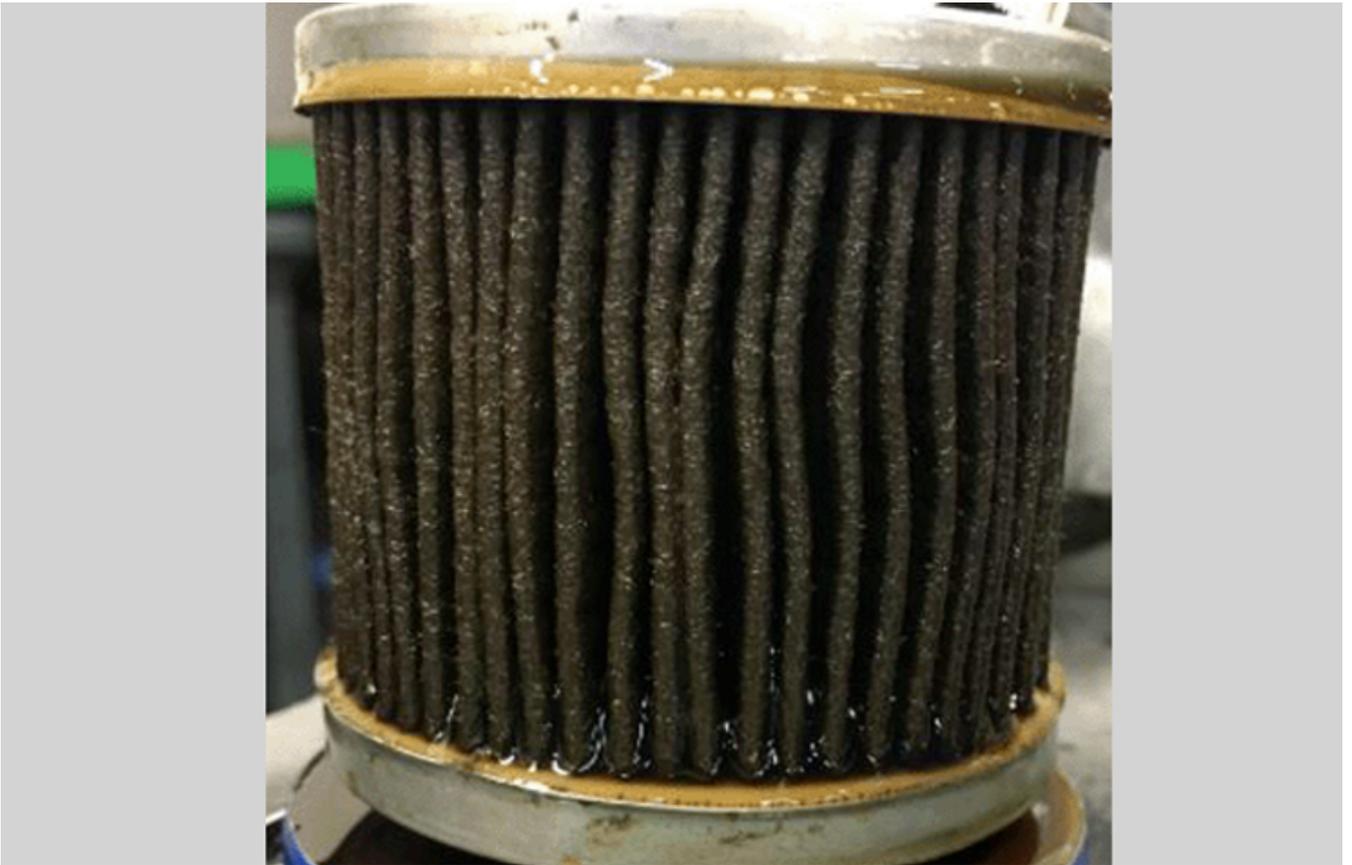
**Fig. 9.**

Begin diagnosis by inspecting the engine oil and filter for bearing material or excessive metal debris. (Fig. 9) Pouring the oil through a white shop towel may be helpful.

**TIP:** There may be light glitter in the oil from the manufacturing process if the engine has not had its first oil change. In this case, further engine inspection is necessary.

Remove the engine oil pan for further inspection of the crankshaft rod and main bearings if bearing debris has been identified.

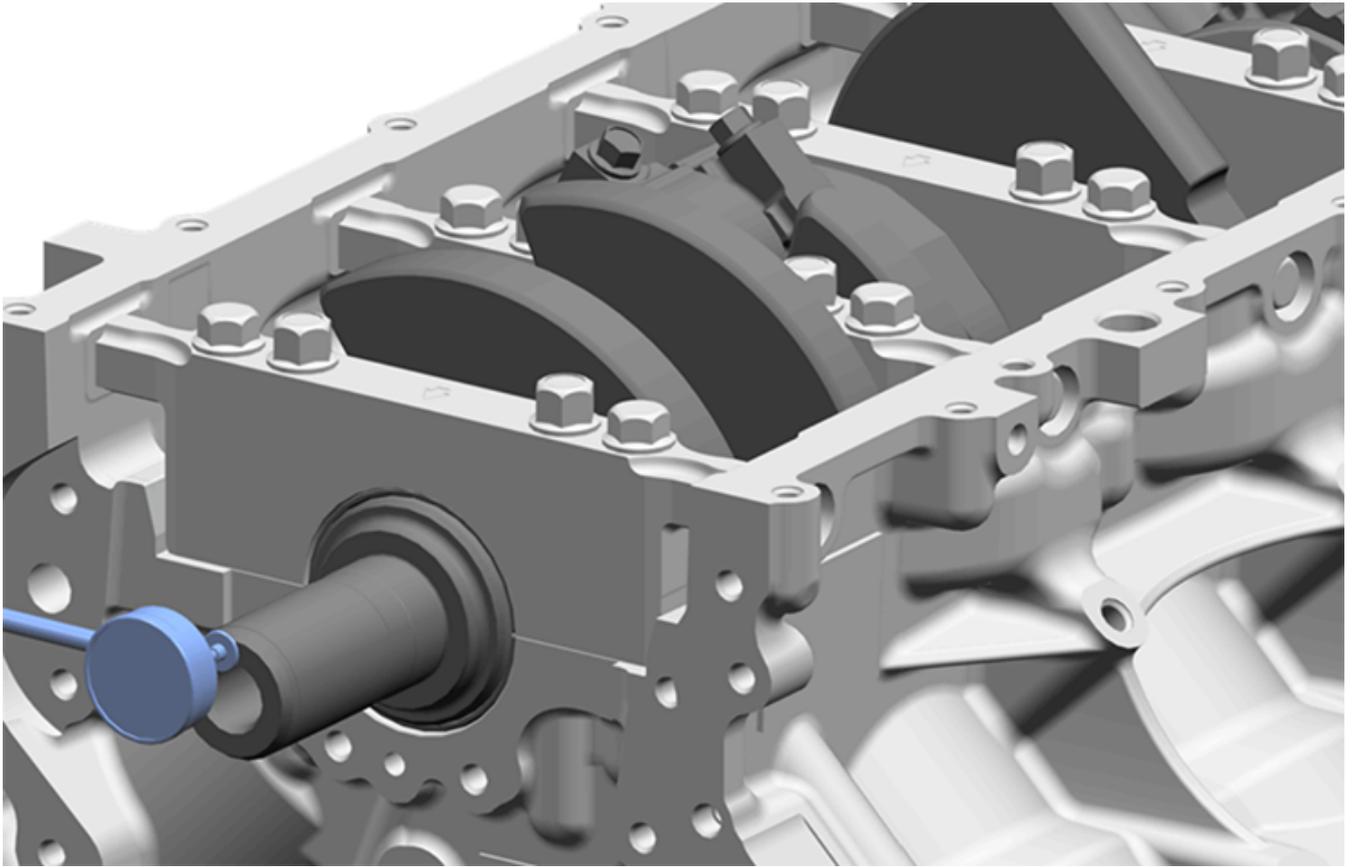
**Fig. 10**

In addition, if material is found in the engine oil, measure crankshaft end play following the appropriate Service Information. (Fig. 10) If there is not excessive crankshaft end play, remove the engine accessory drive belt and run the engine again. If the noise is eliminated, check the accessory drive belt-driven components for possible issues.
