2019 - 2024 Corvette: Crankshaft Bearing Diagnosis

March 21, 2024

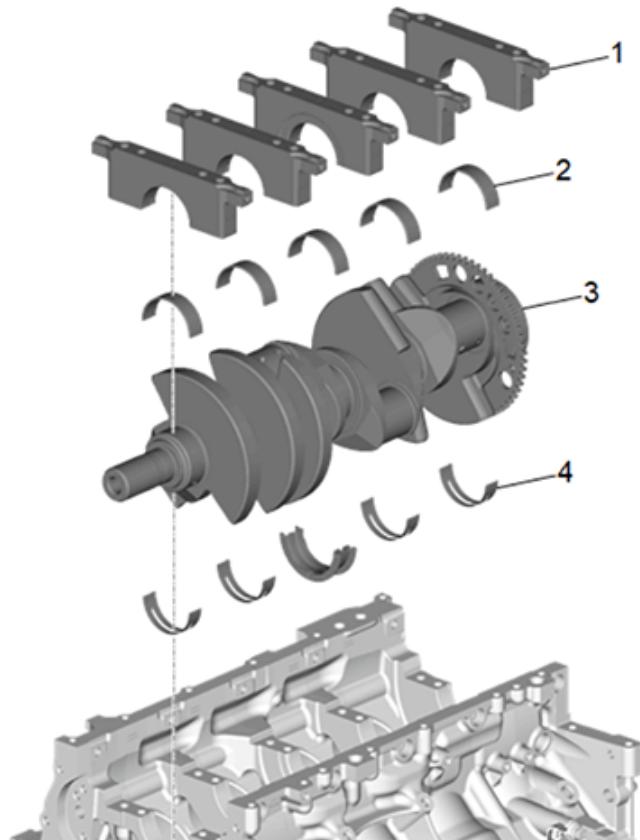
Fig. 8

A growling, knocking or rhythmic thumping sound may be heard on some 4.3L engines (RPO LV3), 5.3L engines (RPO L82, L84) and 6.2L engines (RPO L87, LT1, LT2, LT4, L8T) on some 2019-2024 Camaro, Corvette, Silverado 1500, Sierra 1500; 2020-2024 Silverado 2500/3500, Sierra 2500/3500; 2021-2024 Tahoe, Suburban, Yukon, Escalade; 2021-2024 Express, Savana; and 2022-2024 CT5 models. The engine may be hard to rotate once at operating temperature, which may lead to it locking up and unable to restart. Once the engine cools down to ambient temperature, it may refire and run normally. In addition, the starter fuse may be open. All of these conditions may be a sign of an early bearing failure.

If these engine conditions are present, check for crankshaft bearing failure or a damaged thrust bearing. (Fig. 8) There are several items to inspect to determine if bearing failure has occurred.

TIP: If crankshaft bearing damage is found once all diagnostic procedures are

completed, refer to Bulletins #22-NA-074 and #18-NA-073 for additional repair directions.

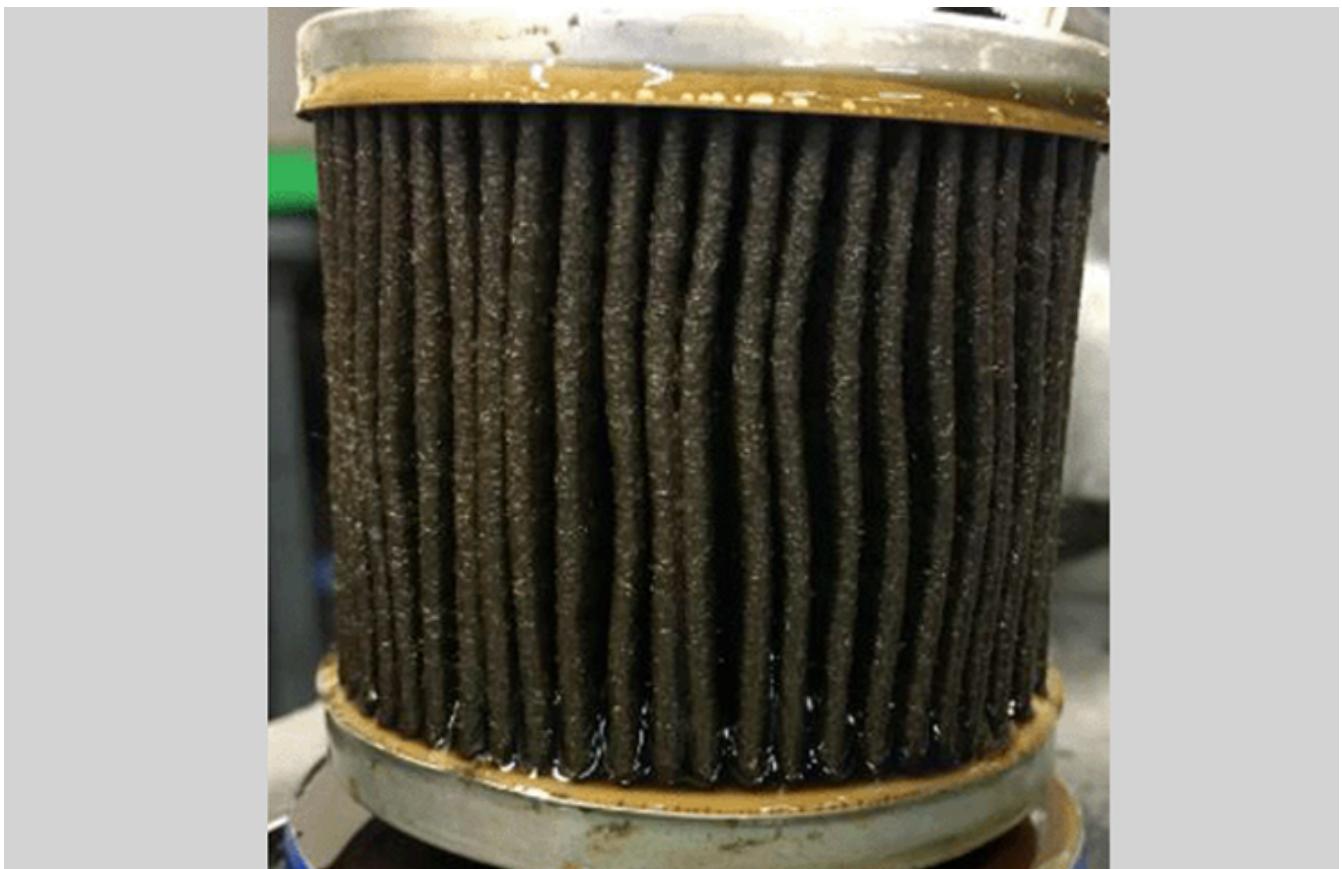
Fig. 9.

Begin diagnosis by inspecting the engine oil and filter for bearing material or excessive metal debris. (Fig. 9) Pouring the oil through a white shop towel may be helpful.

TIP: There may be light glitter in the oil from the manufacturing process if the engine has not had its first oil change. In this case, further engine inspection is necessary.

Remove the engine oil pan for further inspection of the crankshaft rod and main bearings if bearing debris has been identified.

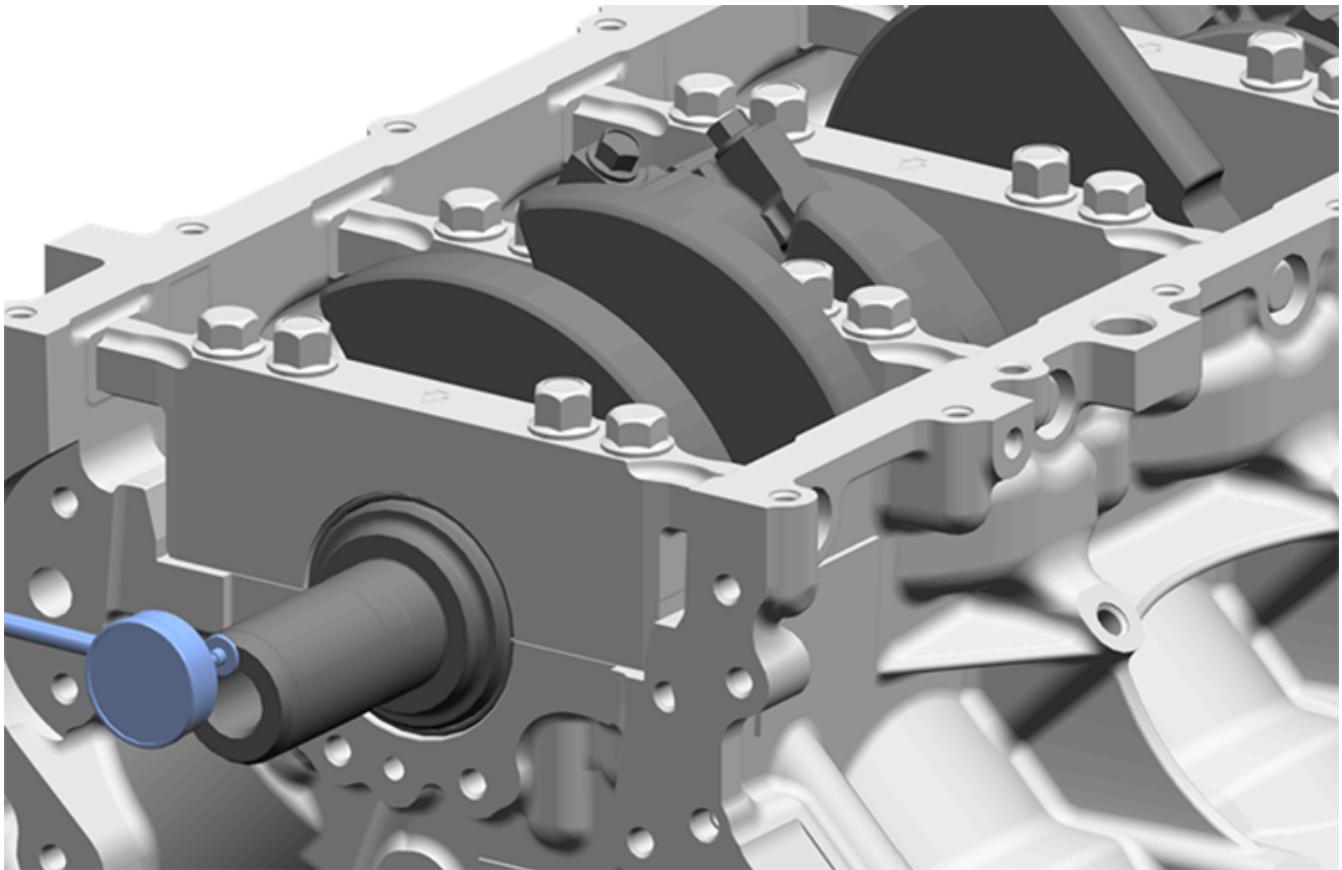
Fig. 10

In addition, if material is found in the engine oil, measure crankshaft end play following the appropriate Service Information. (Fig. 10) If there is not excessive crankshaft end play, remove the engine accessory drive belt and run the engine again. If the noise is eliminated, check the accessory drive belt-driven components for possible issues.
