2019 - 2024 Corvette: Crankshaft Bearing Diagnosis

March 21, 2024

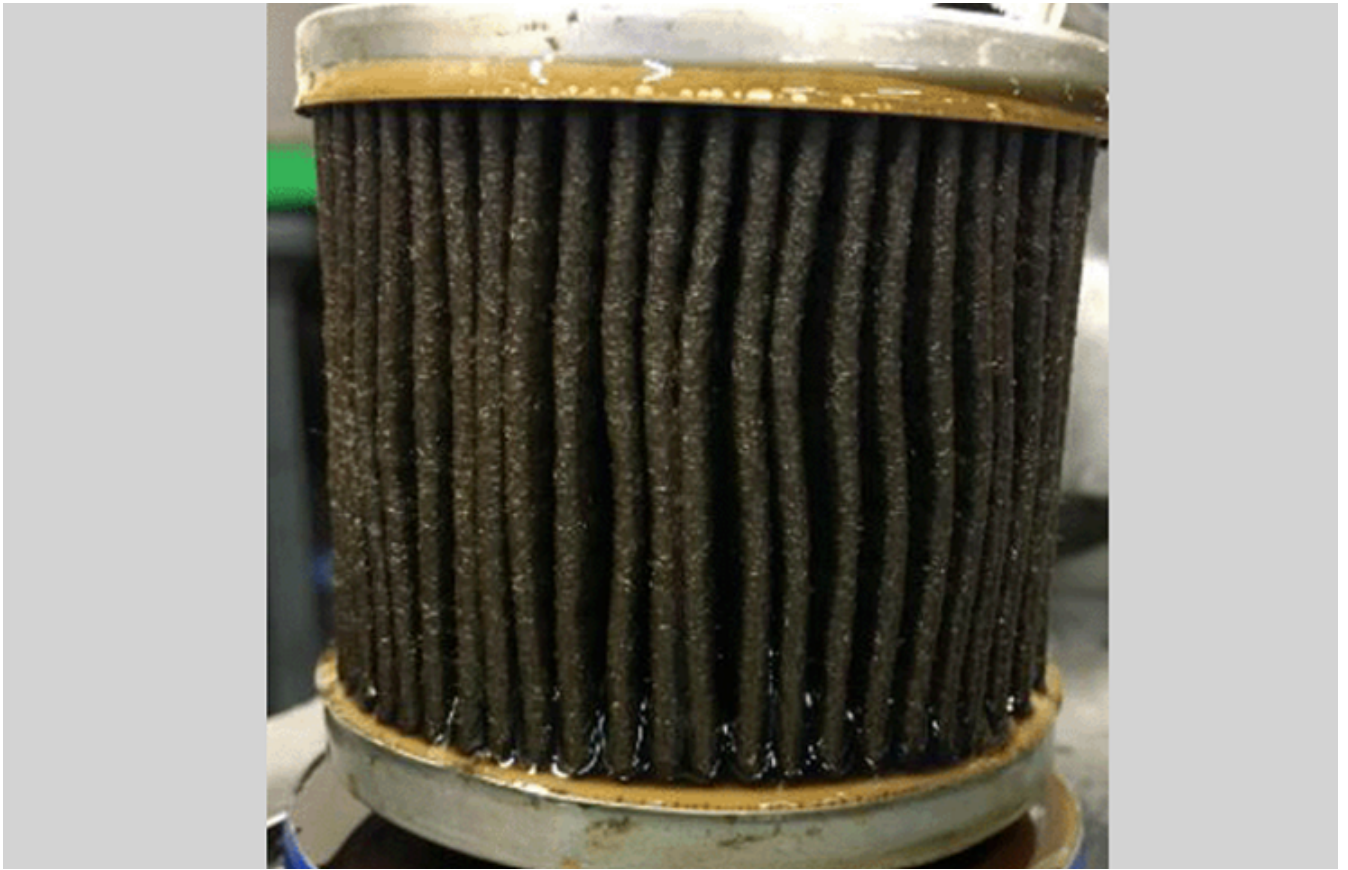
Fig. 9.

Begin diagnosis by inspecting the engine oil and filter for bearing material or excessive metal debris. (Fig. 9) Pouring the oil through a white shop towel may be helpful.

TIP: There may be light glitter in the oil from the manufacturing process if the engine has not had its first oil change. In this case, further engine inspection is necessary.

Remove the engine oil pan for further inspection of the crankshaft rod and main bearings if bearing debris has been identified.
