2015 - 2018 Corvette: Shift Concerns on 8-Speed Transmissions

November 29, 2023

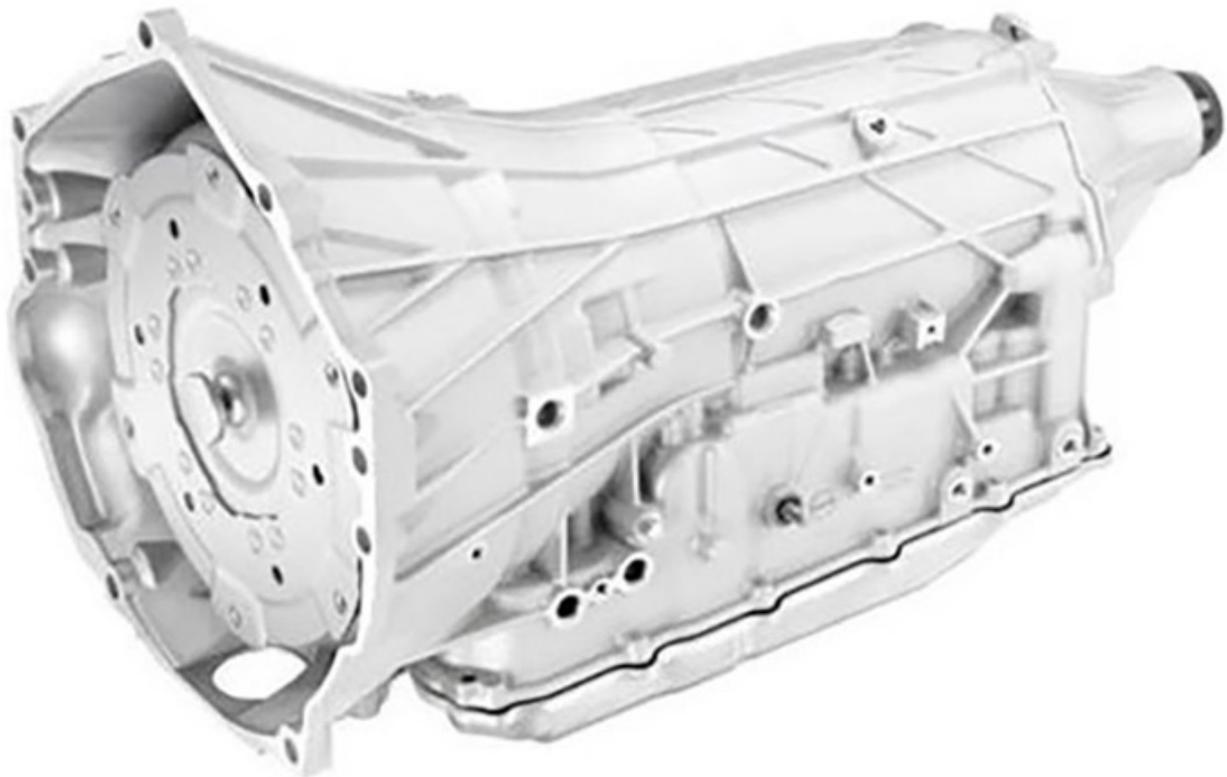
Fig. 5

The 8-speed automatic transmissions (RPO M5N, MNU, M5U, M5X, MHA, M5T, MQE, MQD) in some 2015-2018 Corvette; 2015-2020 Escalade, Yukon; 2015-2023 Silverado 1500, Sierra 1500; 2016-2018 CTS; 2016-2019 ATS, CTS; 2016-2023 Camaro; 2017-2023 Colorado, Canyon; 2017-2024 Express, Savana; and 2020-2024 CT4 models (Fig. 5) may exhibit hard or harsh shifts.

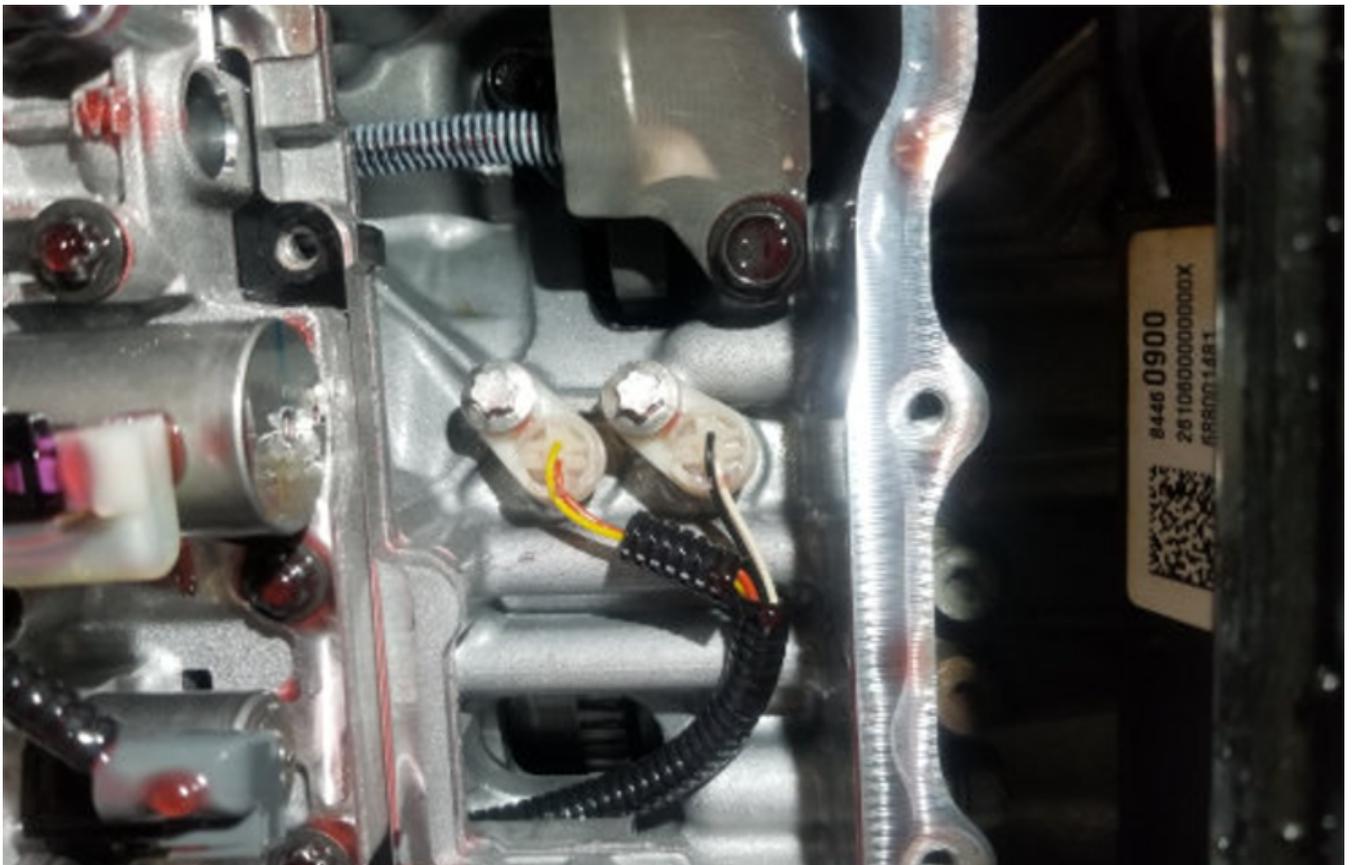
Fig. 7

In addition, if the speed sensors were recently replaced and the Transmission Service Fast Learn fails for excessive vehicle speed, or if DTCs P0717, P0722, P0746 and/or P0796 also set, inspect the speed sensors for the proper orientation. When correctly installed, the smaller portion of the sensor conduit should be facing the rear of the unit. (Fig. 7, Incorrect; Fig. 8, Correct)
