# 2015 - 2018 Corvette: Shift Concerns on 8-Speed Transmissions

November 29, 2023

- **Source:** GM TechLink

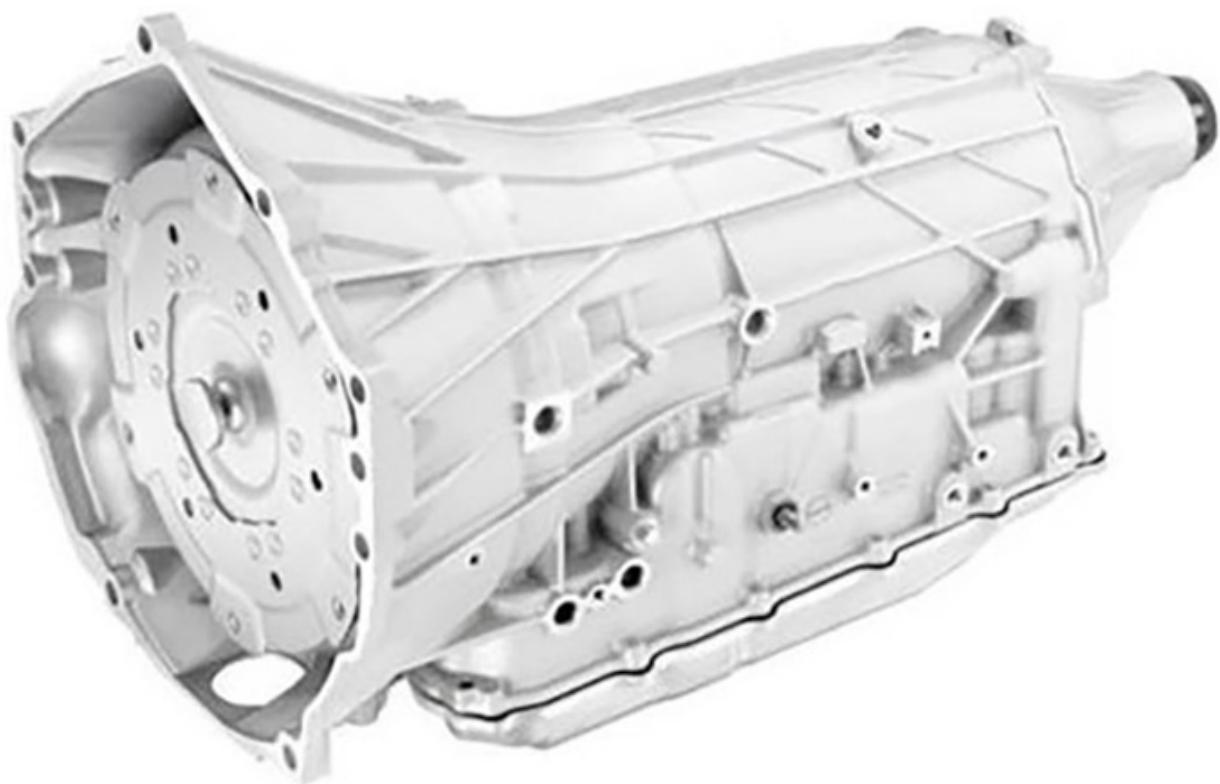
**Fig. 5**

The 8-speed automatic transmissions (RPO M5N, MNU, M5U, M5X, MHA, M5T, MQE, MQD) in some 2015-2018 Corvette; 2015-2020 Escalade, Yukon; 2015-2023 Silverado 1500, Sierra 1500; 2016-2018 CTS; 2016-2019 ATS, CTS; 2016-2023 Camaro; 2017-2023 Colorado, Canyon; 2017-2024 Express, Savana; and 2020-2024 CT4 models (Fig. 5) may exhibit hard or harsh shifts.

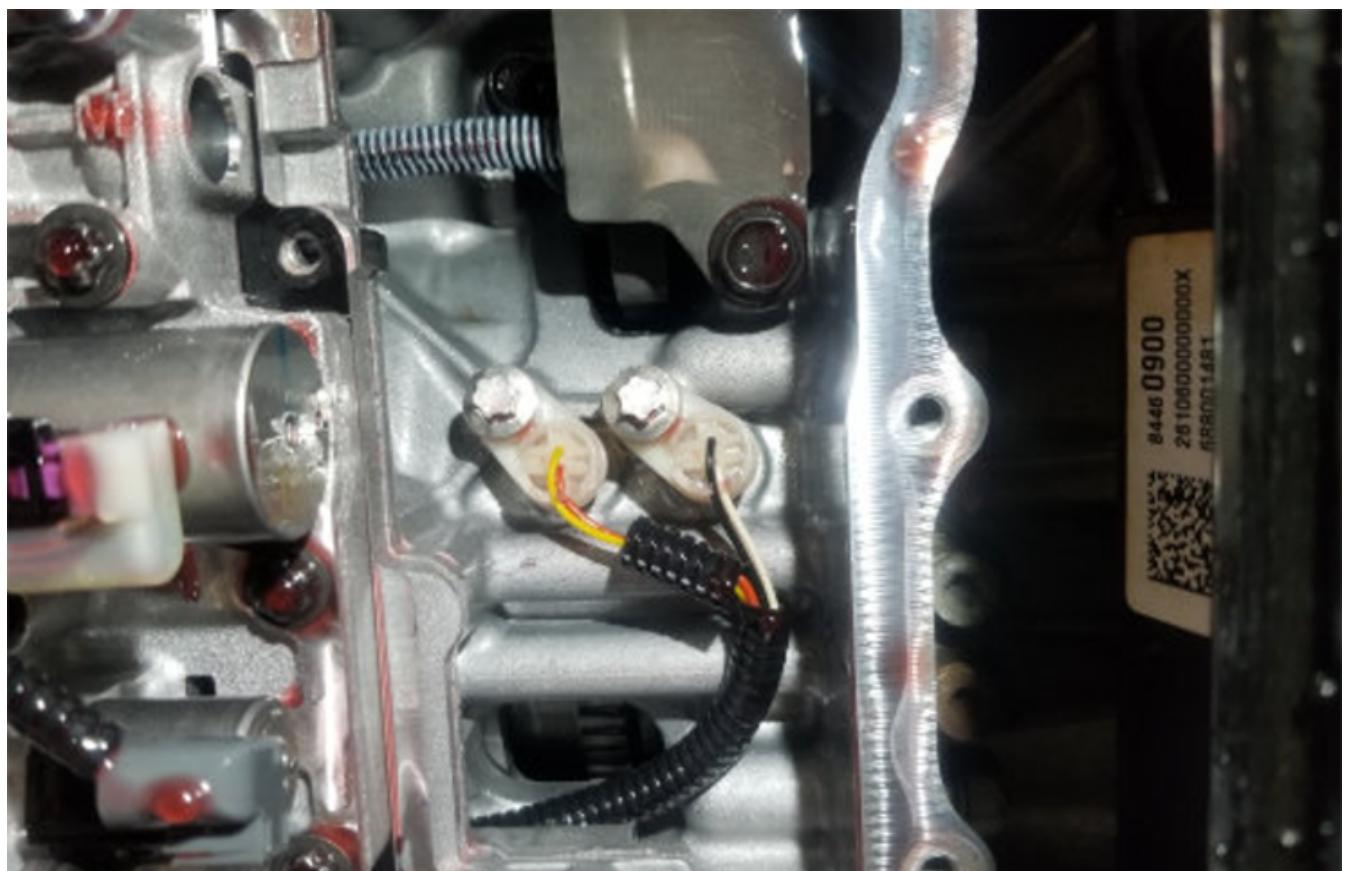
Fig. 7

In addition, if the speed sensors were recently replaced and the Transmission Service Fast Learn fails for excessive vehicle speed, or if DTCs P0717, P0722, P0746 and/or P0796 also set, inspect the speed sensors for the proper orientation. When correctly installed, the smaller portion of the sensor conduit should be facing the rear of the unit. (Fig. 7, Incorrect; Fig. 8, Correct)
