# 2020 - 2024 Corvette: Front Fascia and Headlight Adjustment

November 20, 2023

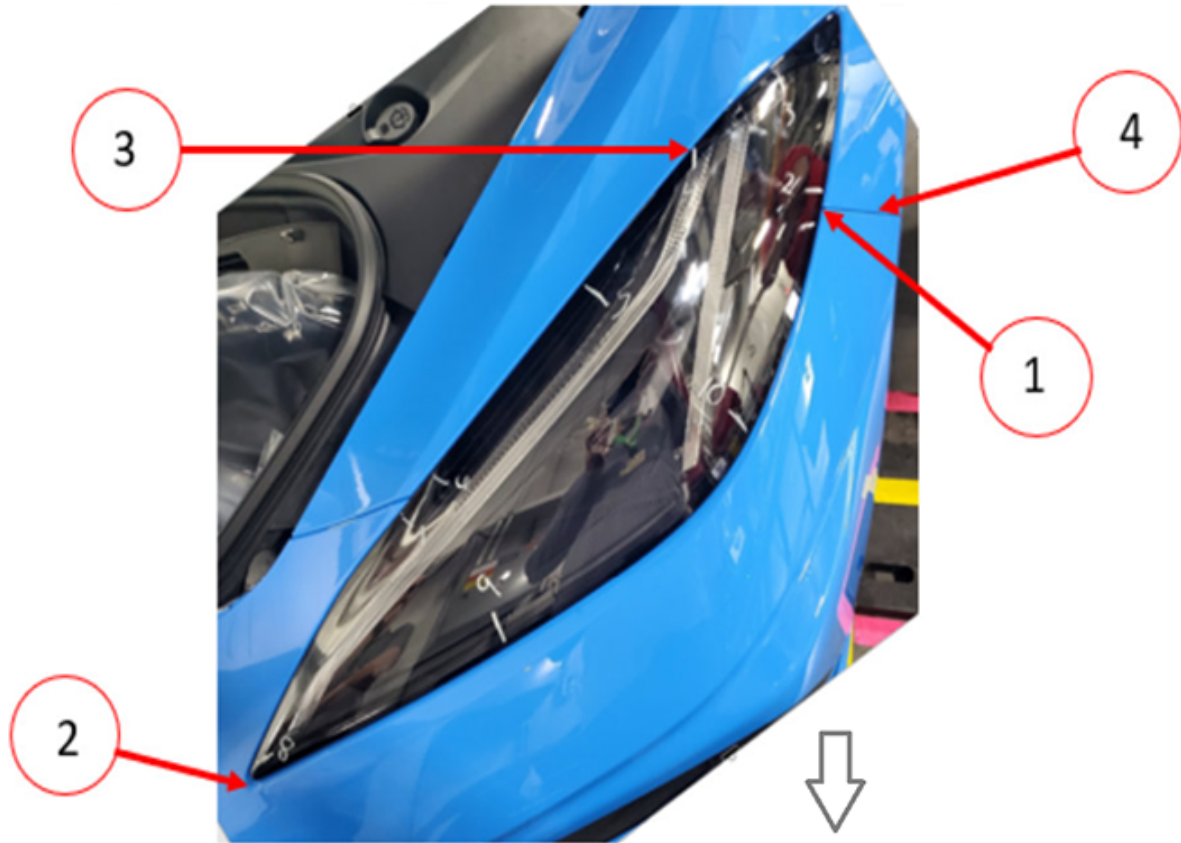
**Fig. 10**

If these conditions are found, there are four potential high-contact areas (Fig. 10) where the paint may chip or peel:

1. Fender/fascia under the headlamp

2. Front corner of the headlamp to the fascia
3. Headlamp tight to fender
4. Front fascia to fender
