# 2020 - 2024 Corvette: Front Fascia and Headlight Adjustment

November 20, 2023

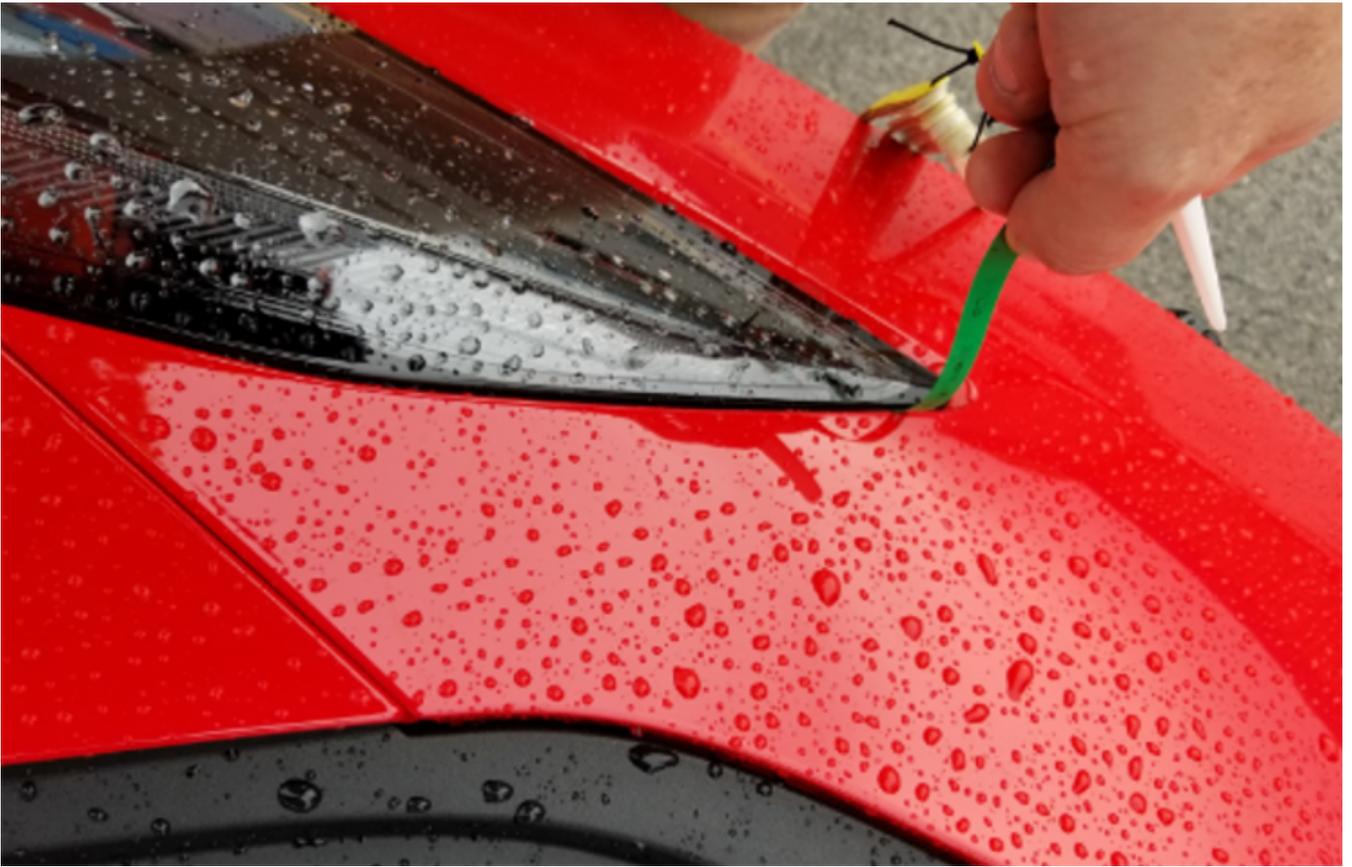
**Fig. 11**

Check for the correct headlamp position before and after any repairs. The headlamp lens should have a minimum 0.5 mm (0.02 in.) gap between the lens and the body panel. (Fig. 11)
