2020 - 2024 Corvette: Front Fascia and Headlight Adjustment

November 20, 2023

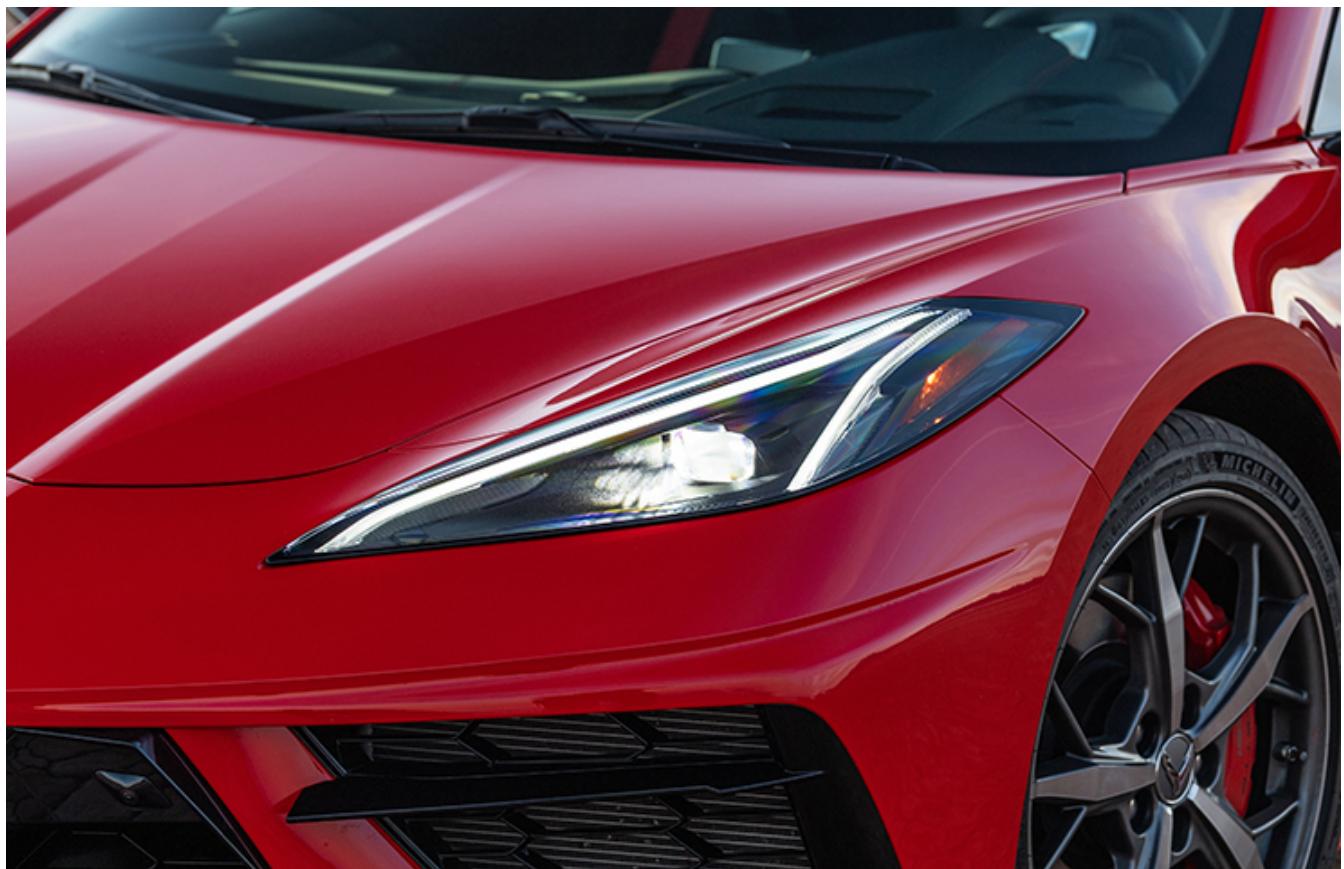
Fig. 9

The paint may have chipped or peeled on the front fascia or fender-to-fascia body seam on some 2020-2024 Corvettes. (Fig. 9) The paint chip may be due to the headlamp being positioned too tightly to the body panel. The fit between the front fascia and fender also may be too tight on the same vehicle.

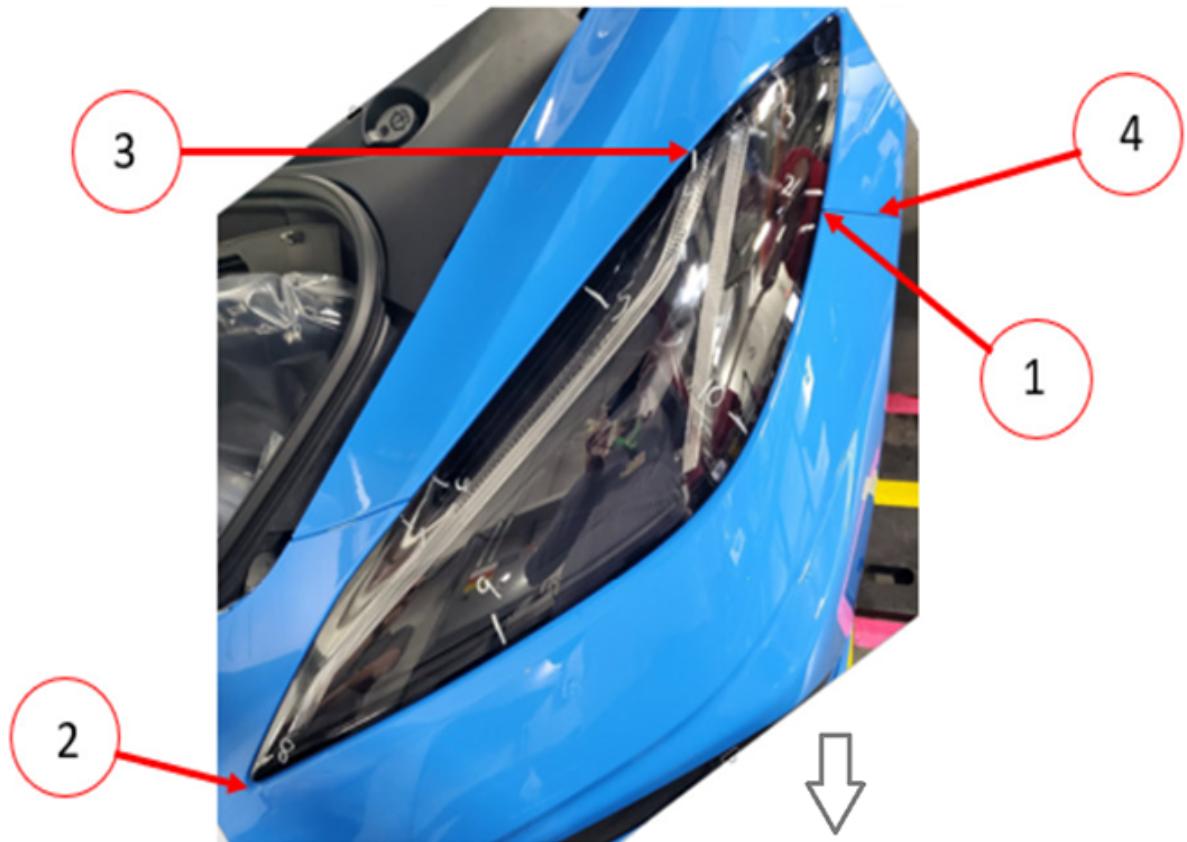
Fig. 10

If these conditions are found, there are four potential high-contact areas (Fig. 10) where the paint may chip or peel:

1. Fender/fascia under the headlamp

2. Front corner of the headlamp to the fascia
3. Headlamp tight to fender
4. Front fascia to fender
