# 1984 Corvette: Campaign: Power Steering Pump Pulley Failure

Number: 84C03

Subject: P/S Pump Pulley Failure

TO: ALL CHEVROLET DEALERS

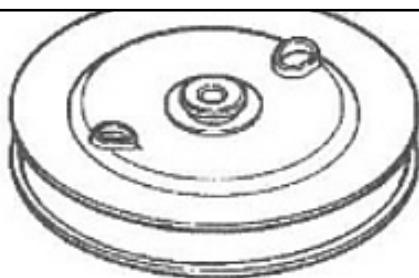
DISCONTINUED  
PULLEY

General Motors has determined that certain 1984 Chevrolet Corvettes are equipped with power steering pump pulleys which may crack at the outer edge. Continued operation may cause the pulley to break, resulting in loss of the drive belt. If the pulley cracks, vehicle occupants should be alerted by a rattling sound coming from the engine compartment.

To prevent the possibility of this condition occurring, it will be necessary to install a new power steering pump pulley on all involved vehicles in accordance with the instructions outlined in this bulletin.
