# 1984 Corvette: Campaign: Power Steering Pump Pulley Failure

Number: 84C03

Subject: P/S Pump Pulley Failure

TO: ALL CHEVROLET DEALERS

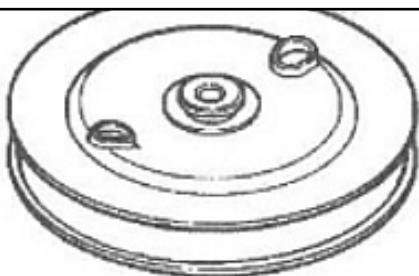
DISCONTINUED  
PULLEY

General Motors has determined that certain 1984 Chevrolet Corvettes are equipped with power steering pump pulleys which may crack at the outer edge. Continued operation may cause the pulley to break, resulting in loss of the drive belt. If the pulley cracks, vehicle occupants should be alerted by a rattling sound coming from the engine compartment.

Power steering pump pulley, P/N 14055114, required to complete this campaign will be shipped directly to the dealers' Service Manager from Chevrolet Central Office. Parts quantities will be determined by the number of vehicles identified on the computer list furnished each involved dealer with the campaign bulletin. Dealers are to install these pulleys only on vehicles within the parameters outlined in this bulletin.
