1984 Corvette: Campaign: Power Steering Pump Pulley Failure

Number: 84C03

Subject: P/S Pump Pulley Failure

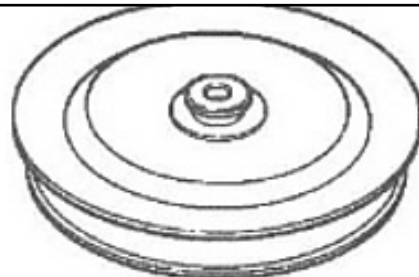
REVISED PULLEY

Power steering pump pulley, P/N 14055114, required to complete this campaign will be shipped directly to the dealers' Service Manager from Chevrolet Central Office. Parts quantities will be determined by the number of vehicles identified on the computer list furnished each involved dealer with the campaign bulletin. Dealers are to install these pulleys only on vehicles within the parameters outlined in this bulletin.
