# 1984 Corvette: Campaign: Power Steering Pump Pulley Failure

Number: 84C03

Subject: P/S Pump Pulley Failure

TO: ALL CHEVROLET DEALERS

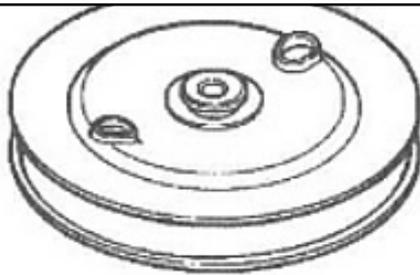
DISCONTINUED  
PULLEY

General Motors has determined that certain 1984 Chevrolet Corvettes are equipped with power steering pump pulleys which may crack at the outer edge. Continued operation may cause the pulley to break, resulting in loss of the drive belt. If the pulley cracks, vehicle occupants should be alerted by a rattling sound coming from the engine compartment.
