2014 Corvette: Techlink Article: Corvette Driveline Support Alignment

Source: GM TechLink

Date: December 5, 2013

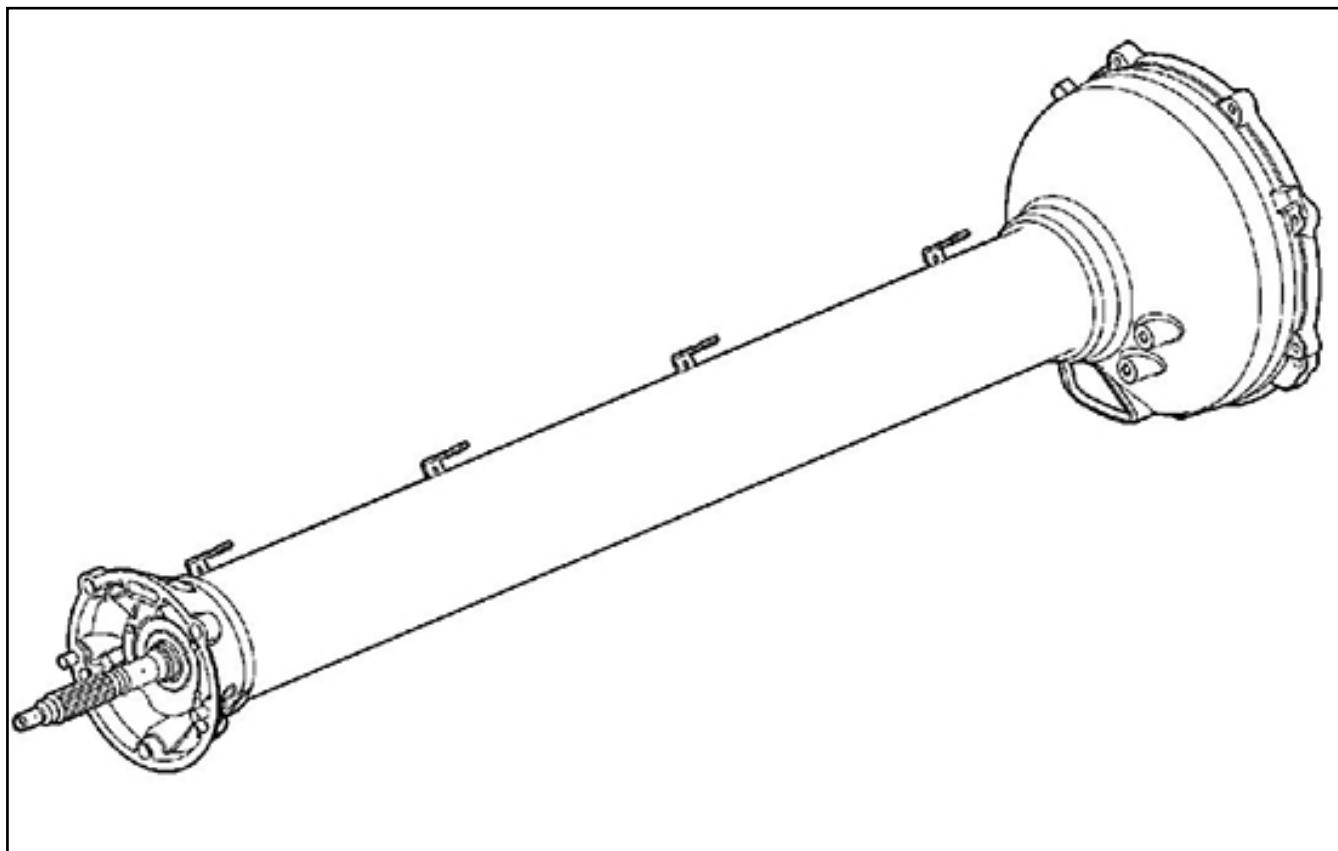
Fig 7

If the driveline support (torque tube) is removed from the 2014 Corvette for any reason, special care must be taken to make sure the propeller shaft splines are in alignment with the front hub bearing. The Driveline Support (Fig. 7) must be aligned with the engine bell housing before attempting to tighten any attachment bolts.

TIP: The propeller input shaft front bearing positioning system is designed to withstand an insertion force of no more than 582 Y (130 lb). If the

fastening bolts are used as an installation method, it may create force above this amount and damage the crankshaft thrust bearing.

When reinstalling the driveline support, the angle may be slightly off horizontally or vertically. This can make the driveline support difficult to align. Do not use the bell housing attachment bolts to draw the driveline support tight against the bell housing. Any small amount of misalignment may cause the input splines of the propeller shaft to catch on the crankshaft, driving it forward. If the engine is started in this condition, it may cause the crankshaft thrust bearing to be immediately worn, necessitating engine replacement.

Refer to the appropriate Service Information for complete procedures on alignment and installation of the driveline support to ensure that the propeller shaft is properly aligned to the front hub bearing.
