# 2014 Corvette: Techlink Article: Tire Chatter

**Source:** GM TechLink

**Date:** December 5, 2013

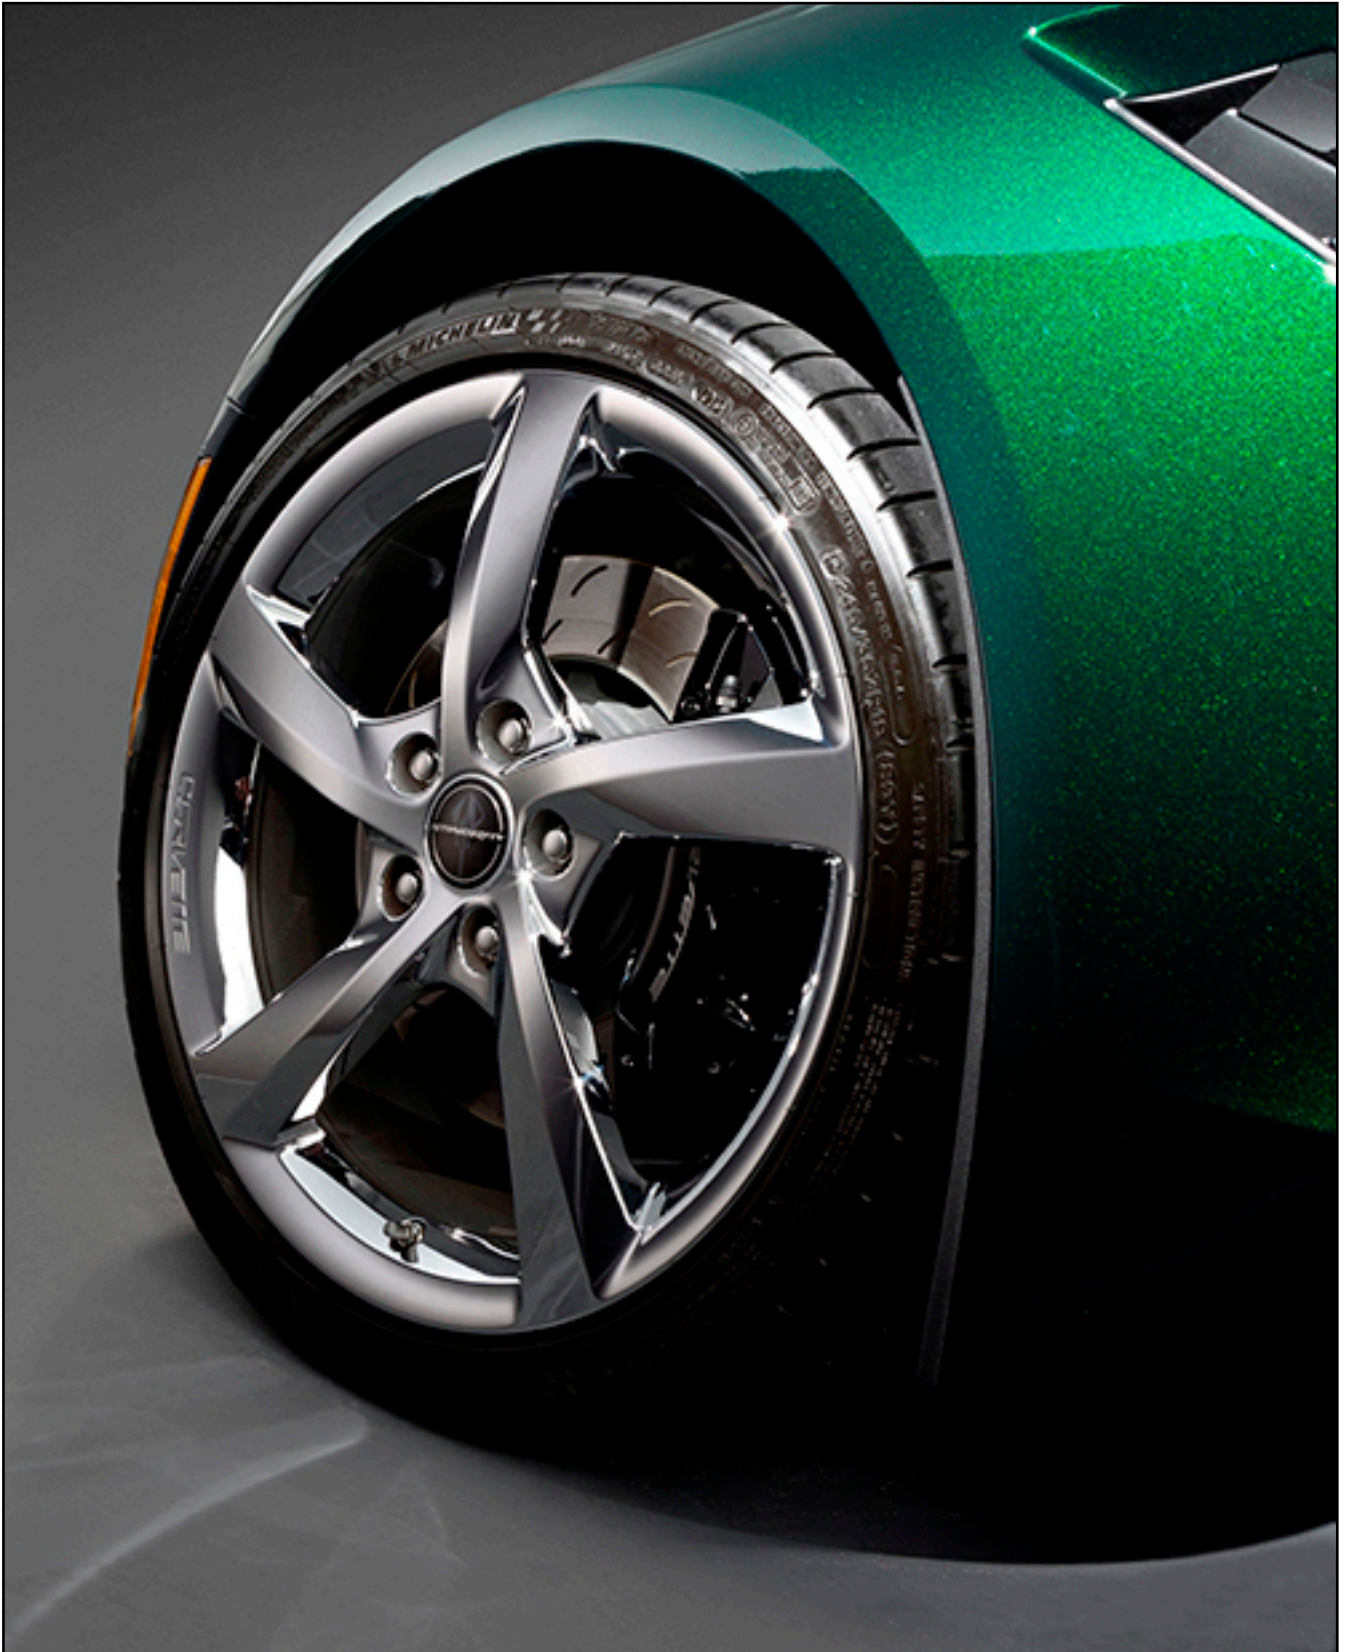
## **Fig. 9**

The 2014 Corvette is equipped with standard P245/40ZR18 front and P285/35ZR19 rear performance summer-only tires and the Z51 Performance Package includes P245/35ZR19 front and P285/30ZR20 rear Michelin Pilot Super Sport ZP summer-only tires. (Fig. 9) These tires may have a chatter noise during low speed turns.

Tire chatter noise, caused by the large amount of tire scrubbing across the pavement, occurs most often during low speed, tight turns (in all directions) when the tires are cool, usually after an extensive ambient soak of the vehicle. The chatter typically diminishes when the tires warm up, but may increase on wet pavement. This is a normal characteristic of the high-performance tires.
