1977 - 1978 Corvette: Service Bulletin: Rear Bumper Cover Wavy

Model and Year: 1977 - 1978 Corvette

Number: 78-T-42

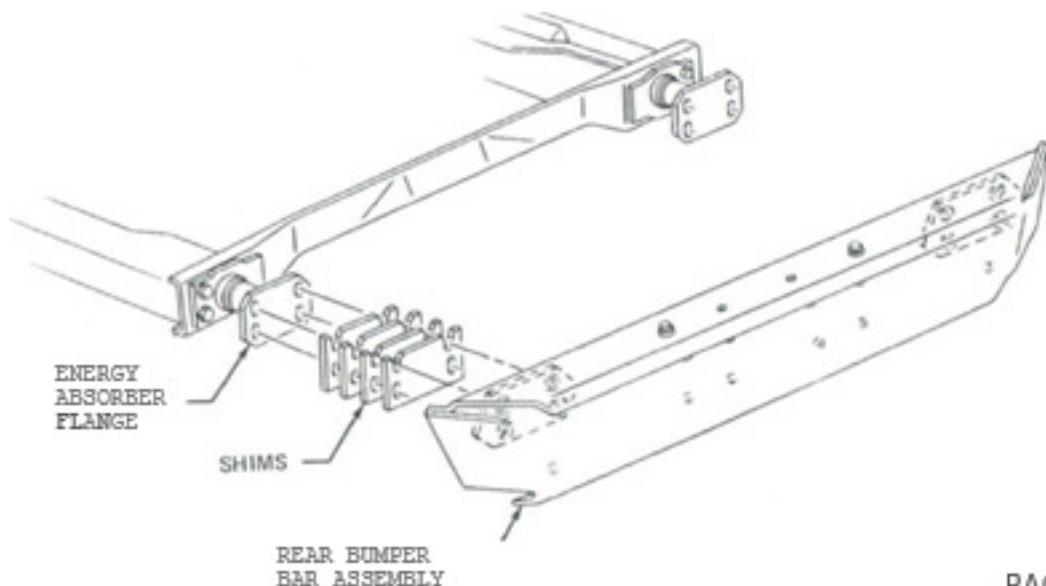
Some 1977-78 Corvettes may exhibit a wavy rear bumper cover above the tail lamps. This condition could be caused by the position of the rear bumper bar relative to the energy absorber. In January, 1978, the assembly plant started using a fixture to improve the adjustment of the bar, thus eliminating the distortion.

1. Loosen the bolts which attach the rear bumper bar to the energy absorber assembly. See illustration. To remove depressions from the cover, raise the bumper bar. If the cover is bulged, lower the bar. If a satisfactory fit is obtained, tighten the bolts (70 Nm/52 ft. lb.). If the cover is still wavy, mark the bumper bar at the point of best vertical fit to the energy absorber.
2. Remove the lower two bolts on each side. Refer to illustration. Since the shims are slotted at the top, removal of the upper bolts is not required.
3. The bar is shimmed at assembly, but may not be at the optimum position. Adding shims (PIN 473279) will stretch the cover and removing shims will

relax it. Shims should be added or removed one at a time.

4. When a satisfactory cover fit is achieved, tighten the energy absorber to bumper bar bolts.

Each site must be adjusted independently. Due to manufacturing tolerances, one side of the bar may have more shims than the other and be at a different position in the energy absorber slots.
