# 1977 - 1978 Corvette: Service Bulletin: Rear Bumper Cover Wavy

**Subject:** Rear Bumper Cover Wavy  
**Model and Year:** 1977 - 1978 Corvette  
**Source:** Chevrolet Dealer Service Bulletin  
**Number:** 78-T-42  
**Section:** XIV  
**Date:** July 1978

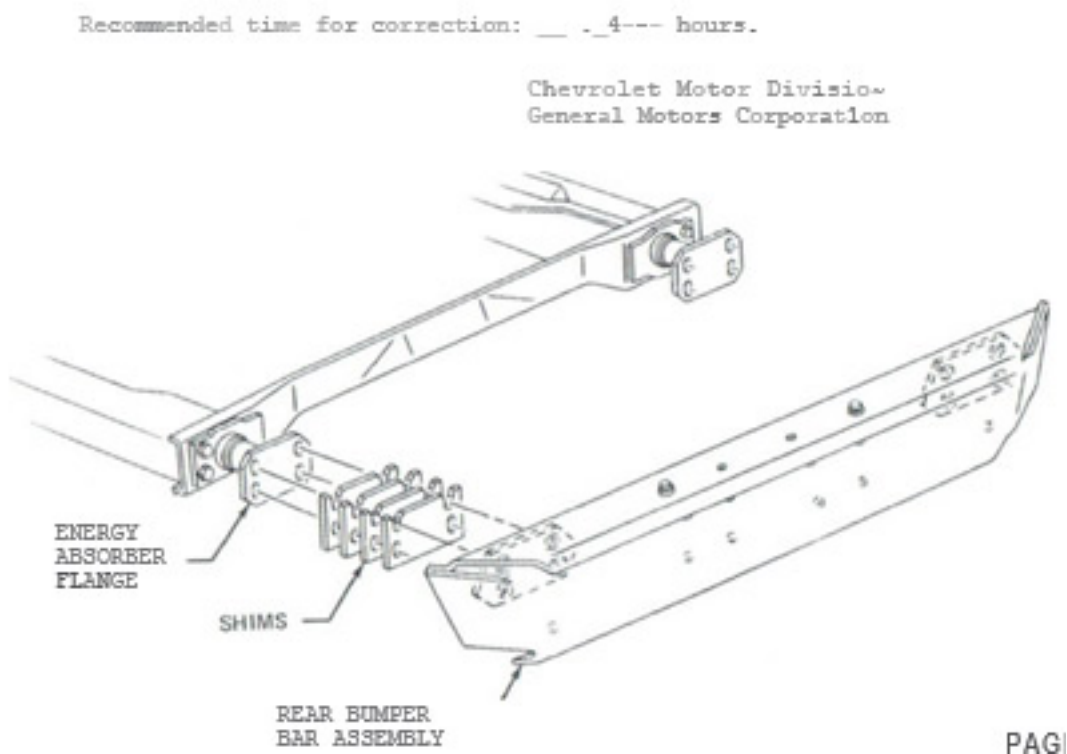
Some 1977-78 Corvettes may exhibit a wavy rear bumper cover above the tail lamps. This condition could be caused by the position of the rear bumper bar relative to the energy absorber. In January, 1978, the assembly plant started using a fixture to improve the adjustment of the bar, thus eliminating the distortion.

1. Loosen the bolts which attach the rear bumper bar to the energy absorber assembly. See illustration. To remove depressions from the cover, raise the bumper bar. If the cover is bulged, lower the bar. If a satisfactory fit is obtained, tighten the bolts (70 Nm/52 ft. lb.). If the cover is still wavy, mark the bumper bar at the point of best vertical fit to the energy absorber.
2. Remove the lower two bolts on each side. Refer to illustration. Since the shims are slotted at the top, removal of the upper bolts is not required.
3. The bar is shimmed at assembly, but may not be at the optimum position. Adding shims (PIN 473279) will stretch the cover and removing shims will

relax it. Shims should be added or removed one at a time.

4. When a satisfactory cover fit is achieved, tighten the energy absorber to bumper bar bolts.

Each site must be adjusted independently. Due to manufacturing tolerances, one side of the bar may have more shims than the other and be at a different position in the energy absorber slots.
