# 1977 - 1978 Corvette: Service Bulletin: Rear Bumper Cover Wavy

**Subject:** Rear Bumper Cover Wavy  
**Model and Year:** 1977 - 1978 Corvette  
**Source:** Chevrolet Dealer Service Bulletin  
**Number:** 78-T-42  
**Section:** XIV  
**Date:** July 1978

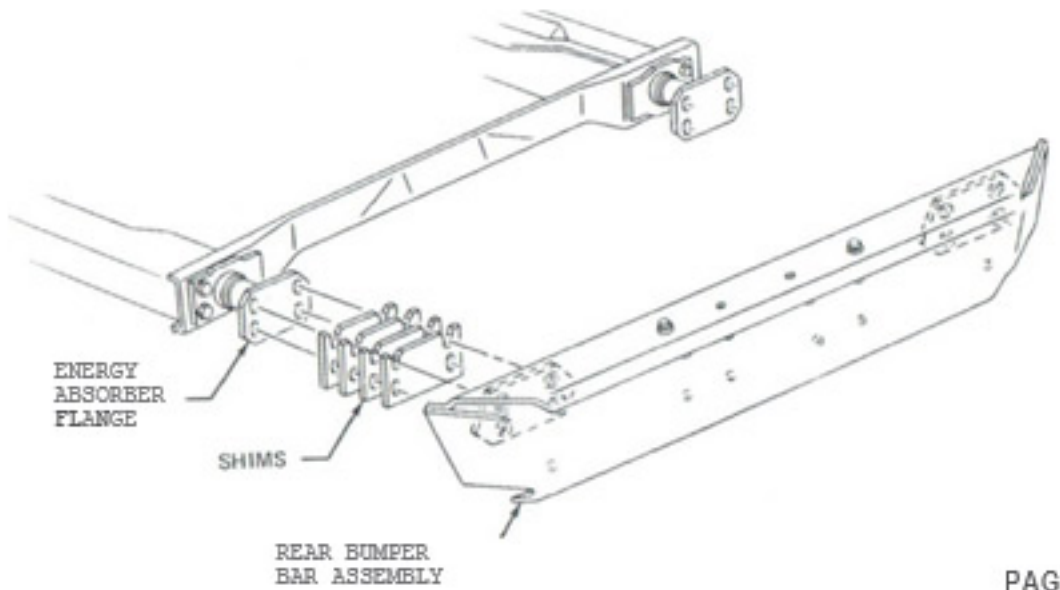
Some 1977-78 Corvettes may exhibit a wavy rear bumper cover above the tail lamps. This condition could be caused by the position of the rear bumper bar relative to the energy absorber. In January, 1978, the assembly plant started using a fixture to improve the adjustment of the bar, thus eliminating the distortion.

1. Loosen the bolts which attach the rear bumper bar to the energy absorber assembly. See illustration. To remove depressions from the cover, raise the bumper bar. If the cover is bulged, lower the bar. If a satisfactory fit is obtained, tighten the bolts (70 Nm/52 ft. lb.). If the cover is still wavy, mark the bumper bar at the point of best vertical fit to the energy absorber.
2. Remove the lower two bolts on each side. Refer to illustration. Since the shims are slotted at the top, removal of the upper bolts is not required.
3. The bar is shimmed at assembly, but may not be at the optimum position. Adding shims (PIN 473279) will stretch the cover and removing shims will relax it. Shims should be added or removed one at a time.
4. When a satisfactory cover fit is achieved, tighten the energy absorber to bumper bar bolts.

Each site must be adjusted independently. Due to manufacturing tolerances, one side of the bar may have more shims than the other and be at a different position in the energy absorber slots.
