1999 - 2001 Corvette: Service Bulletin: Windnoise Around B-Pillar (Add Sealer)

Number: 01-08-58-001

Subject: Windnoise Around B-Pillar (Add Sealer)

Model Year: 1999-2001 Corvette Hardtop

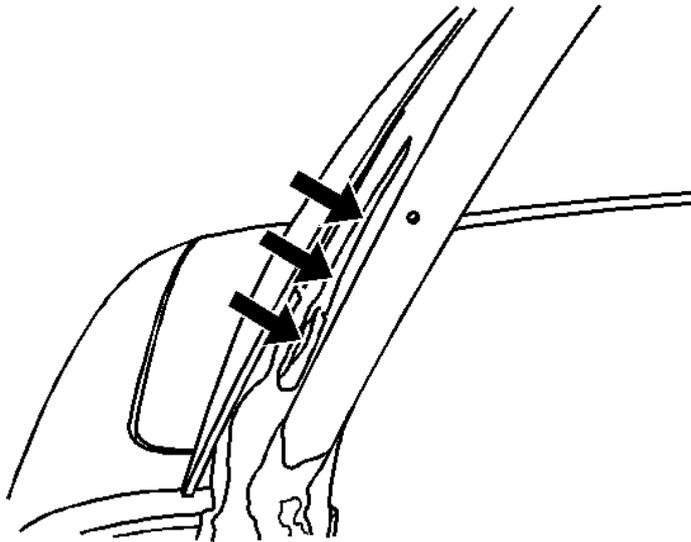
Some owners may comment on windnoise around the B-pillar.

The windnoise may be caused by a void in the sealer behind the B-pillar weatherstrip retainer.

Remove the weatherstrip retainer and the B-pillar exterior molding. Seal the void with GM RTV Silicone Rubber Sealant-Black, P/N 12345739 (in Canada, use P/N 10953541).
