# 1999 - 2001 Corvette: Service Bulletin: Windnoise Around B-Pillar (Add Sealer)

**Number:** 01-08-58-001

**Subject:** Windnoise Around B-Pillar (Add Sealer)

Model Year: 1999-2001 Corvette Hardtop

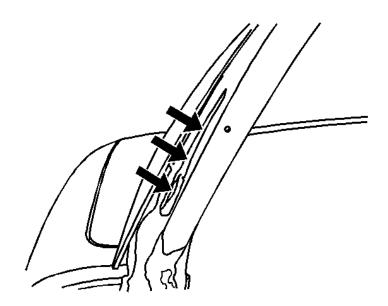
Some owners may comment on windnoise around the B-pillar.

The windnoise may be caused by a void in the sealer behind the B-pillar weatherstrip retainer.

Remove the weatherstrip retainer and the B-pillar exterior molding. Seal the void with GM RTV Silicone Rubber Sealant-Black, P/N 12345739 (in Canada, use P/N 10953541).
