# 1999 - 2001 Corvette: Service Bulletin: Windnoise Around B-Pillar (Add Sealer)

**Number:** 01-08-58-001

**Model Year:** 1999-2001 Corvette Hardtop

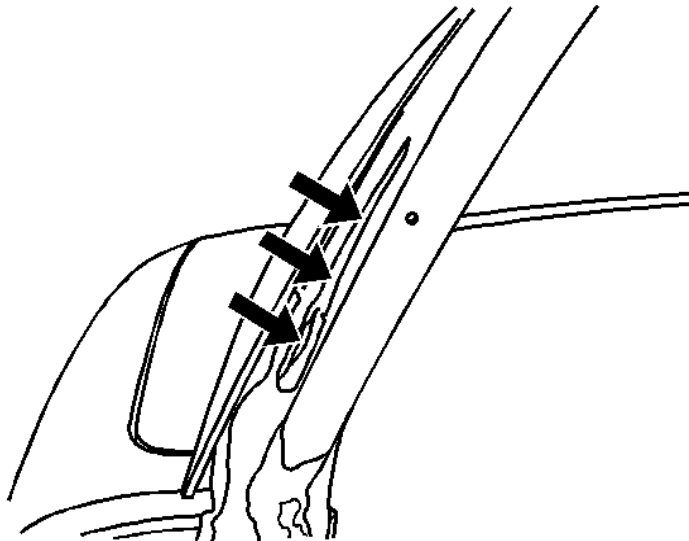
The windnoise may be caused by a void in the sealer behind the B-pillar weatherstrip retainer.

Remove the weatherstrip retainer and the B-pillar exterior molding. Seal the void with GM RTV Silicone Rubber Sealant-Black, P/N 12345739 (in Canada, use P/N 10953541).
