1997 - 1998 Corvette: Chevrolet Pro Service News: Water Leak Repair Guide

Source: Chevrolet Pro Service News

Date: June 1998, Volume 7, Issue Number 6

Subject: Corvette Water Leak Repair

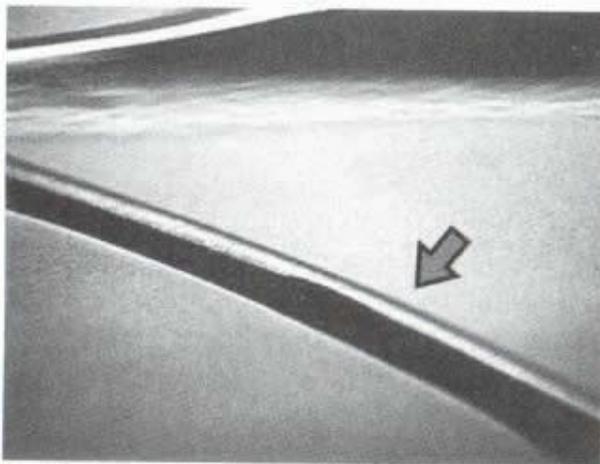
Rolled roof bow weatherstrip

A drip from either rear corner of the roof panel is generally the simplest to correct. First, confirm the leak. Then check to see whether the forward edge of the roof weatherstrip has rolled rearward and overlaps the rear weatherstrip edge. The condition is caused during incorrect roof panel installation, where the customer lays the roof panel flat, and slides it into place from the front to the rear.

To correct it, remove the panel and position the rear dowel pins first. Use the dowel pins as pivots to lower the front of the panel onto its seal, then secure the roof latches.

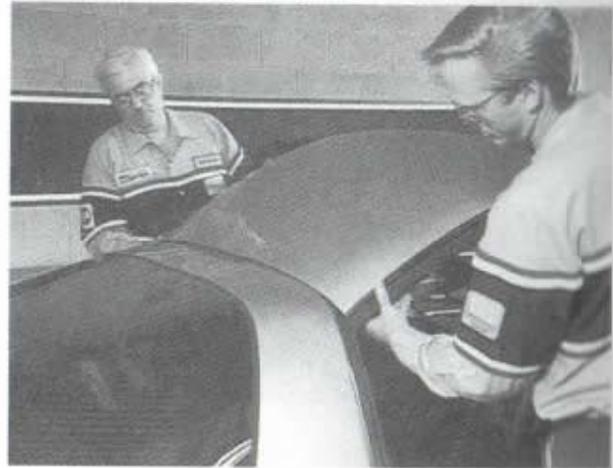
Pivoting roof panel on dowel pins

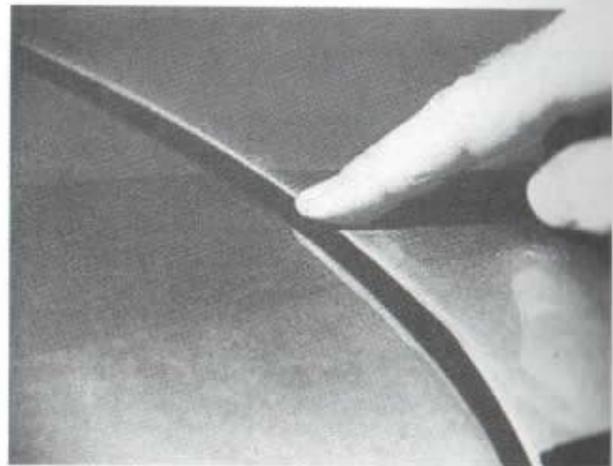
Smooth rear weatherstrip seal edge

Confirm that only the smooth edge of the rear weatherstrip seal is visible with the roof panel installed. You can prevent comebacks for this condition by demonstrating proper roof panel installation to the customer.

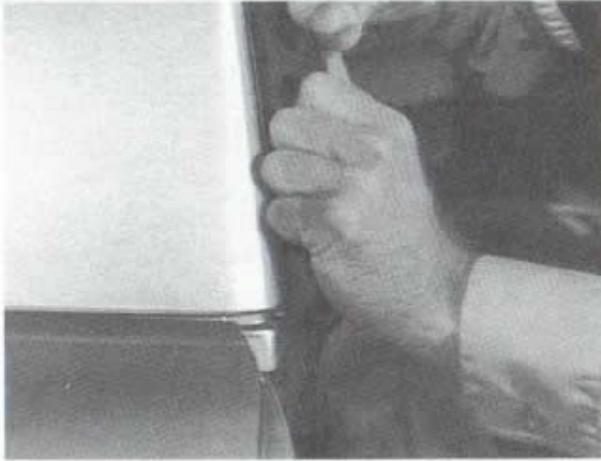
A leak at the rear edge of either door window results from a lack of contact pressure between the window and the roof bow weatherstrip. To correct it, firmly grasp the roof bow side glass weatherstrip at its midway point up the glass. Then stretch the lower portion of the weatherstrip down in its retainer, forming a slight bulge near the bottom.

Stretching lower portion of weatherstrip downward

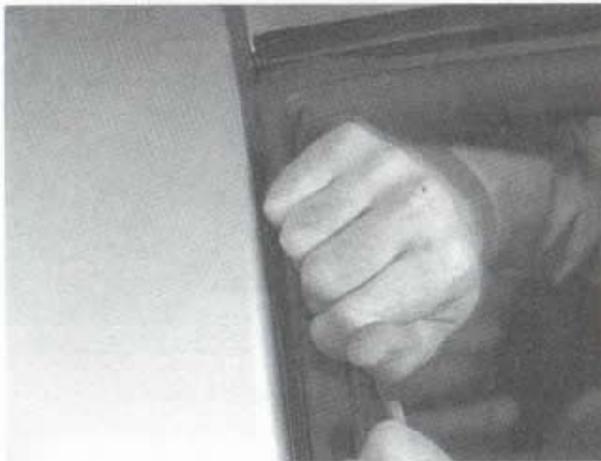
Stretching upper portion of weatherstrip upward

Continue holding the center of the weatherstrip in place, and stretch its upper portion snug against the roof weatherstrip. If the area still leaks, rear window tip-in adjustment is necessary to increase pressure between the door glass and the roof bow weatherstrip.

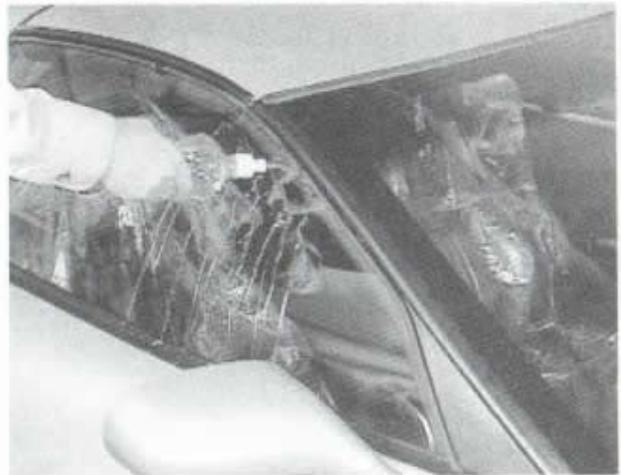
Window tip-in adjustments can also affect leaks at the front edge of the door glass. A confirmed leak along the windshield weatherstrip means you'll need to increase tip-in at the front of the window, ahead of the blow-out clip.

Leaks ahead of the blow-out clip require tip-in adjustment.

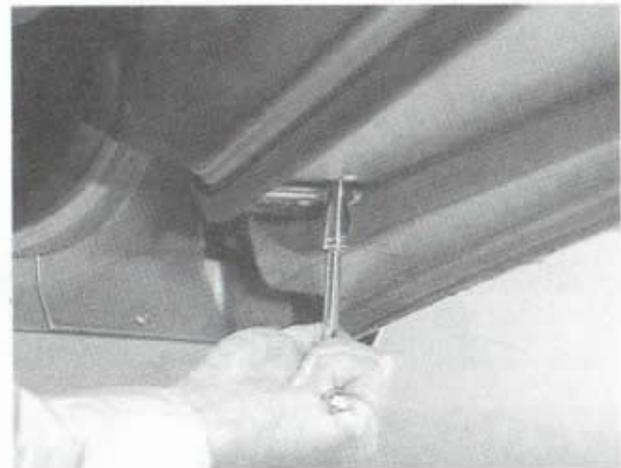
Loosening front lower regulator nut

Start front tip-in adjustments by removing the front lower access plug from the door. Loosen the front lower regulator nut inside the door, slide the regulator outboard and retighten the nut. Reinstall the lower access plug.

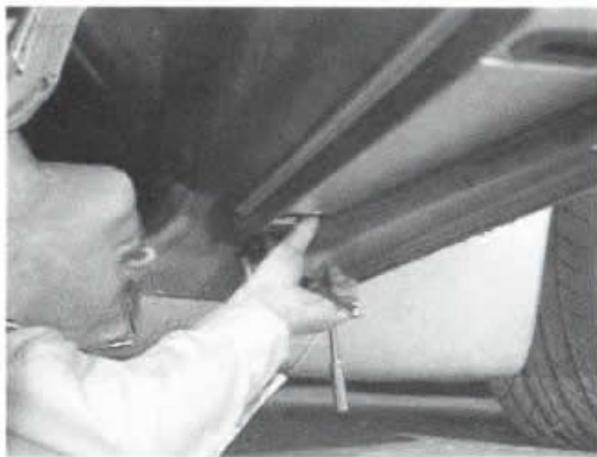
Sliding regulator outboard

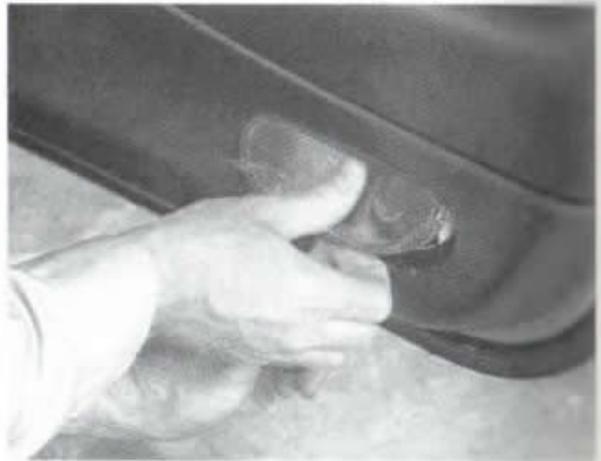
Removing reflector

If rear window tip-in is necessary, remove the reflector from the door after removing the front plug and loosening the regulator nut. Loosen the jack screw jam nut, and turn the jack screw counterclockwise to increase rear tip-in pressure. Finish by locking down the jam nut and re-installing the door reflector.

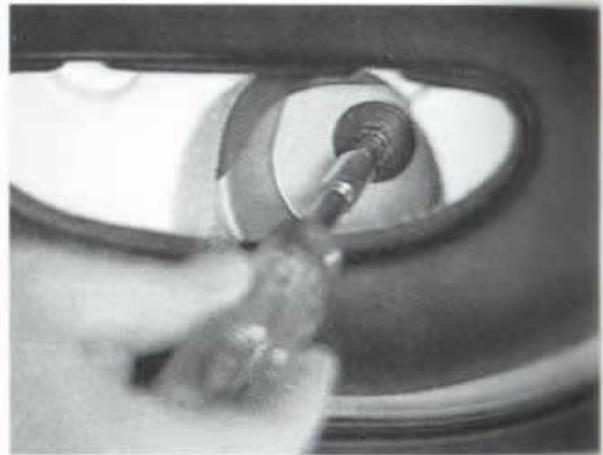
Jack screw is located behind reflector.

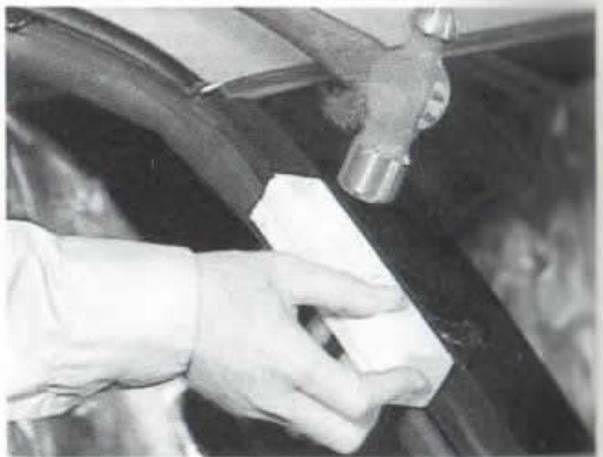
Bending windshield weatherstrip retainer downward

If door glass front edge leaks persist following tip-in adjustment, place a block of wood along the lip of the windshield weatherstrip retainer. Tap the block with a hammer to bend the retainer slightly downward toward the window.

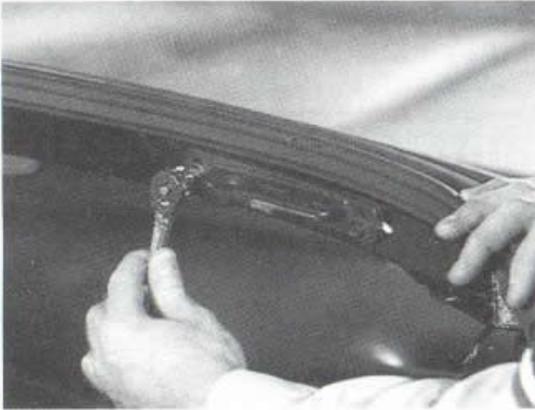
Leaks from the roof at the upper corner of the A-pillar are caused by a lack of contact pressure between the roof panel and the windshield weatherstrip. This condition requires a roof latch adjustment. After water-testing, remove the roof panel, upper garnish trim and sunshades. Then loosen the latch striker bolts on each side. Adjust the strikers downward to increase the contact pressure of the roof panel to the windshield weatherstrip. Retighten the bolts, reinstall the roof panel and water-test to confirm the fix, and reinstall the garnish trim and sunshades.

Loosening latch striker bolts

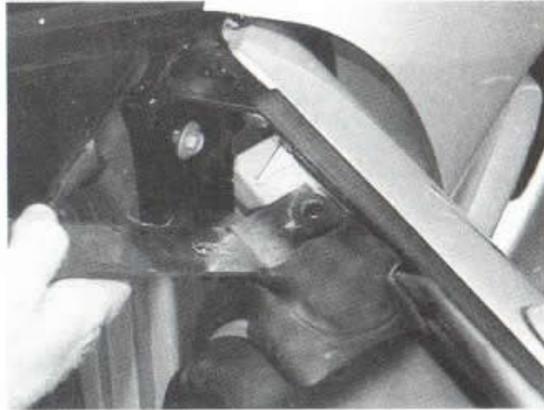
Complaints of leaks from the bottom of the windshield A-pillar onto the door trim panel are due to a collapsing door weatherstrip pocket. The collapsed pocket results in a lack of contact pressure between the windshield and door weatherstrips. After water-testing, remove the fir tree fastener at the front lip of the door weatherstrip. Then obtain a piece of closed-cell foam weatherstripping, about 1/2 inch in diameter by 1-1/2 inches long (12mm x 62mm). Rubber hose will also work. The insert stuffer simply needs to be water-resistant and moderately resilient.

Fir tree fastener at front lip of door weatherstrip

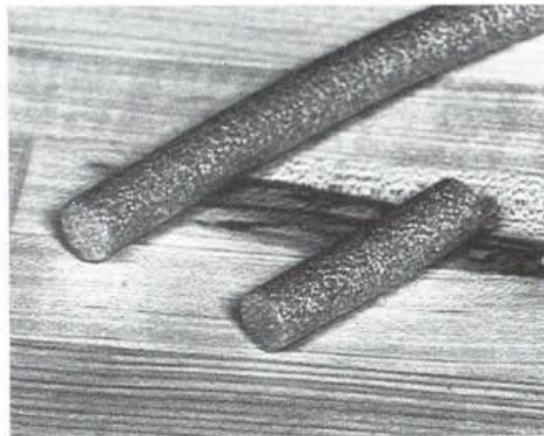
Closed-cell foam weatherstrip, 1/2 inch in diameter, 1-1/2 inches long

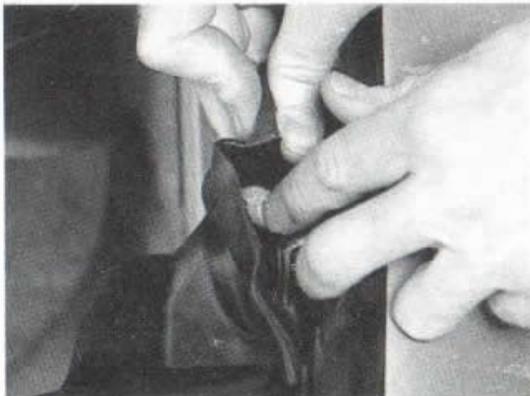
Inserting stuffer into door weatherstrip pocket

Push the stuffer into the door weatherstrip pocket until it just reaches the edge of the door trim panel. The stuffer increases contact pressure between the weatherstrips inboard of the A-pillar weatherstrip drain. It also prevents the collapse of the door weatherstrip under pressure.
